भारत सरकार  
Government of India  
विद्युत मंत्रालय  
Ministry of Power  
उत्तर क्षेत्रीय विद्युत समिति  
Northern Regional Power Committee

**विषय:** संरक्षण उप-समिति की 45<sup>वीं</sup> बैठक के कार्यवृत्त।  
**Subject:** Minutes of 45<sup>th</sup> Protection Sub-Committee Meeting.

## ***Minutes of 45<sup>th</sup> Meeting of Protection Sub-committee***

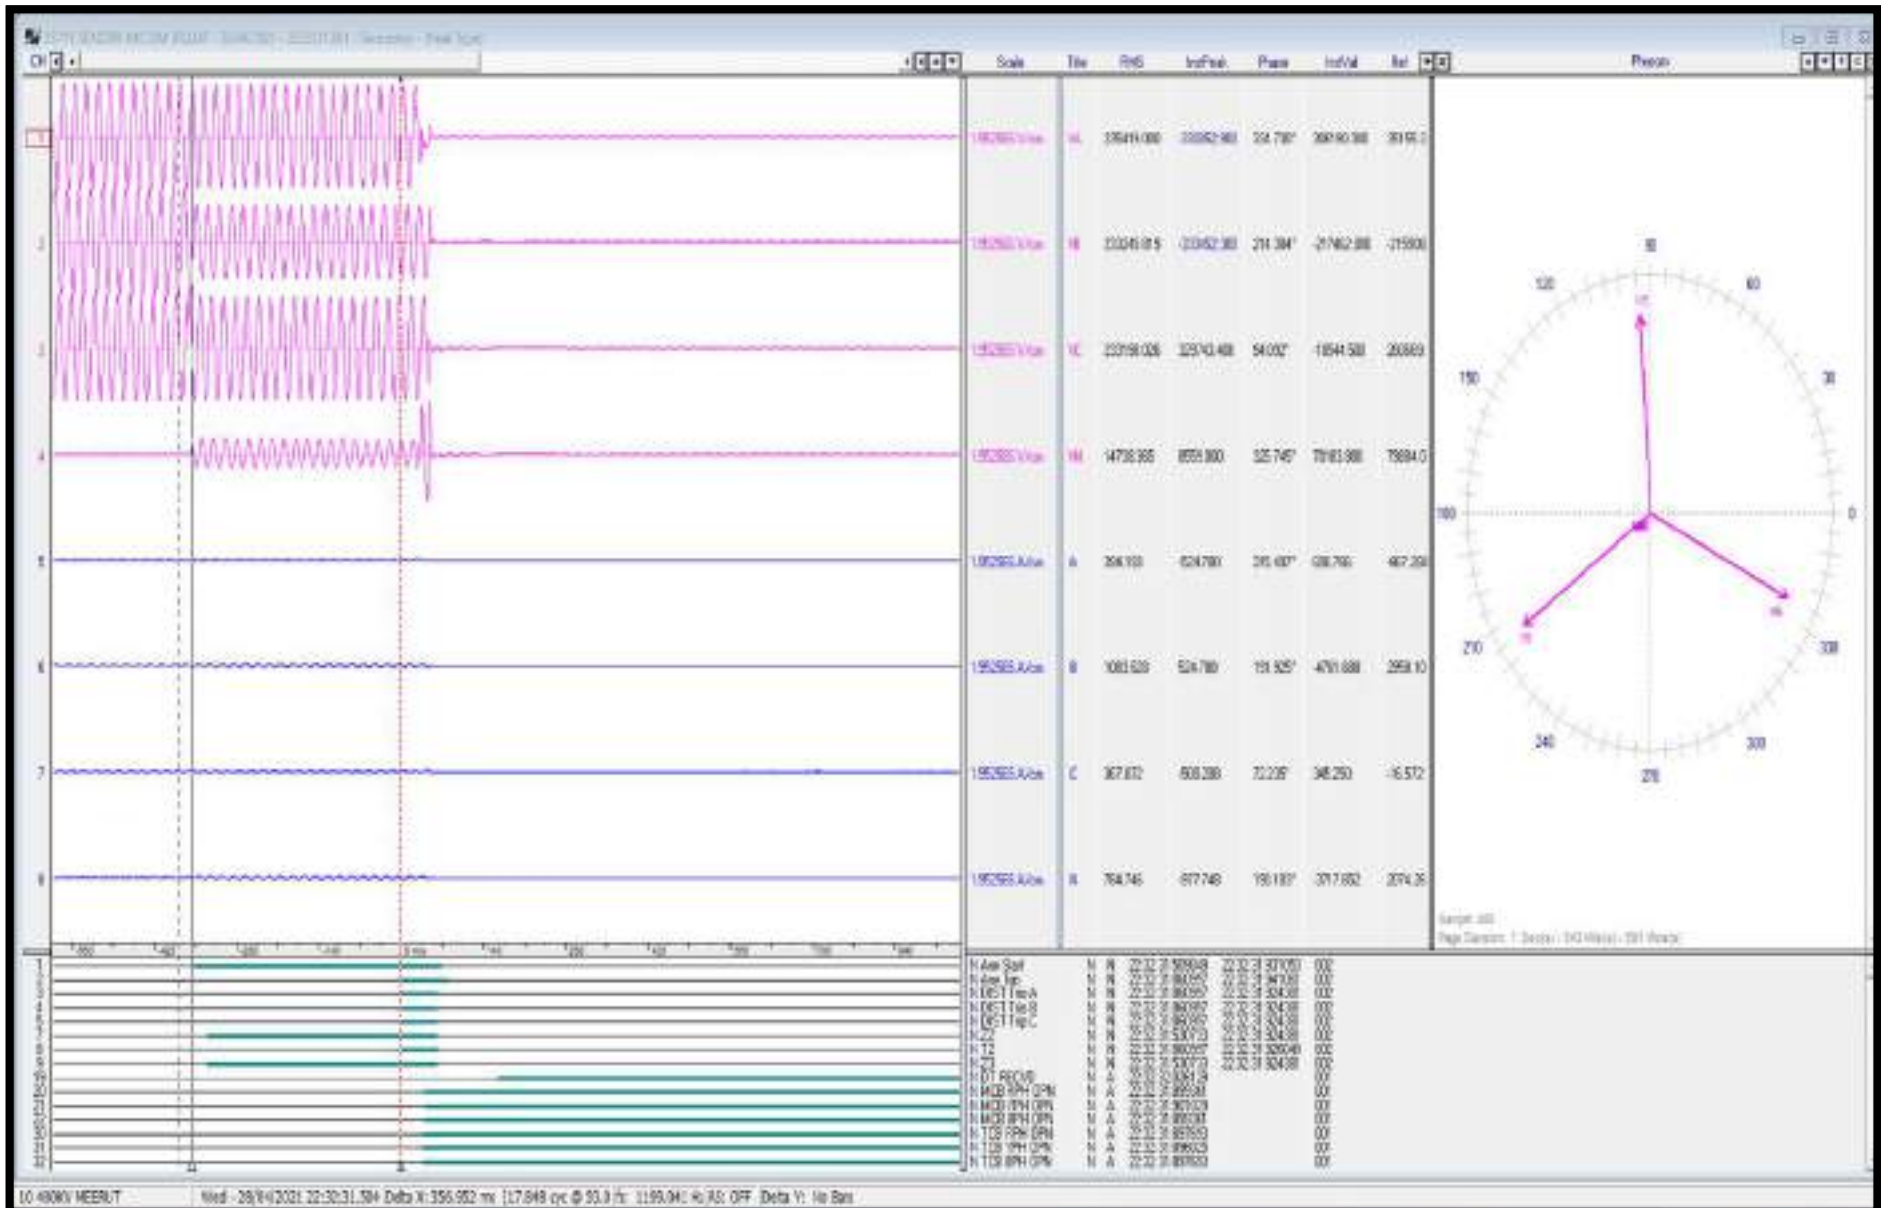
# DR of 400kV Muzaffarnagar-Meerut(end)

Z-2 trip within 350ms, DT received after 500ms

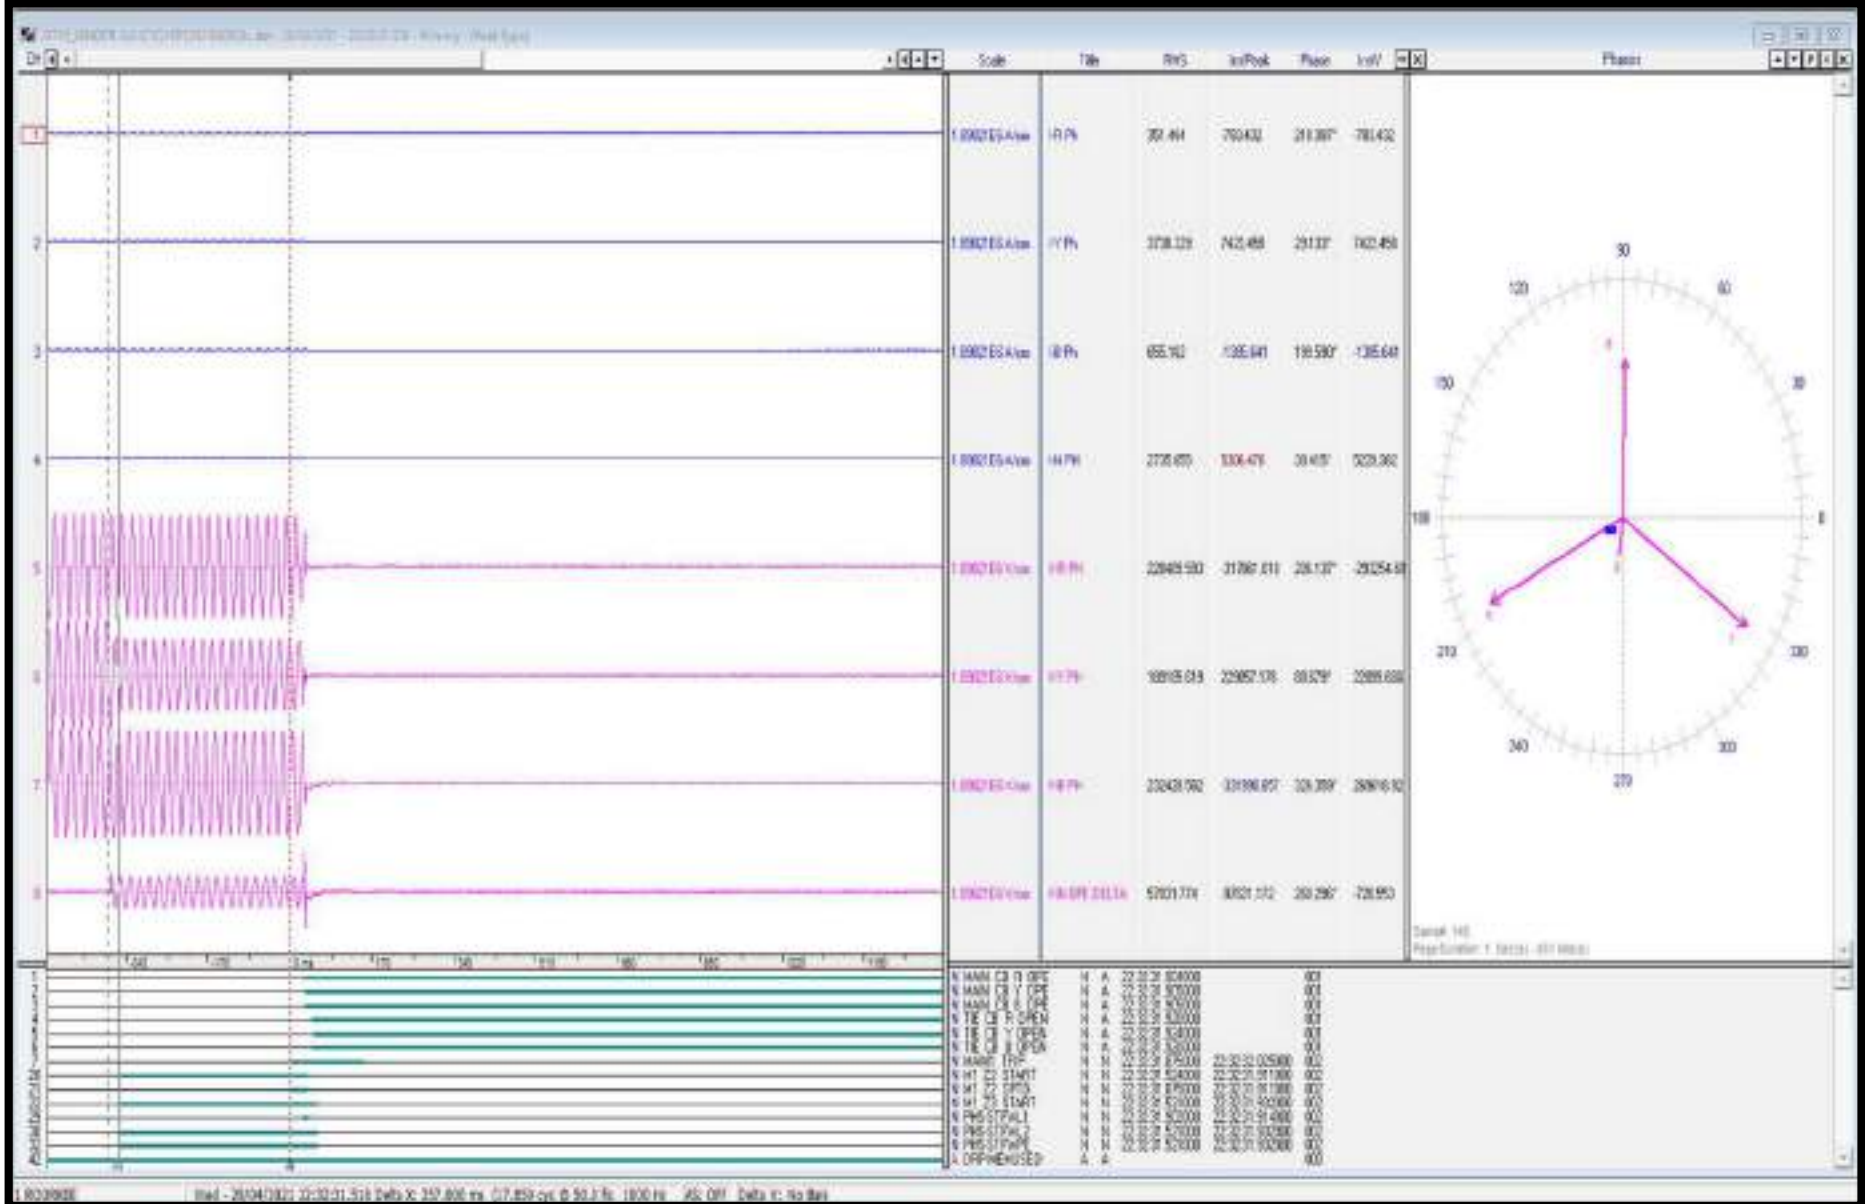
# DR of 400kV Muzaffarnagar-Roorkee(end)

Z-2 trip within 350ms

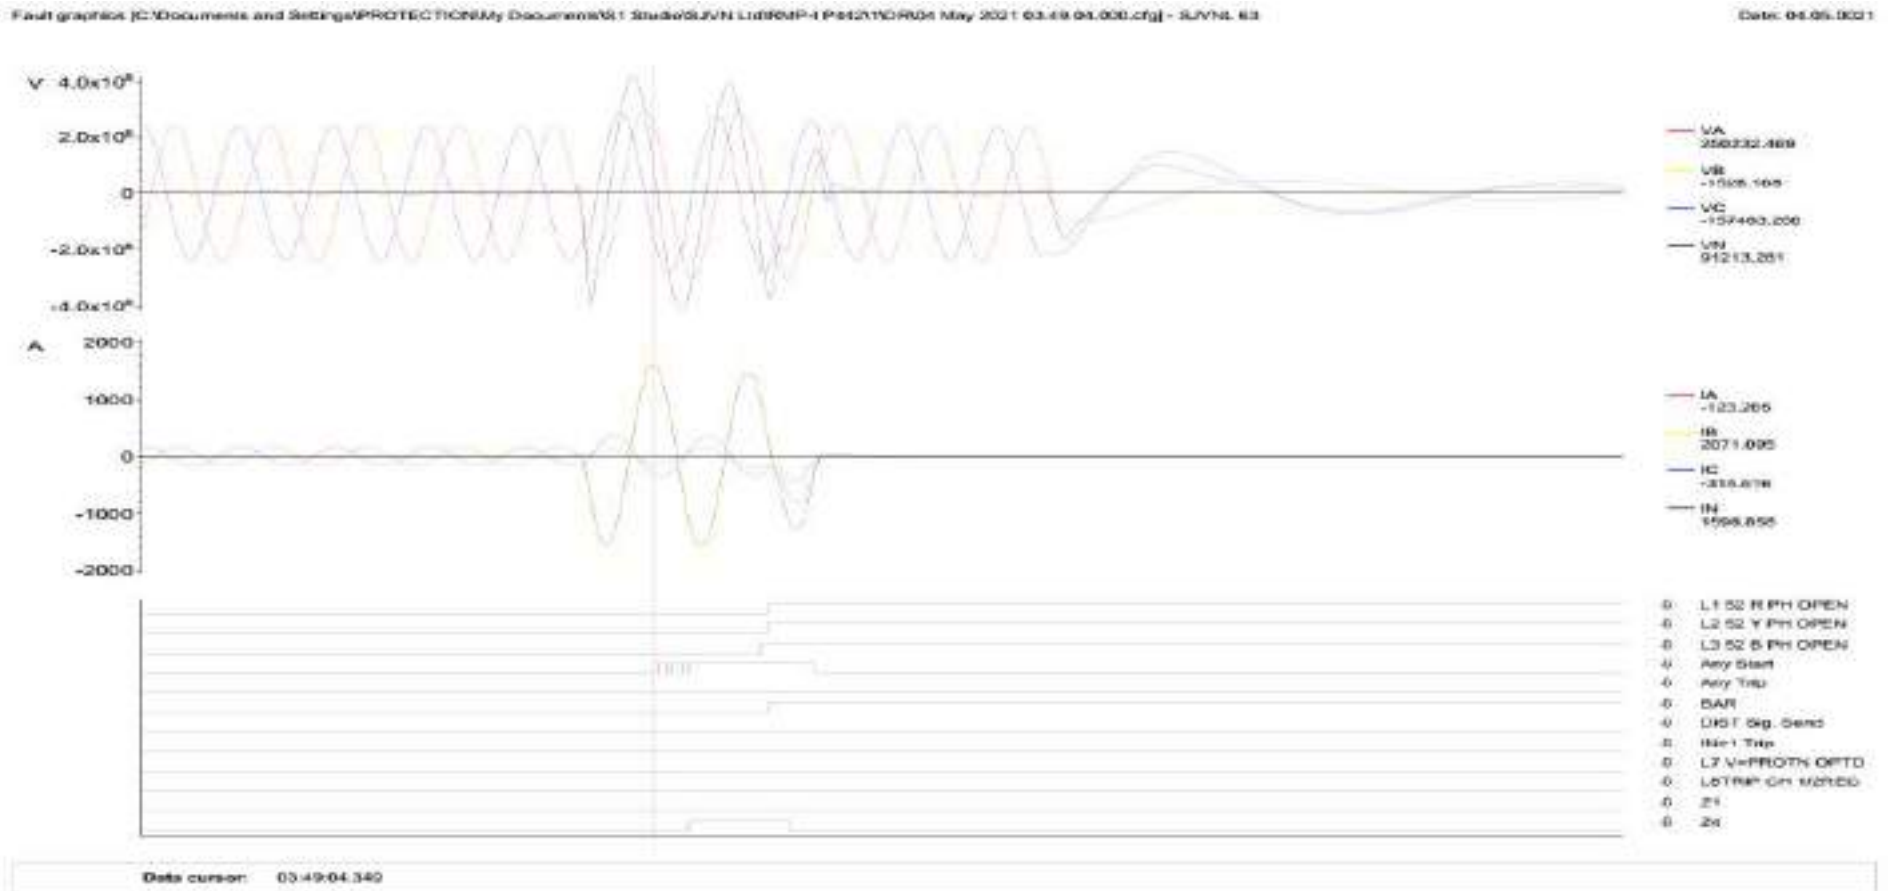
On dated 04.05.2021, as per initial investigation carried out, there is no fault in the 400KV GIS System (Busbar-2) The probable cause of Busbar-2 operation may be due to some wiring/CT polarity issue.

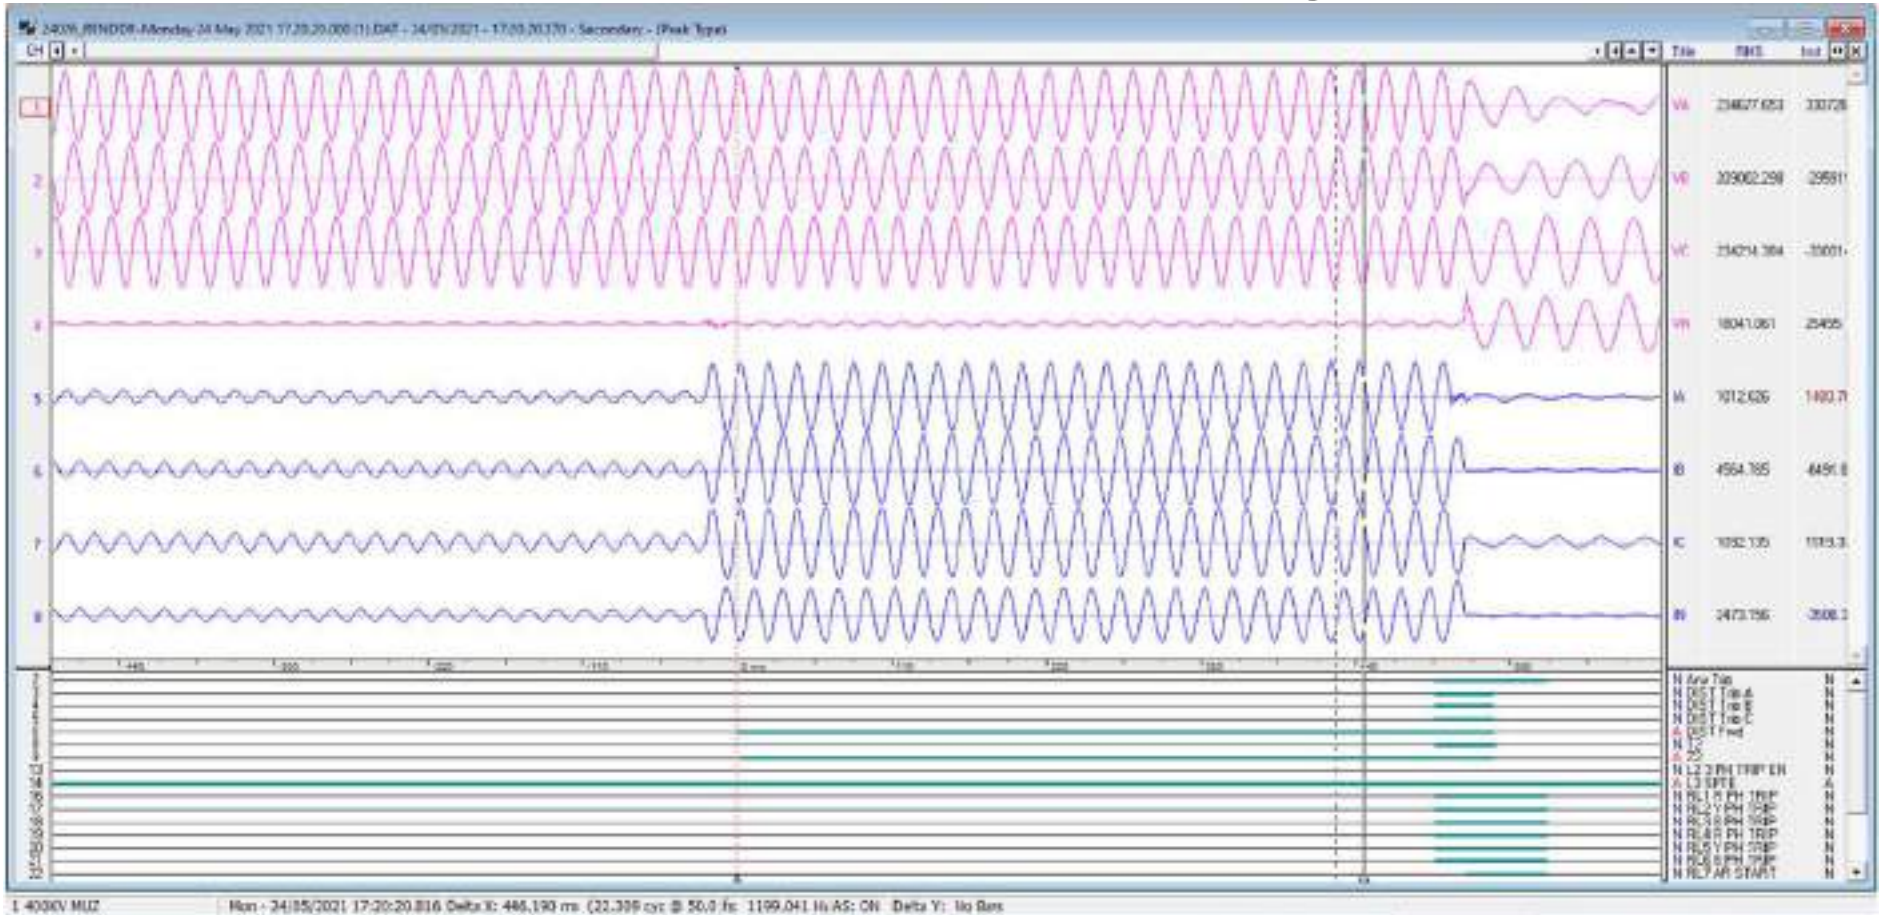
# DR of 400KV Alknanda GVK(UPC)-Muzaffarnagar (UP)(End)Ckt-1

1. Tripped in Zone-2 from Muzaffarnagar end.
2. Fault current observed in all 3- phases.

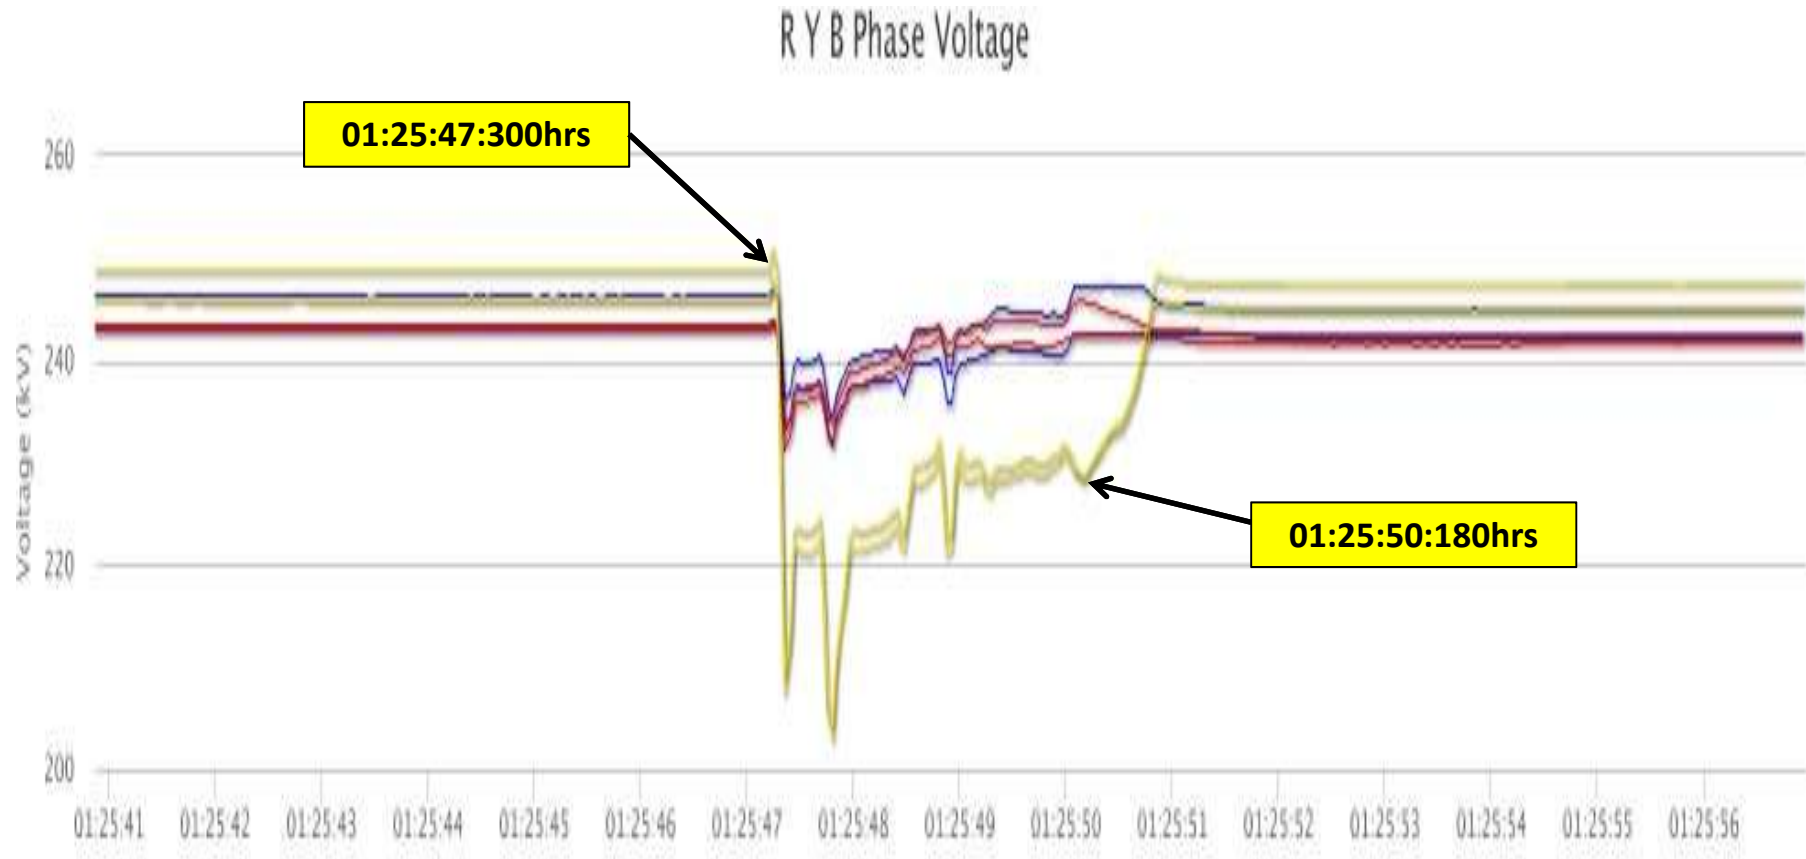
01:25hrs/17-June-21

**As per PMU, Y-N phase to earth fault with delayed clearance in 3880ms is observed.**

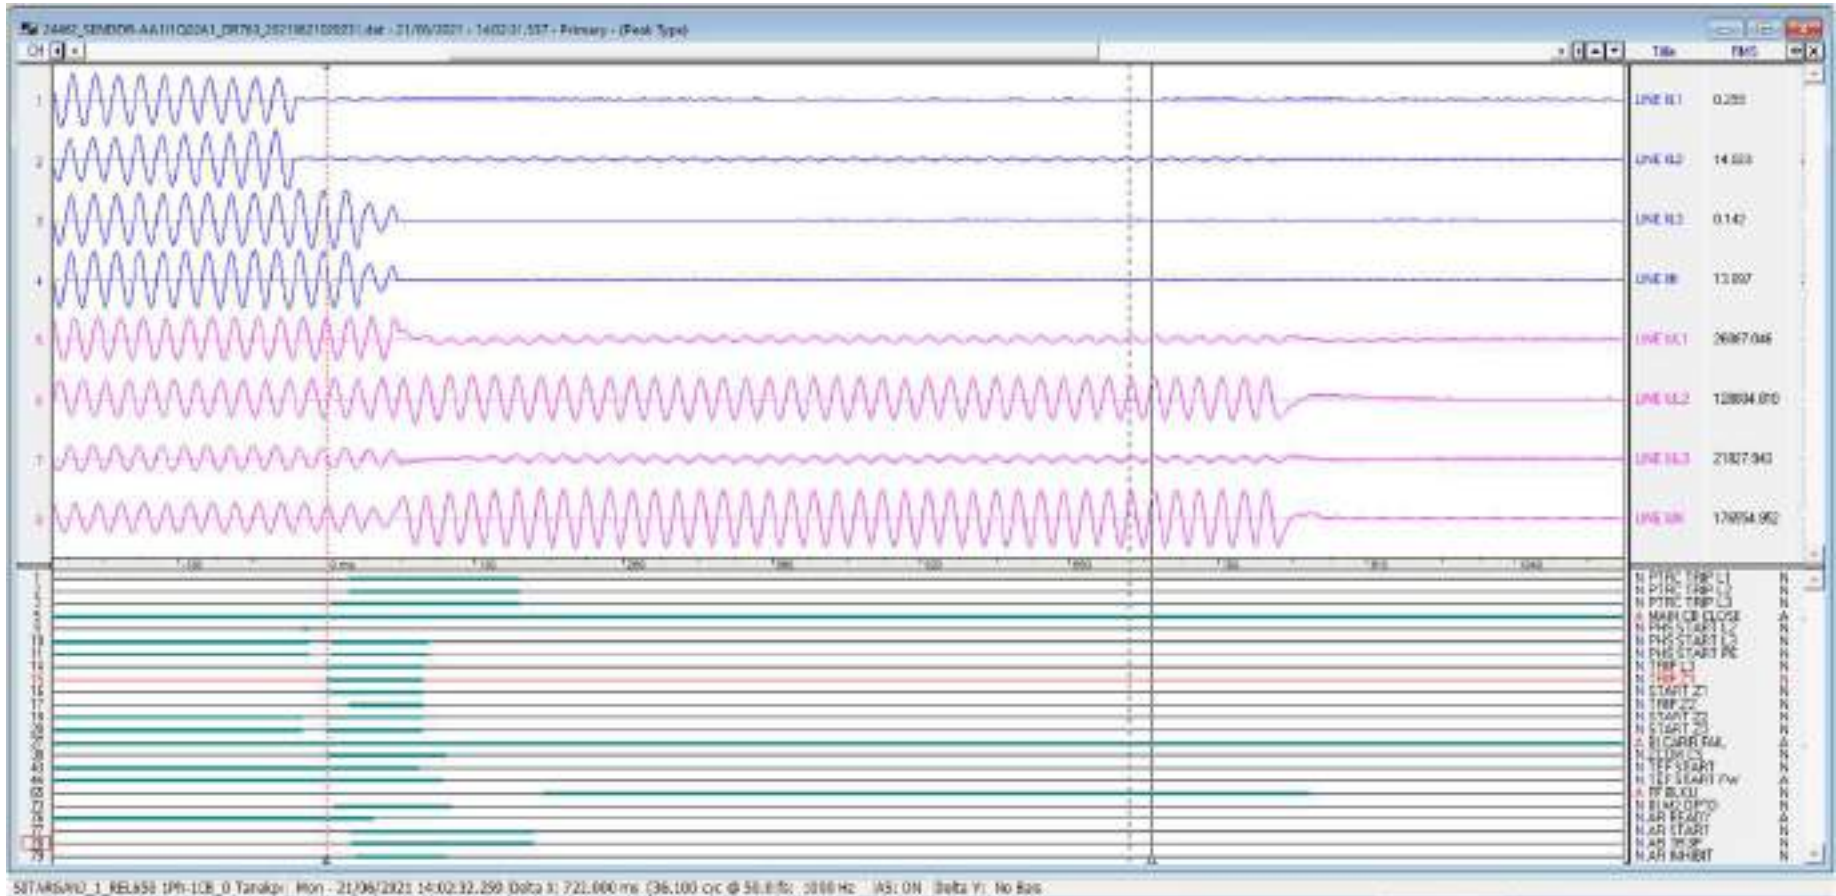
# DR of 220 kV Tanakpur(NH) (End)– Sitarganj -1

1. B-Earth fault visible in DR.
2. Line tripped in Zone-1.
3. AR not attempted. Carrier is showing fail.

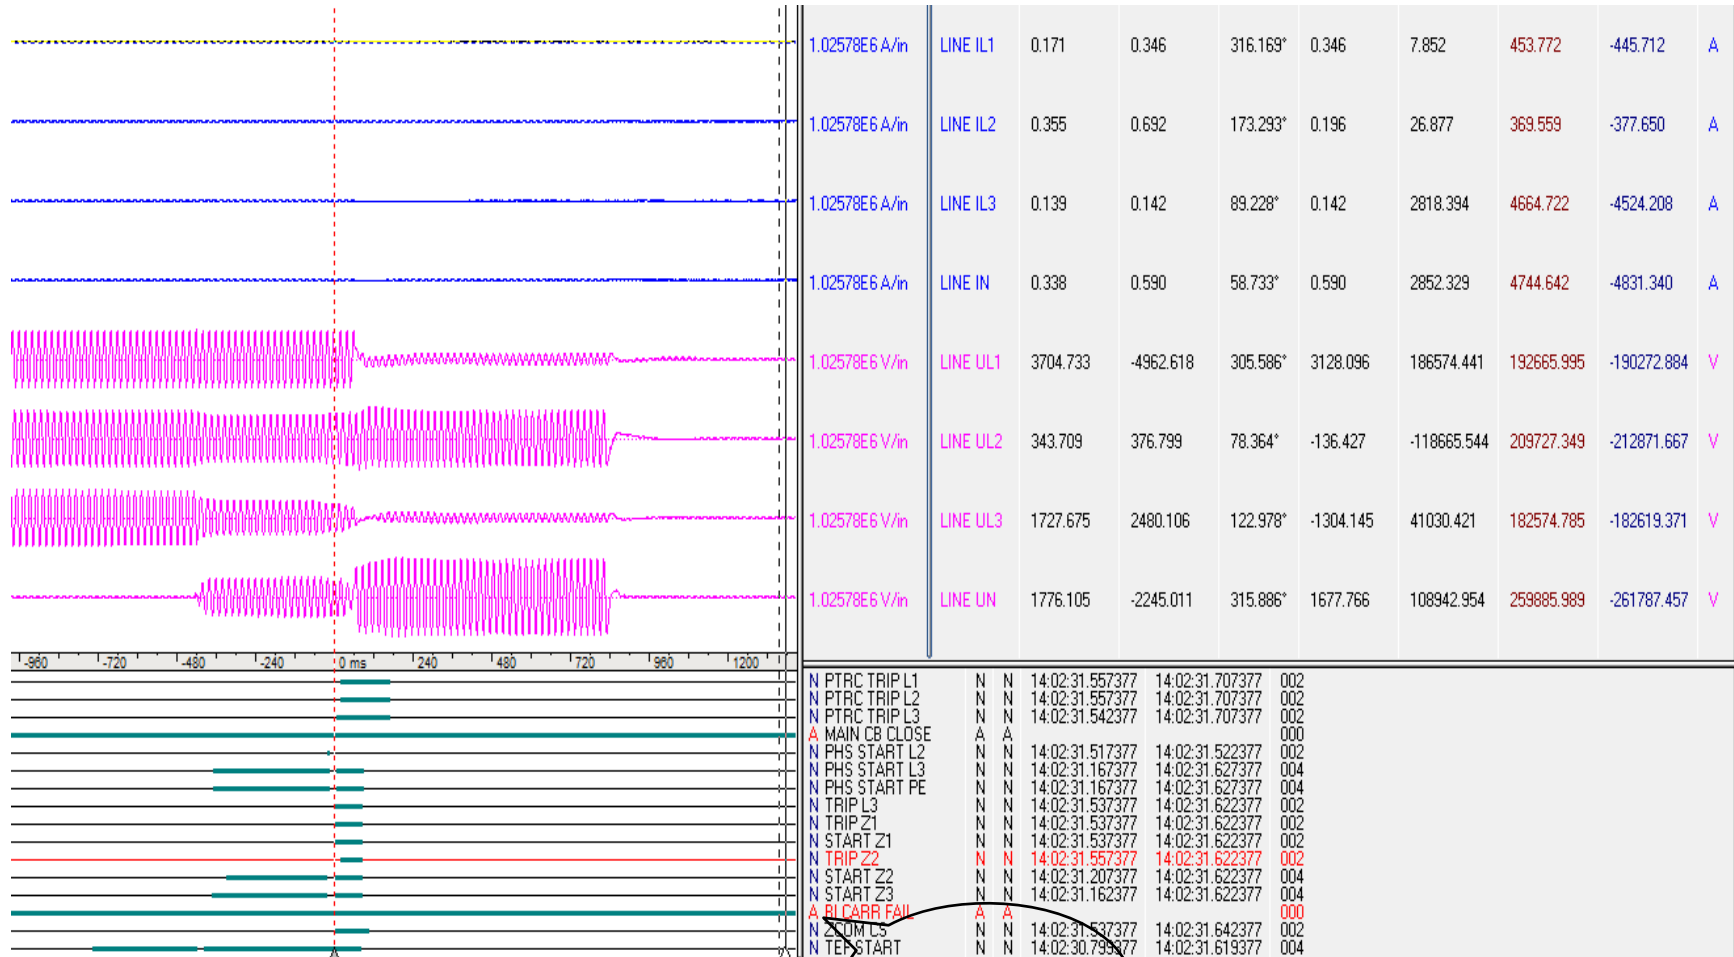
# Relay DR of Tanakpur-Sitaraganj Line#2

Carrier fail

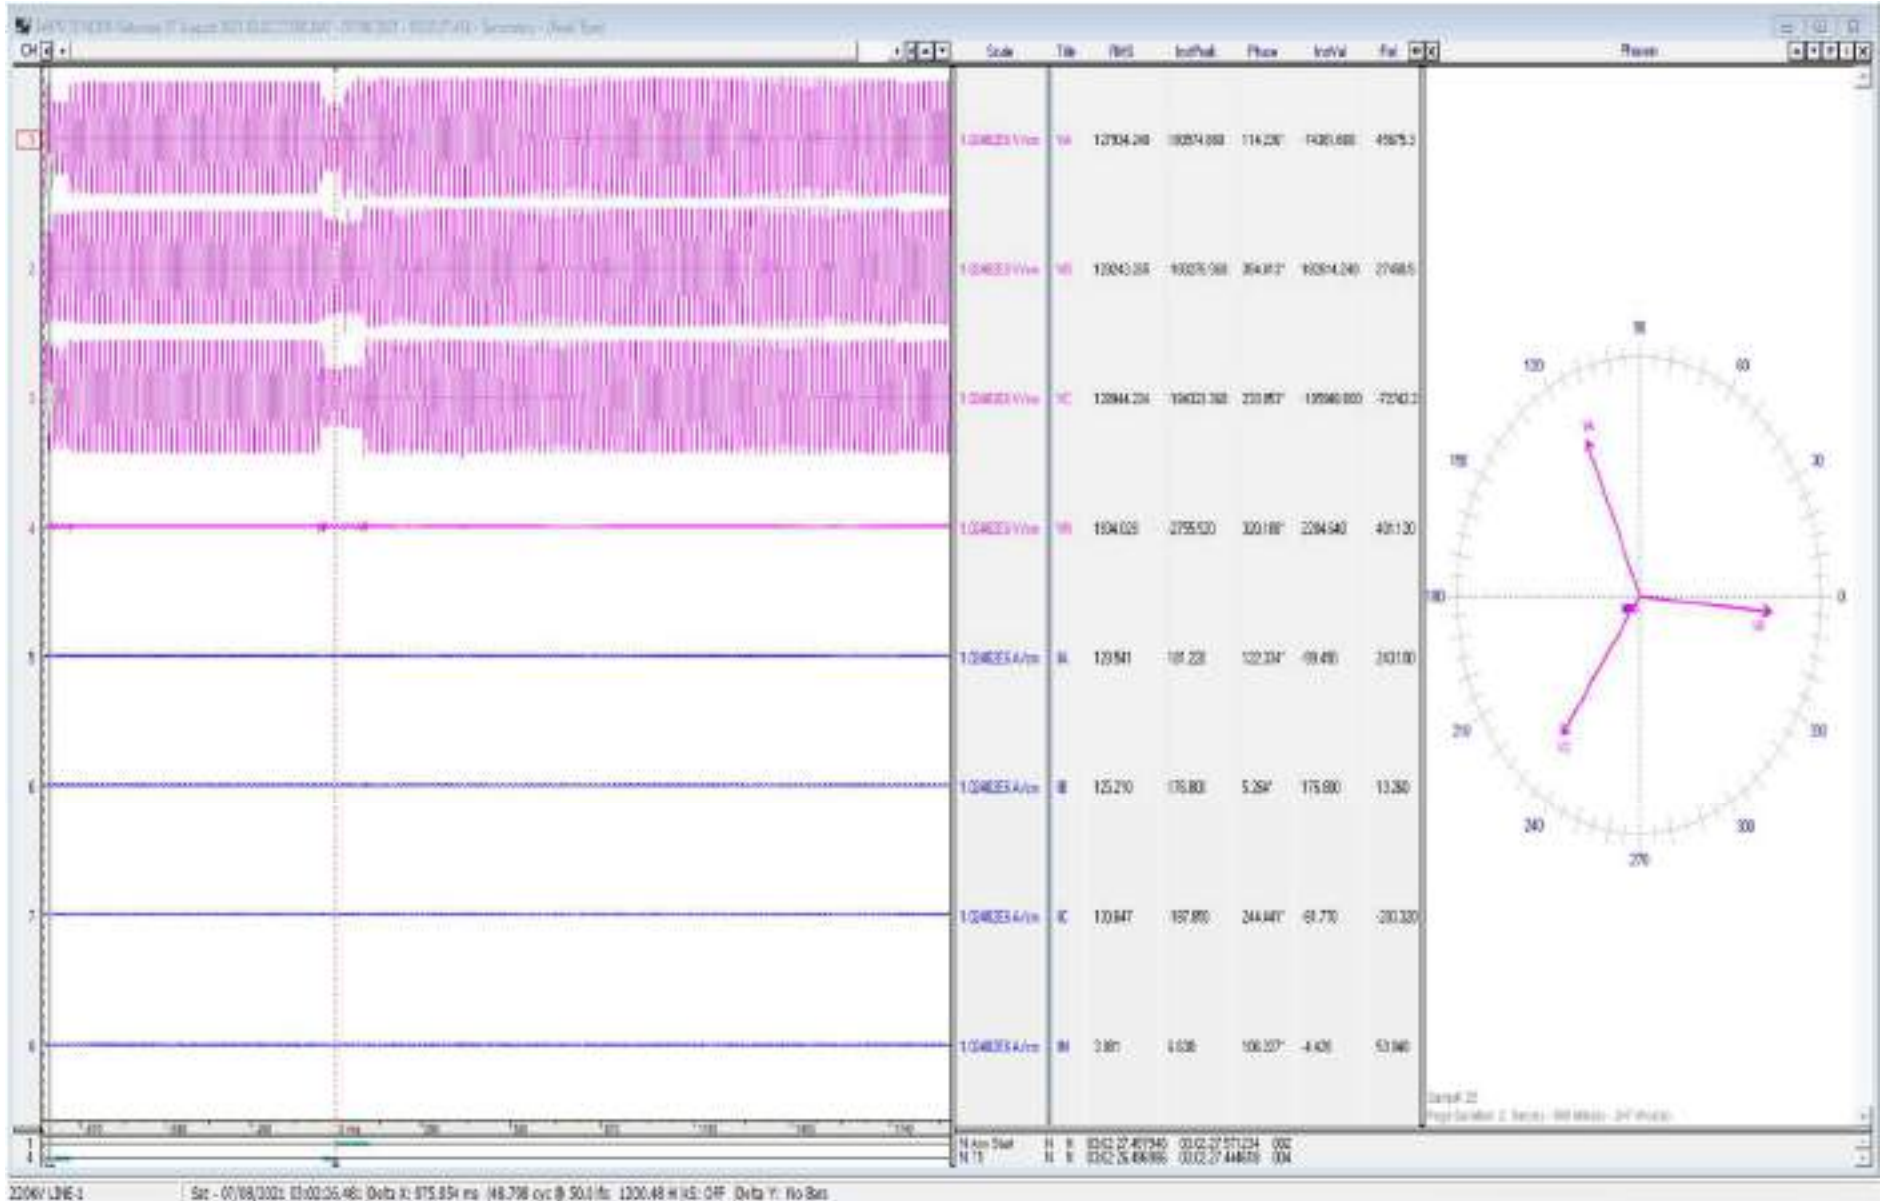
# DR of 220kV Singoli Bhatwari-Srinagar ckt (Singoli end)

Which protection had initiated the tripping? Not recorded in DR

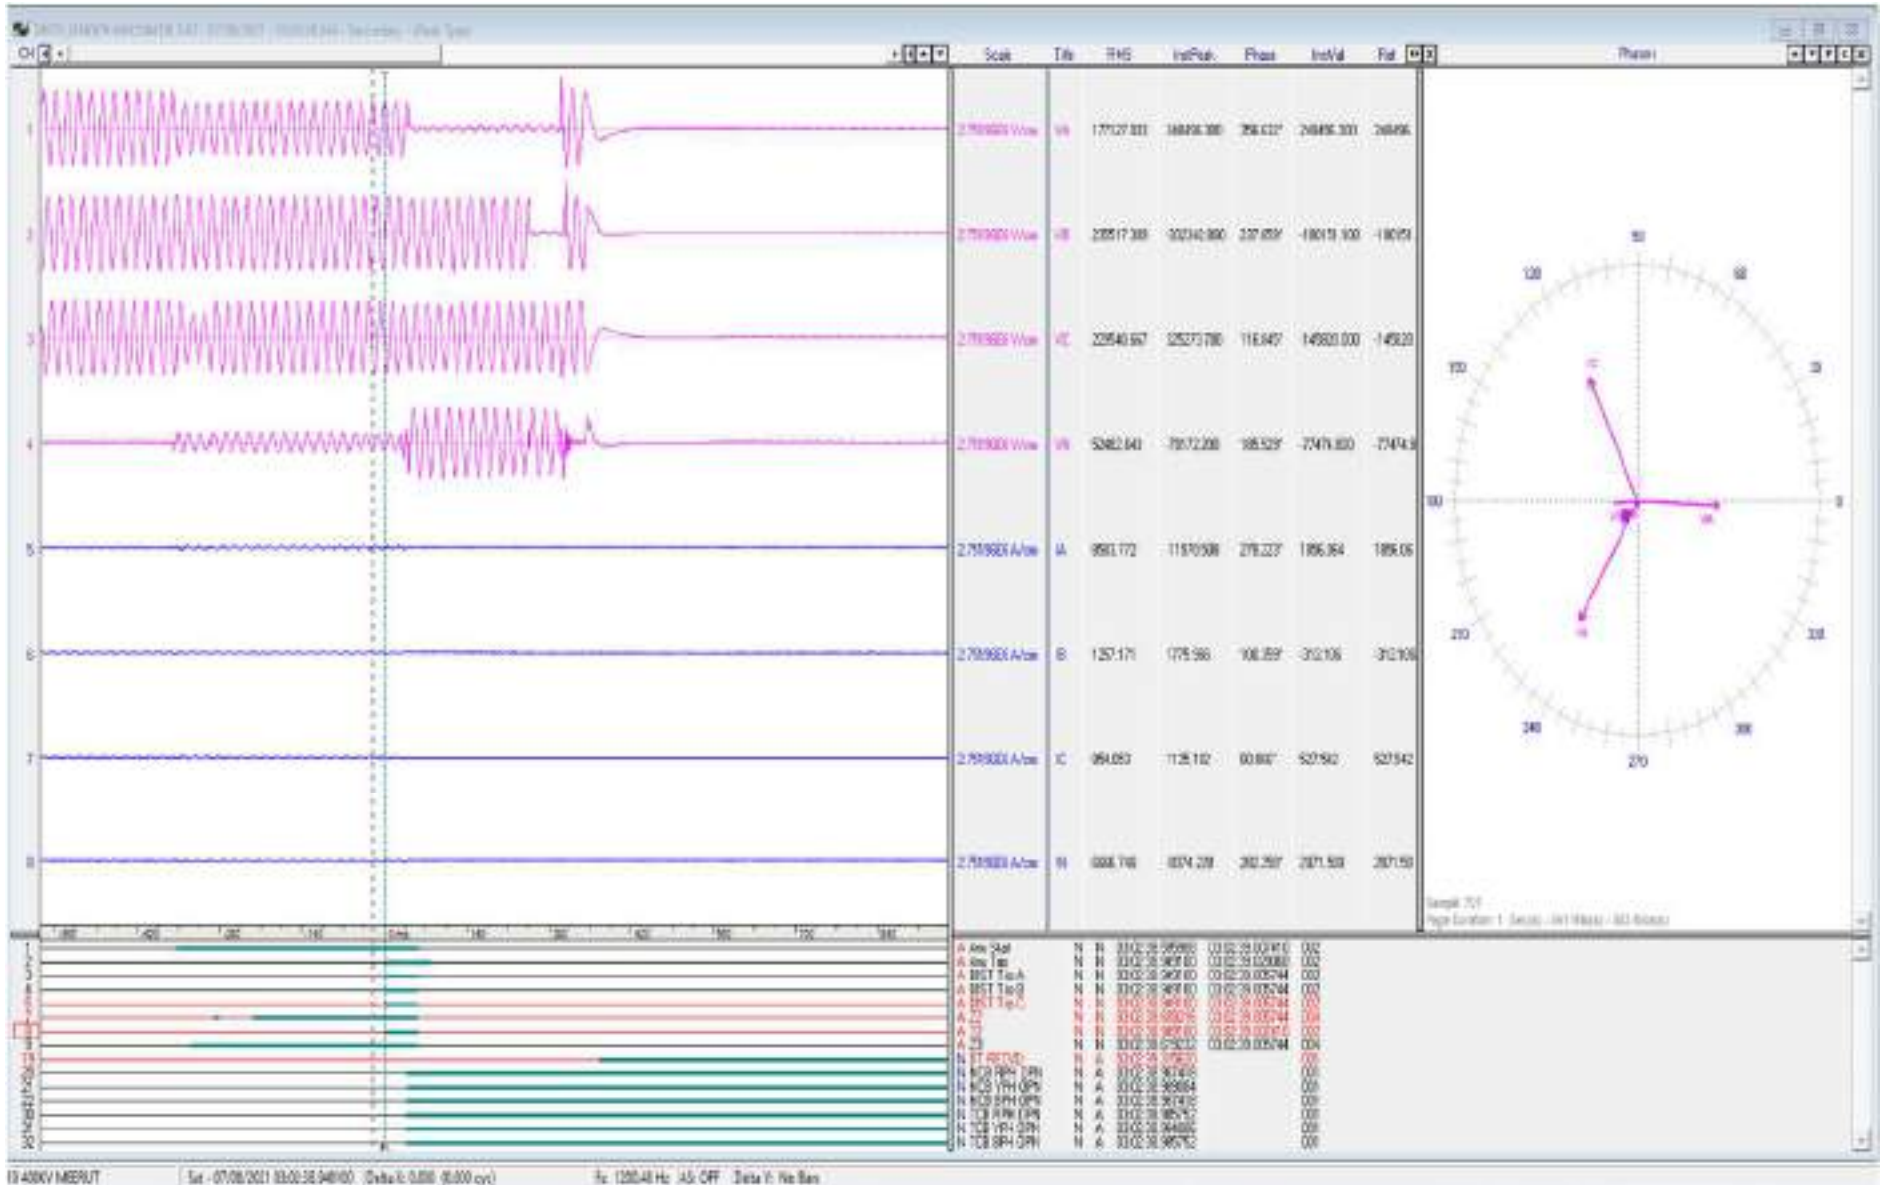
# DR of 400kV Muzaffarnagar-Meerut ckt (Meerut end)

Line tripped in Z-2 from Meerut end after 300ms

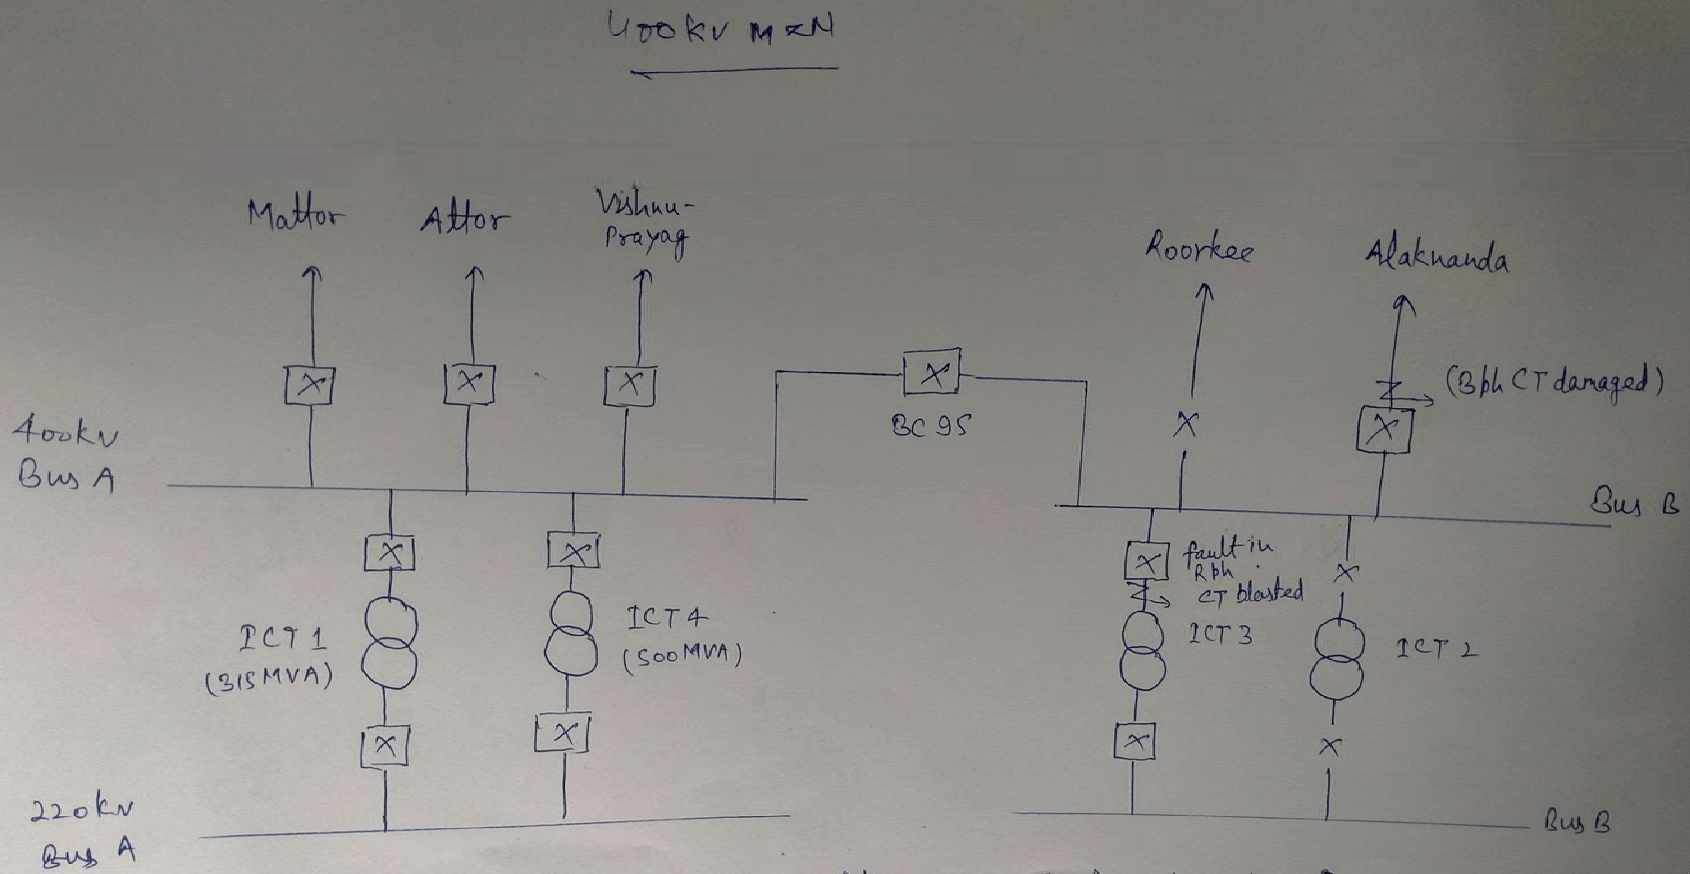
# SLD

⇒ R-ph CT was blasted of ICT-3, due to it B-ph CT of Alaknanda line was damaged  
 (2) Bus Reactor (63 MVA) charged by TBC and TBC charged by BUS 1.

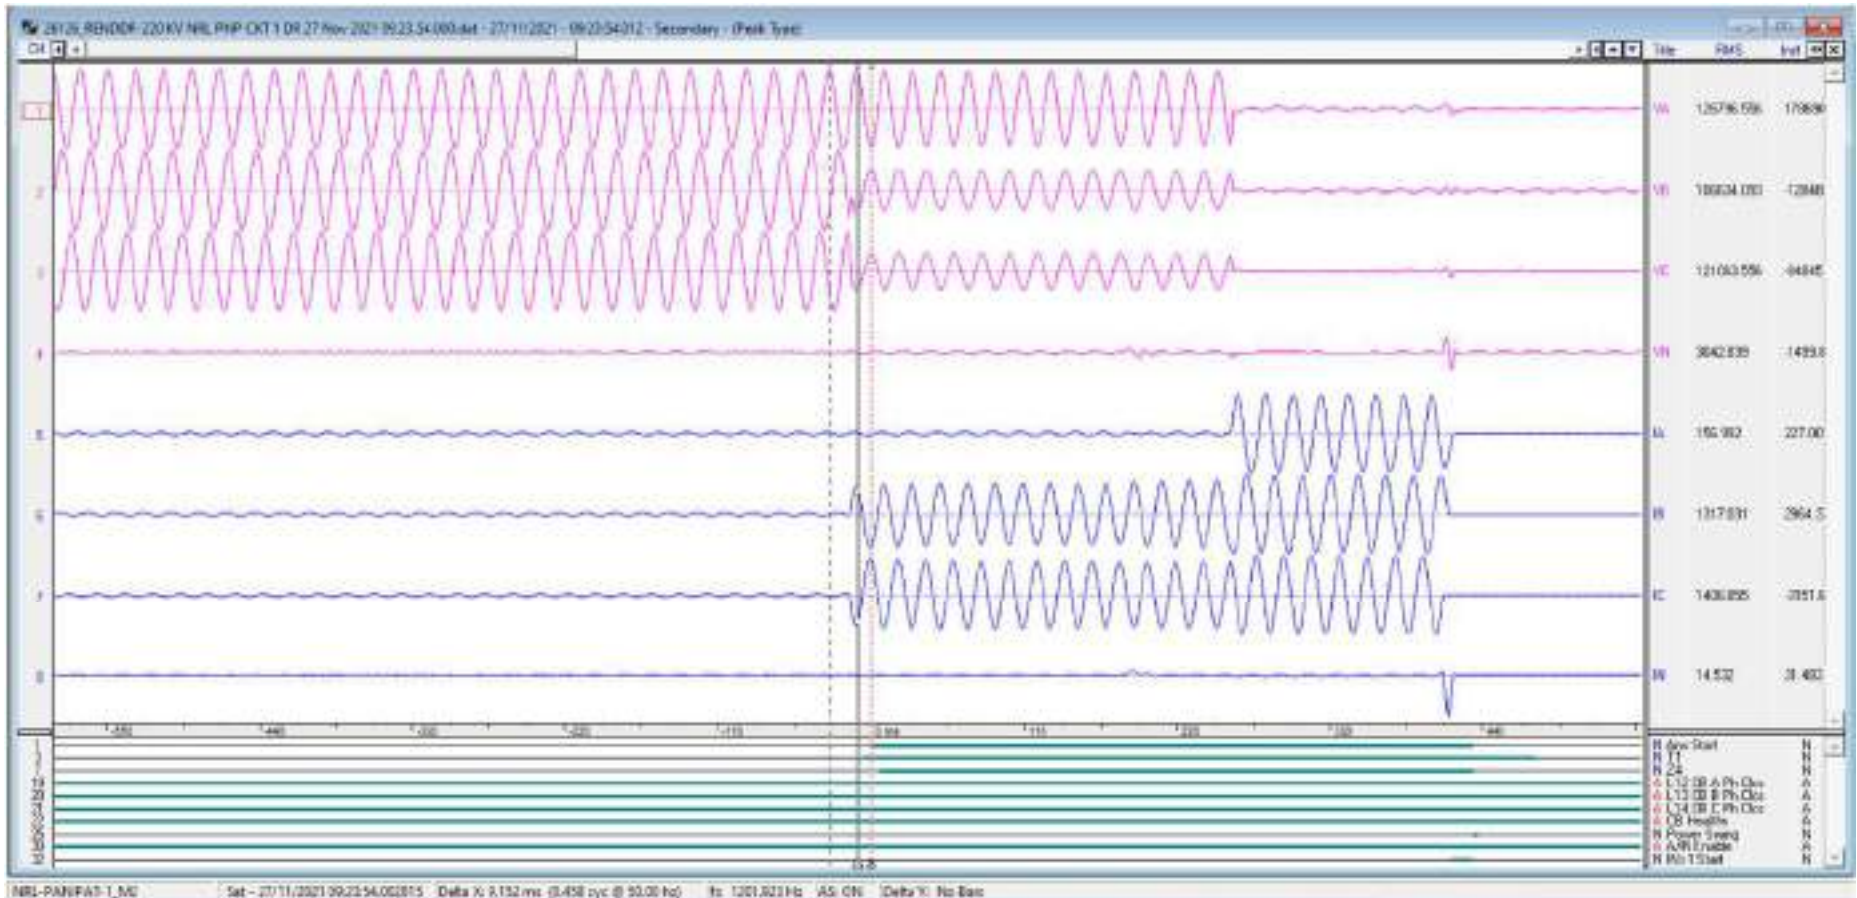
# DR of 220 kV Narela(End)-Panipat CKT-1

1. Fault in Y-B phase.
2. Fault sensed in Z-4 reverse.
3. Timer?
