भारत सरकार  
Government of India  
विद्युत मंत्रालय  
Ministry of Power  
उत्तर क्षेत्रीय विद्युत समिति  
Northern Regional Power Committee

**विषय:** संरक्षण उप-समिति की 45<sup>वीं</sup> बैठक के कार्यवृत्त।  
**Subject:** Minutes of 45<sup>th</sup> Protection Sub-Committee Meeting.

## ***Minutes of 45<sup>th</sup> Meeting of Protection Sub-committee***

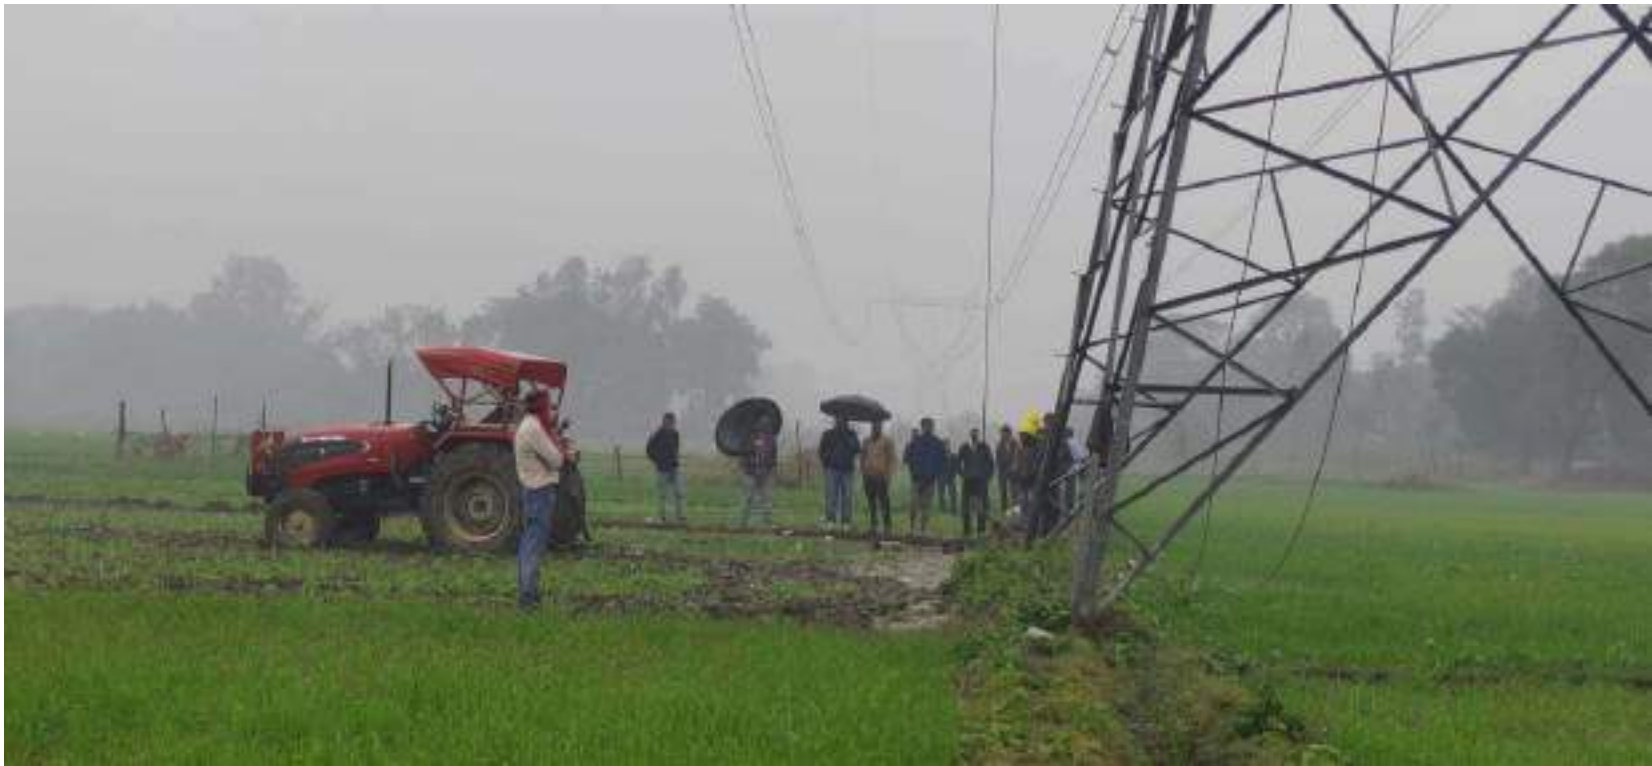
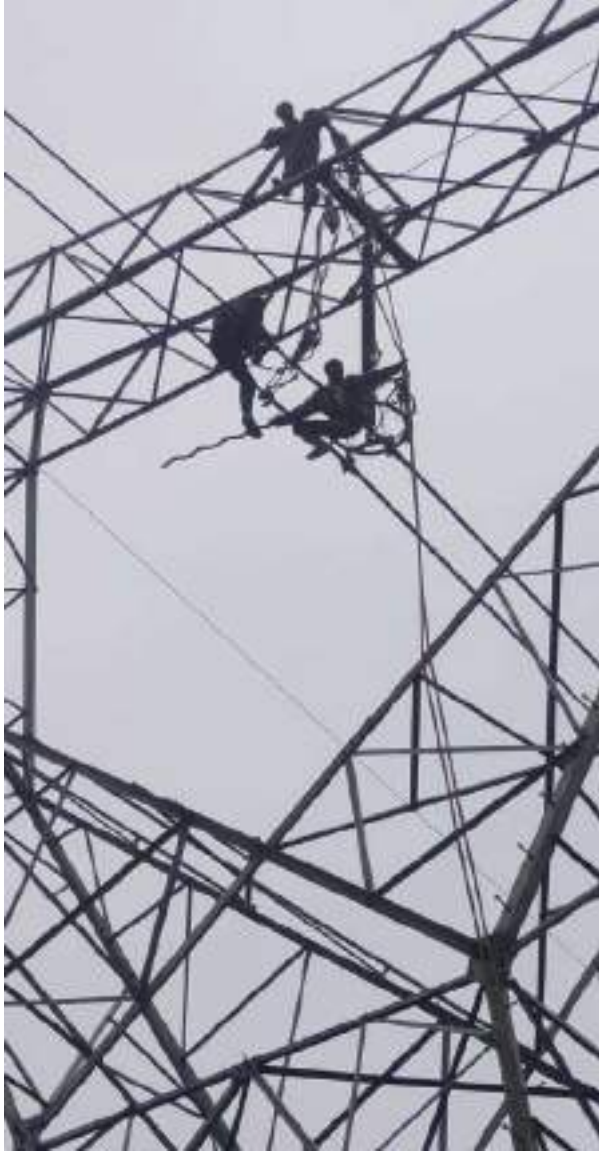
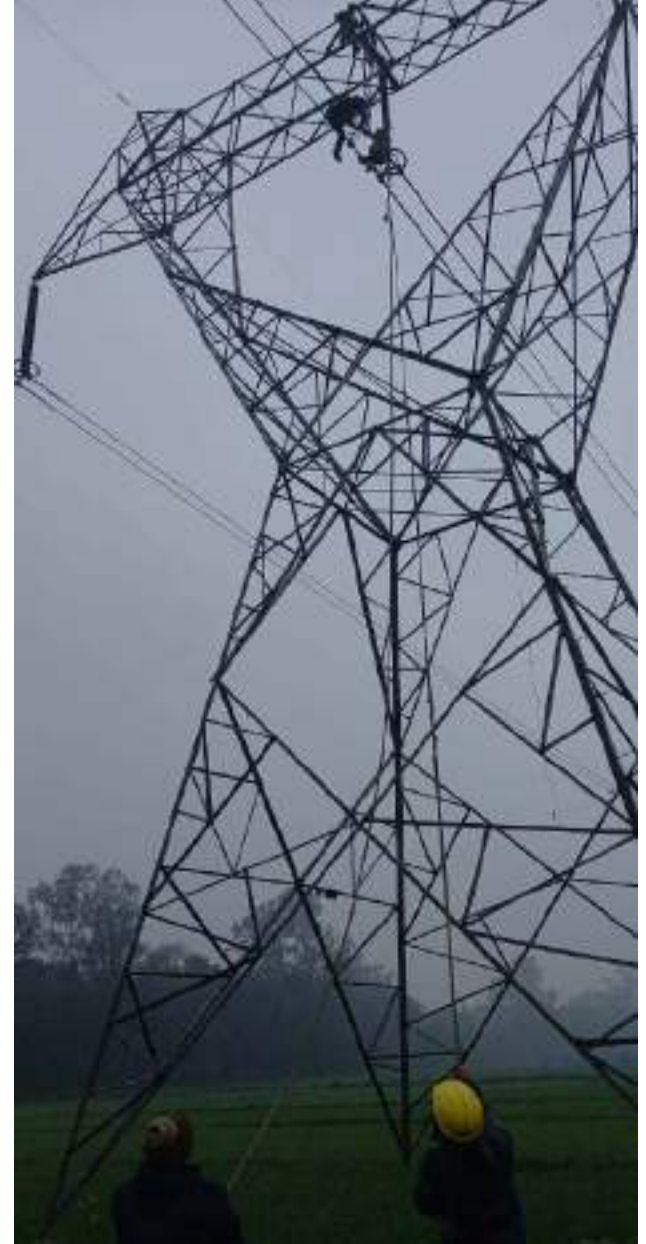
loc. no. 101

- **Y phase** Suspension string was found damaged & broken at **loc. no. 101**, Distance about 35-36 km from Sultanpur end.. String replaced..
