भारत सरकार  
Government of India  
विद्युत मंत्रालय  
Ministry of Power  
उत्तर क्षेत्रीय विद्युत समिति  
Northern Regional Power Committee

**विषय: संरक्षण उप-समिति की 46 वीं बैठक के कार्यवृत्त ।**  
**Subject: Minutes of 46<sup>th</sup> Protection Sub-Committee Meeting.**

## ***Minutes of 46<sup>th</sup> Meeting of Protection Sub-committee***

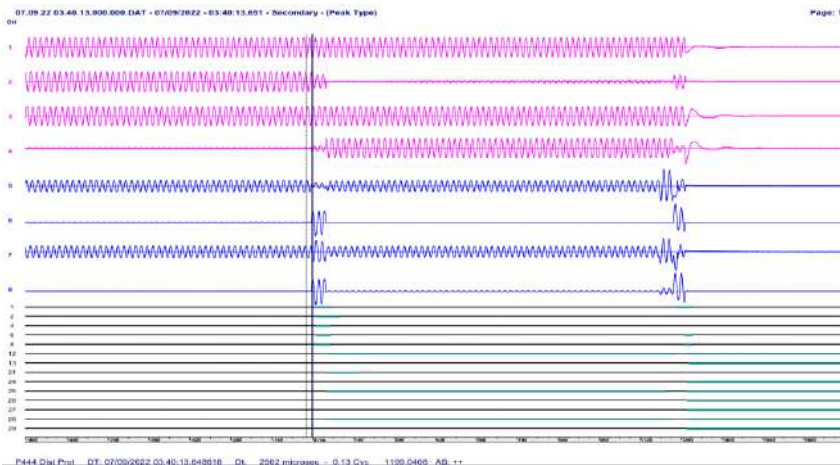
## 400 KV Muradnagar 2-Mathura (UP)(End) Ckt-1

1. Y-Phase to earth fault seen
2. AR attempted and failed due to persistent fault.
3. Kindly send DR in .cfg format.
