भारत सरकार  
Government of India  
विद्युत मंत्रालय  
Ministry of Power  
उत्तर क्षेत्रीय विद्युत समिति  
Northern Regional Power Committee

**विषय:** संरक्षण उप-समिति की 45<sup>वीं</sup> बैठक के कार्यवृत्त।  
**Subject:** Minutes of 45<sup>th</sup> Protection Sub-Committee Meeting.

## ***Minutes of 45<sup>th</sup> Meeting of Protection Sub-committee***

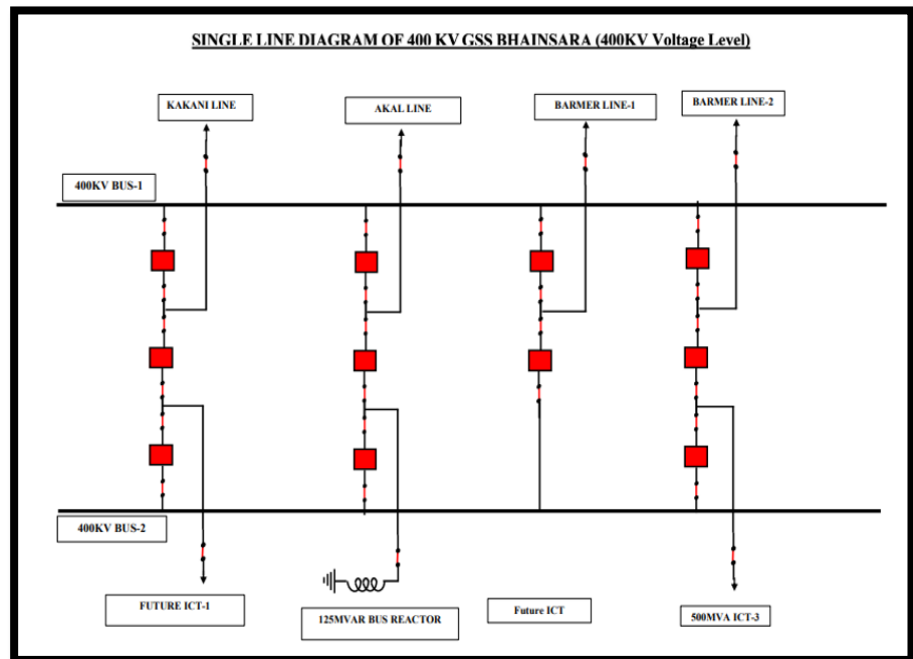
Fig. 1: SLD of 400/220kV Jaisalmer(Raj)

- b. RVPNL representative informed the following:
  - i. 400/220kV Jaisalmer (Bhainsra) (Raj) station have one and half breaker scheme at 400kV level. (SLD diagram of 400/220kV Jaisalmer is shown below in figure 1)

- iv. Later fault cleared with the tripping of 400 KV Akal-Jaisalmer ckt in Z-2 distance protection with the delay of 300ms and 400 KV Barmer-Jaisalmer ckt on earth fault protection operation with delay of 670ms.

- v. LBB of Tie CB of 400kV Jaisalmer-Kankani ckt at Jaisalmer end was enabled after the event.

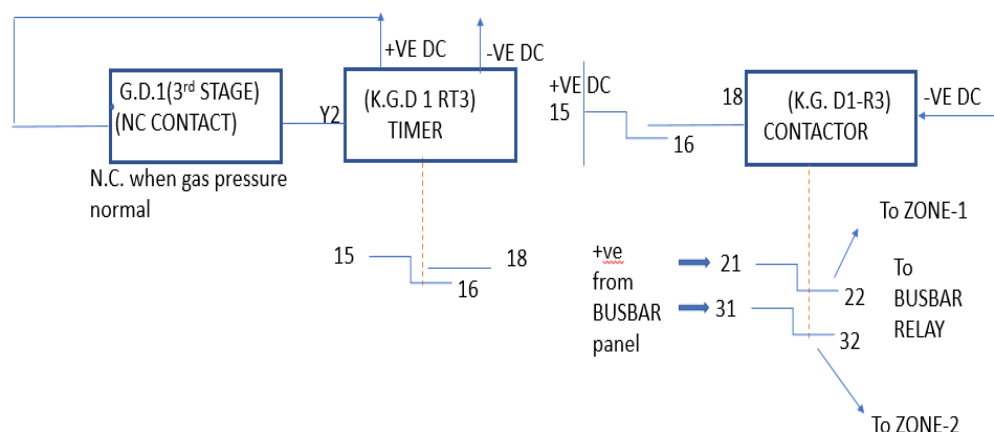
- ii. At 21:22 hrs, DC source-1 got failed. And as DC source changeover relay is of mechanical type, it changes the DC supply with some delay.
  - iii. As per logic of Bus Bar protection, it operates on three conditions, one, on Bus differential/LBB operation, second, on Gas Detector Stage-3 detection and third, on both DC source failures.

- iv. NO & NC are used and in normal condition, it remain in close condition.
  - v. So, during changeover time delay, as both the DC source were not available, bus bar protection got triggered. And subsequently elements connected to both the bus tripped.

K.G.D1-RT3 to be in energized position. Contact 15 & 18 should be NC & K.G.D1-R3 contactor should be in energized position & therefore, bus bar tripping contact 21, 22 & 31,32 will be NO & system will run healthy and tripping can be avoided.

- a. Automatic fail safe change-over to be ensured from both the DC sources. (**Action:** UPPTCL; **Time:**30 days)

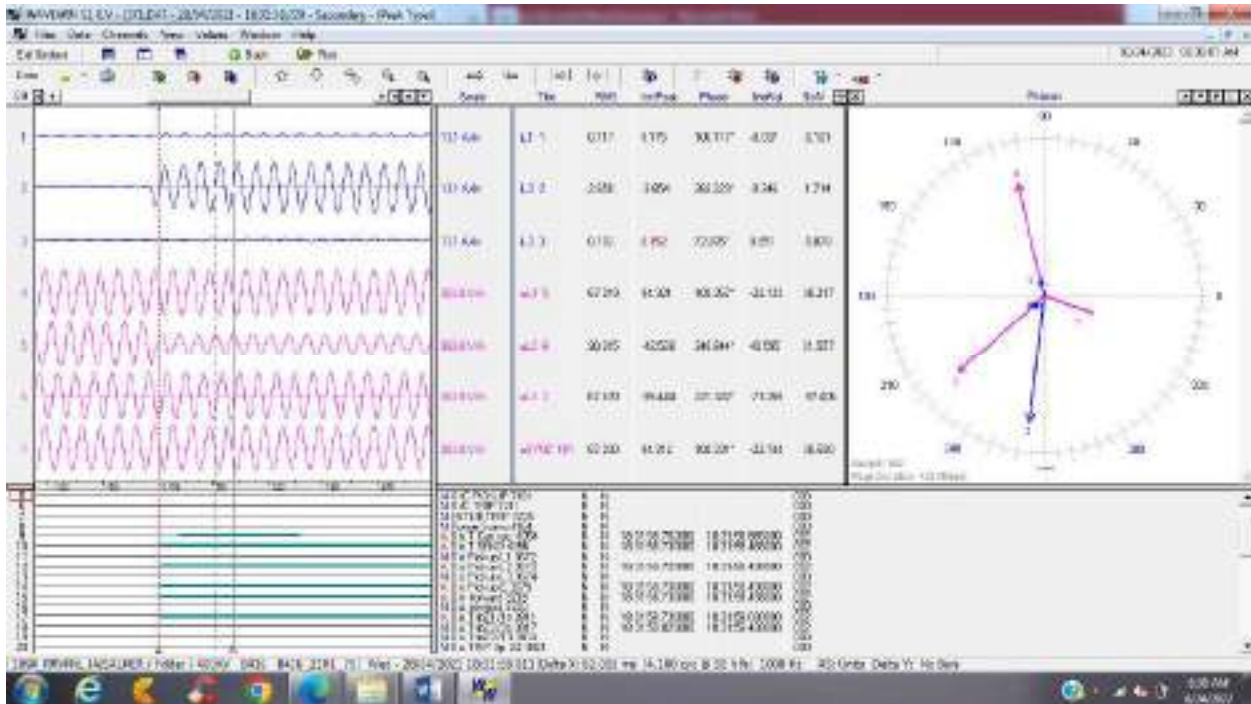
1. A fault on Y phase to earth occurred on 400 KV Jaisalmer-Kankani line at 38.9 km distance from Jaisalmer end and 107.5 km from Kankani end at 18:31:58:729.
2. Distance relay at Jaisalmer end picked up in zone 1 and initiated tripping of breakers at 18:31:58:729.

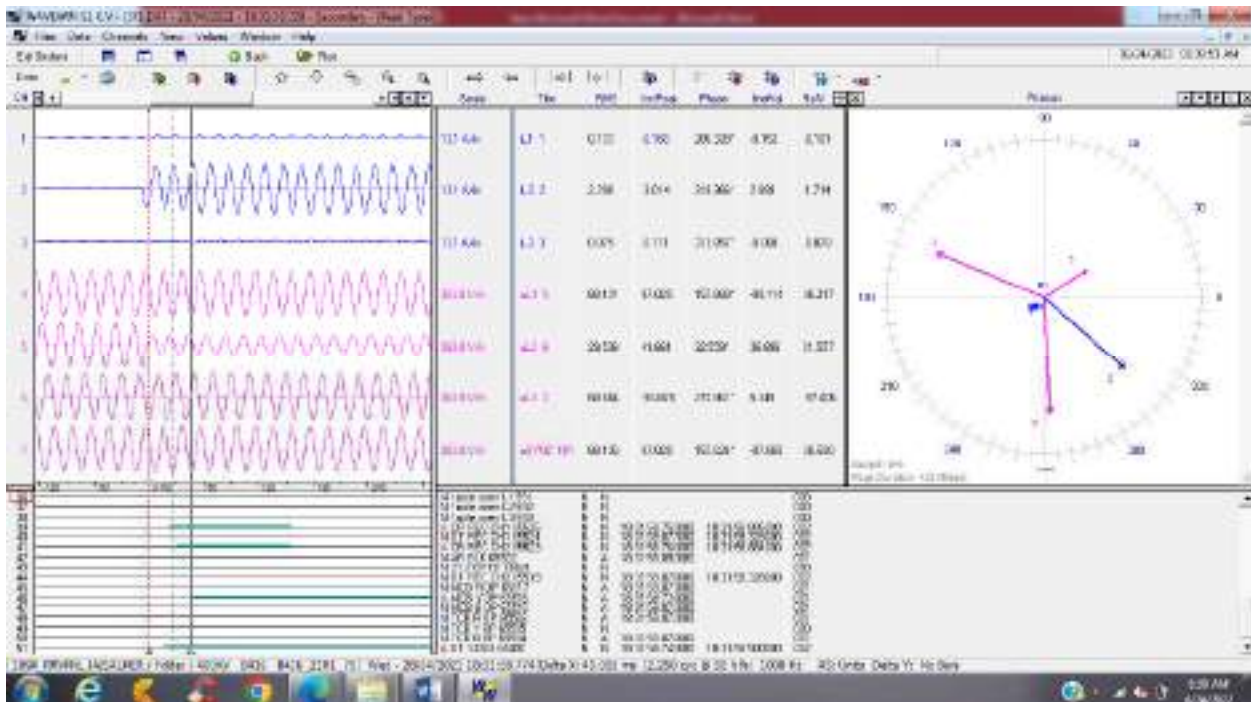
3. Y phase pole of main breaker opened at 18:31:58:774 but tie breaker pole stuck and did not open. Tie LBB was accidentally left disabled after routine testing.

- Before the operation of distance relay in zone timing of 800 ms, line was tripped on earth fault in time of 673ms.
- Tie breaker LBB was made enable after the event.

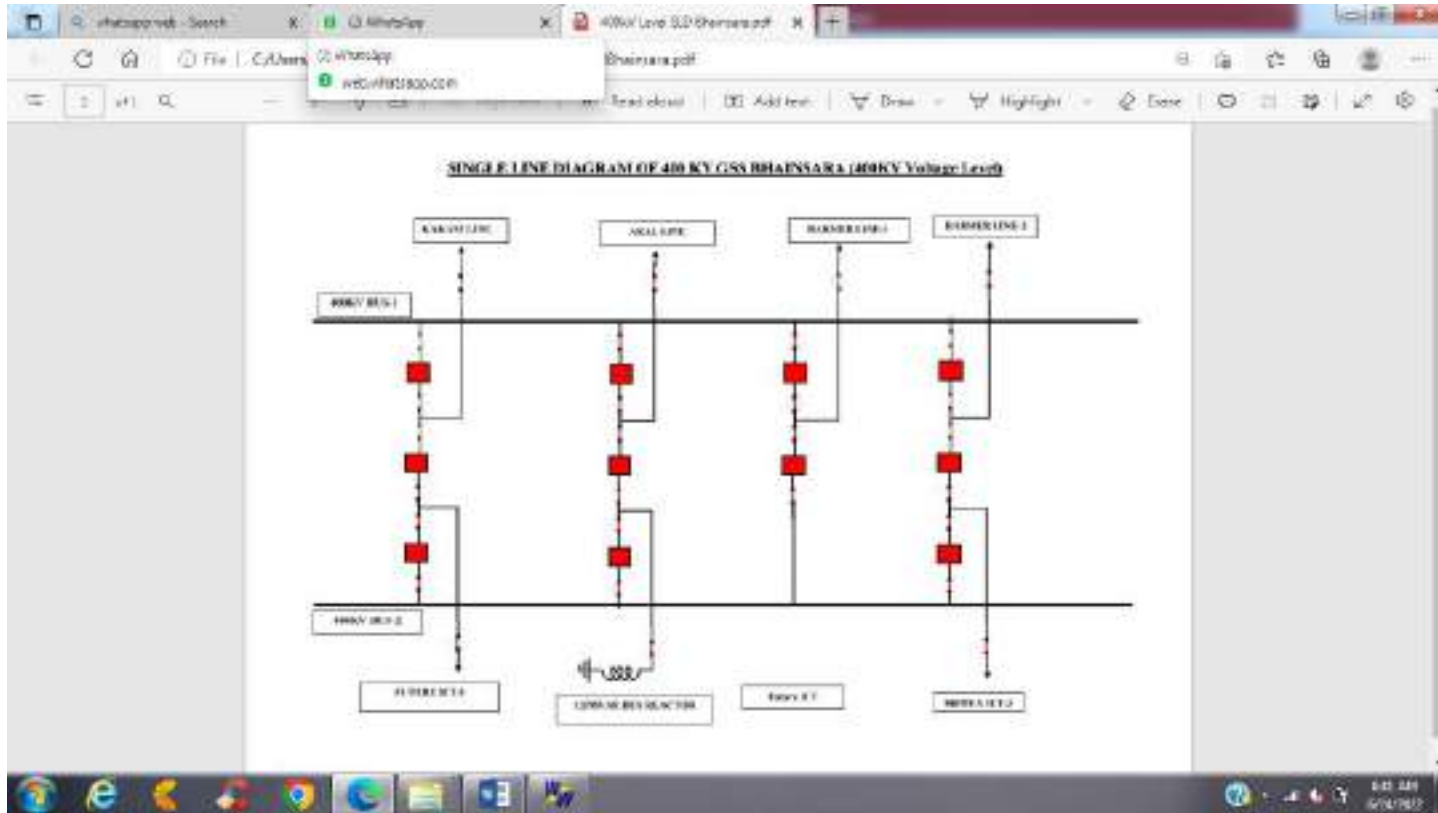
- Therefore the fault was continuously feeded from remote ends of Akal and barmer through 400 KV Akal-Jaiselmer & 400 KV Barmer-Jaiselmer lines.

- 400 KV Akal-Jaiselmer line tripped on zone 2 timing in 300ms as from Akal end in zone 2, reach of 125 KM is covered.
- 400 KV Barmer-Jaiselmer Line distance relays started in zone 3 as for zone 2 reach distance upto 150 km is covered and fault was around 155 km.

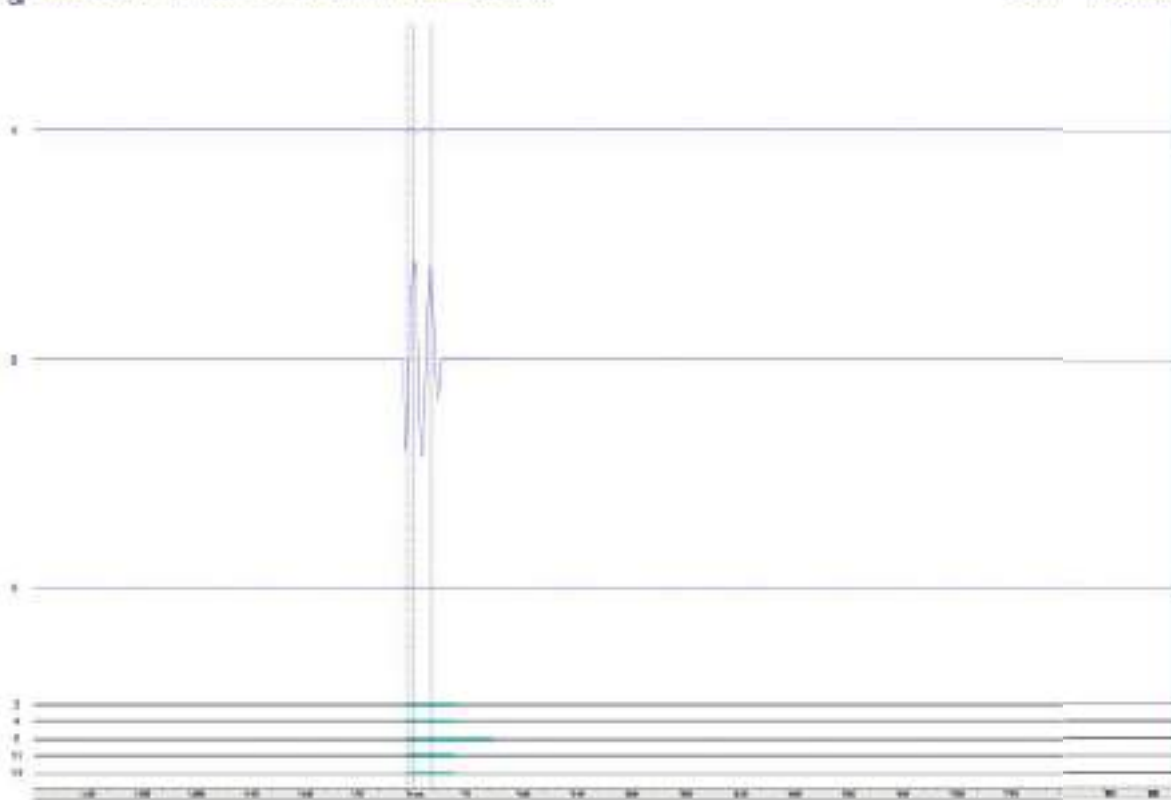
1) Bus Bar-II operated at 03:49:04:339 Hrs. on account of Y-Ph to Ground Fault Hrs.

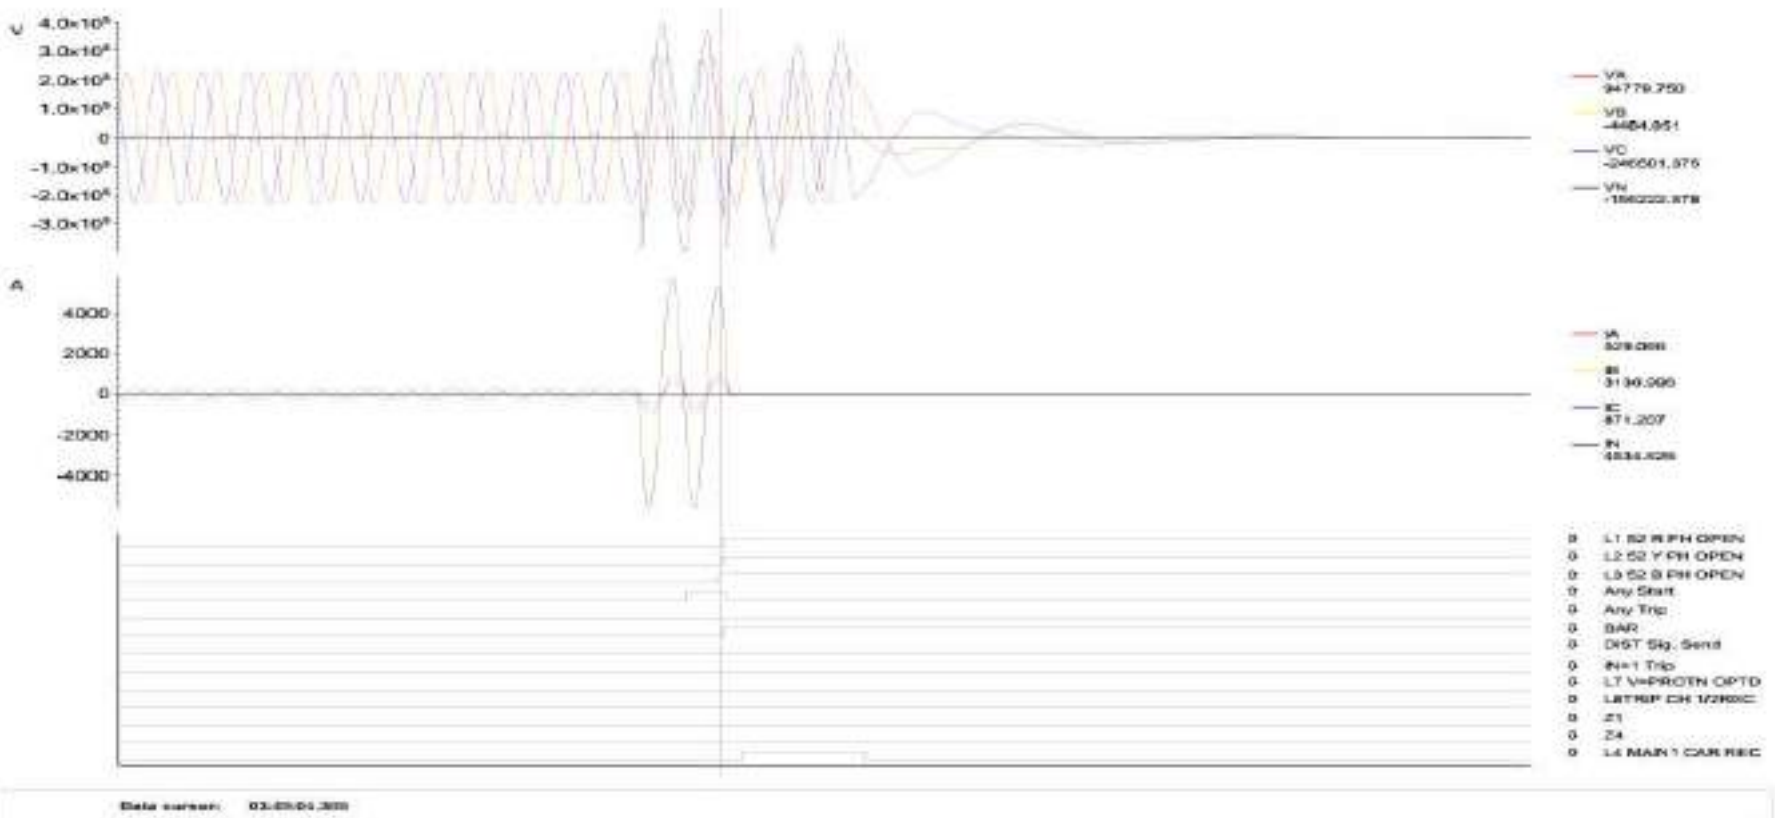
- 1) NJ Panchkula-I CB opened at 03:49:04:380 Hrs on account of operation of Bus Bar Protection. No Fault was observed in the line.

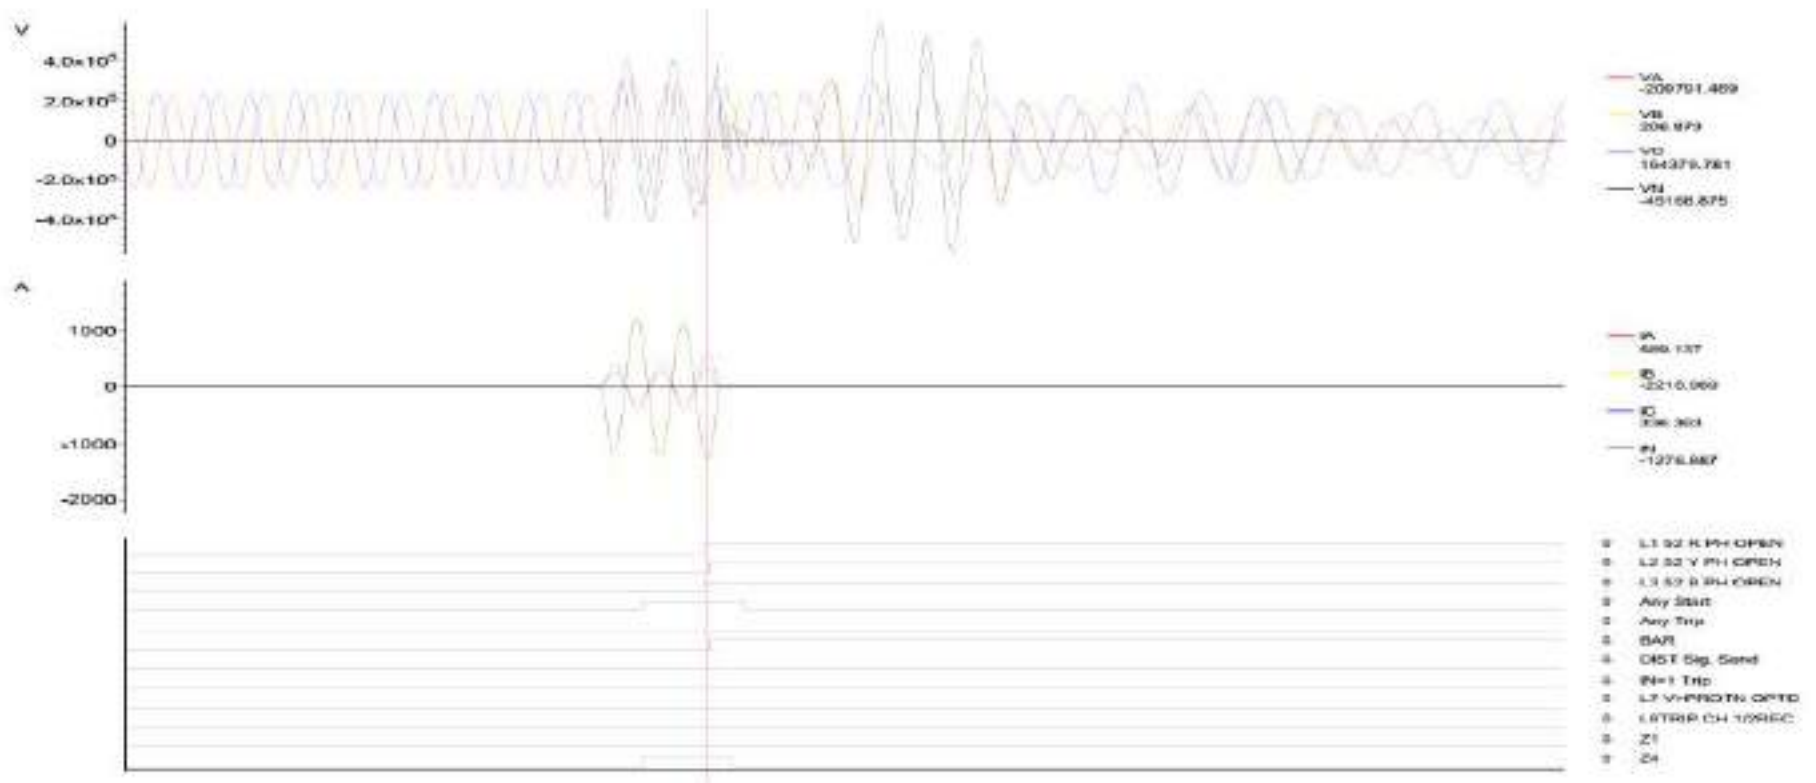
NJ Gumma-II CB opened at 03:49:04:379 Hrs on account of operation of Bus Bar Protection. No Fault was observed in the line.

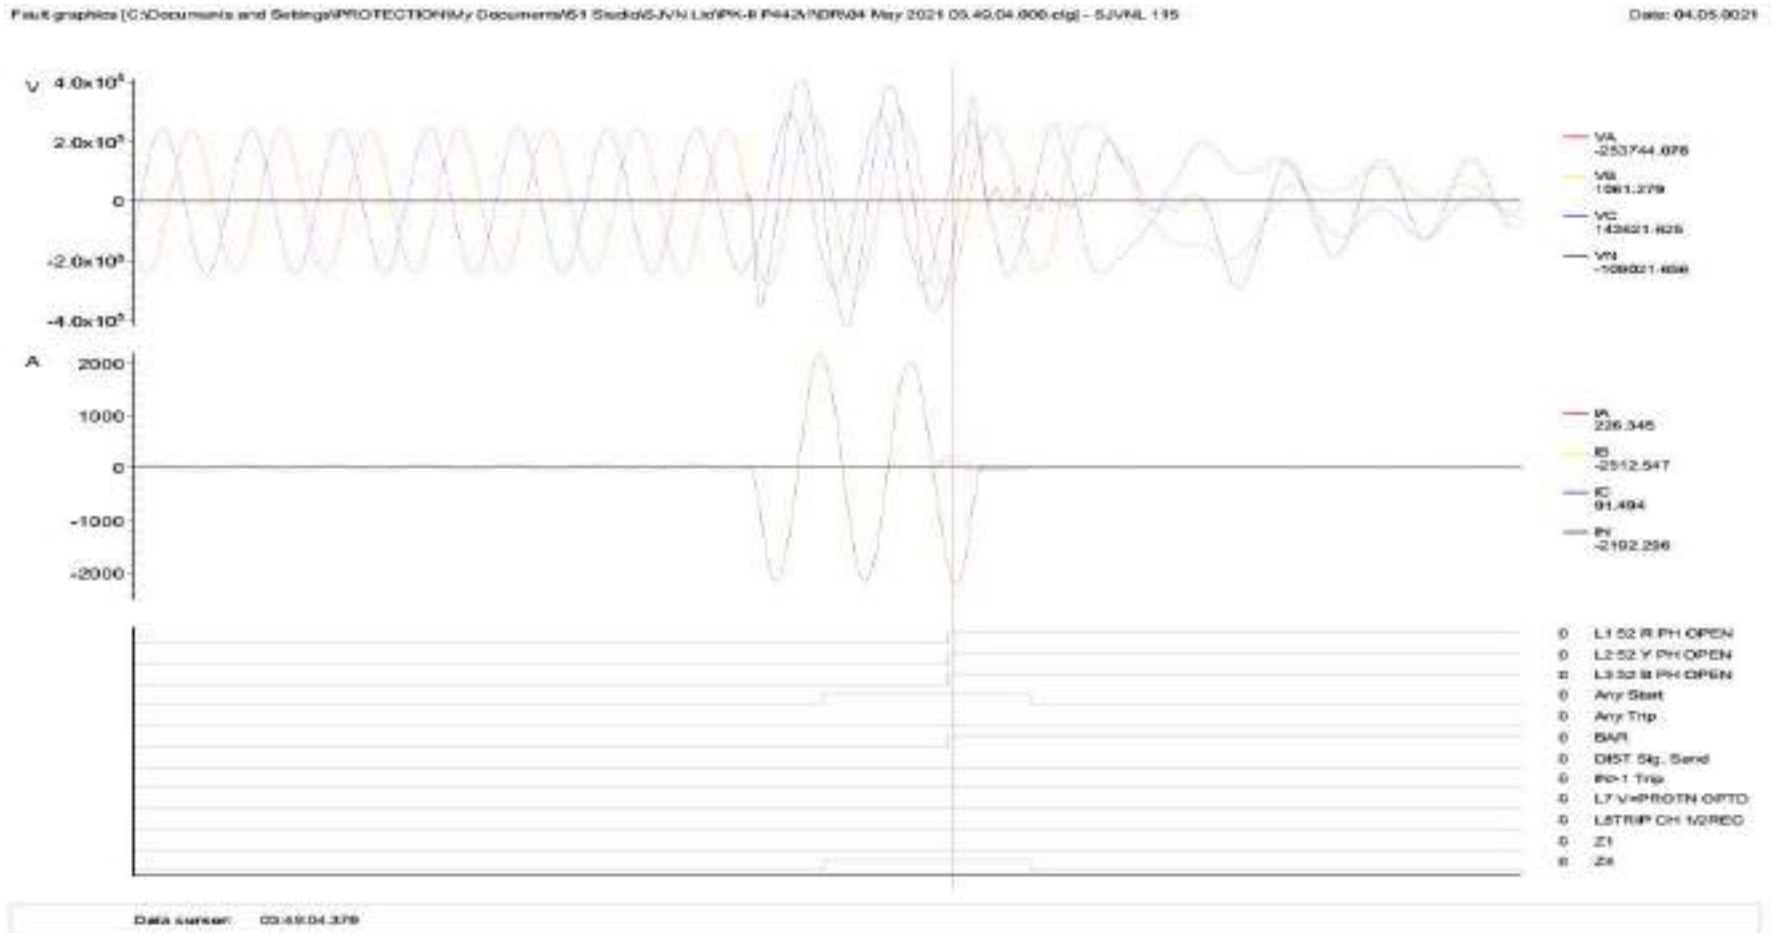
NJ Rampur-I CB opened at 03:49:04:380 Hrs on account of Bus Bar Protection operation. No Fault was observed in the line.

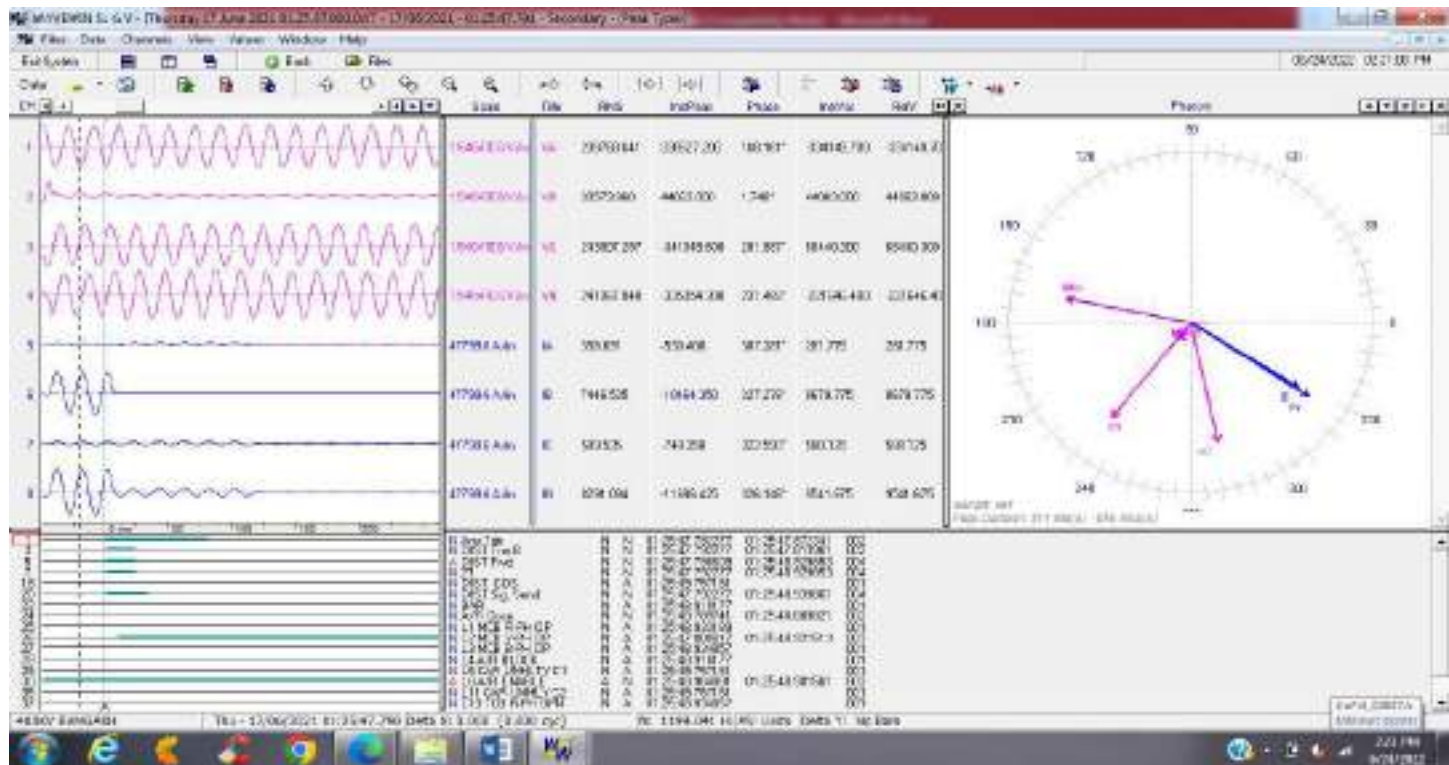
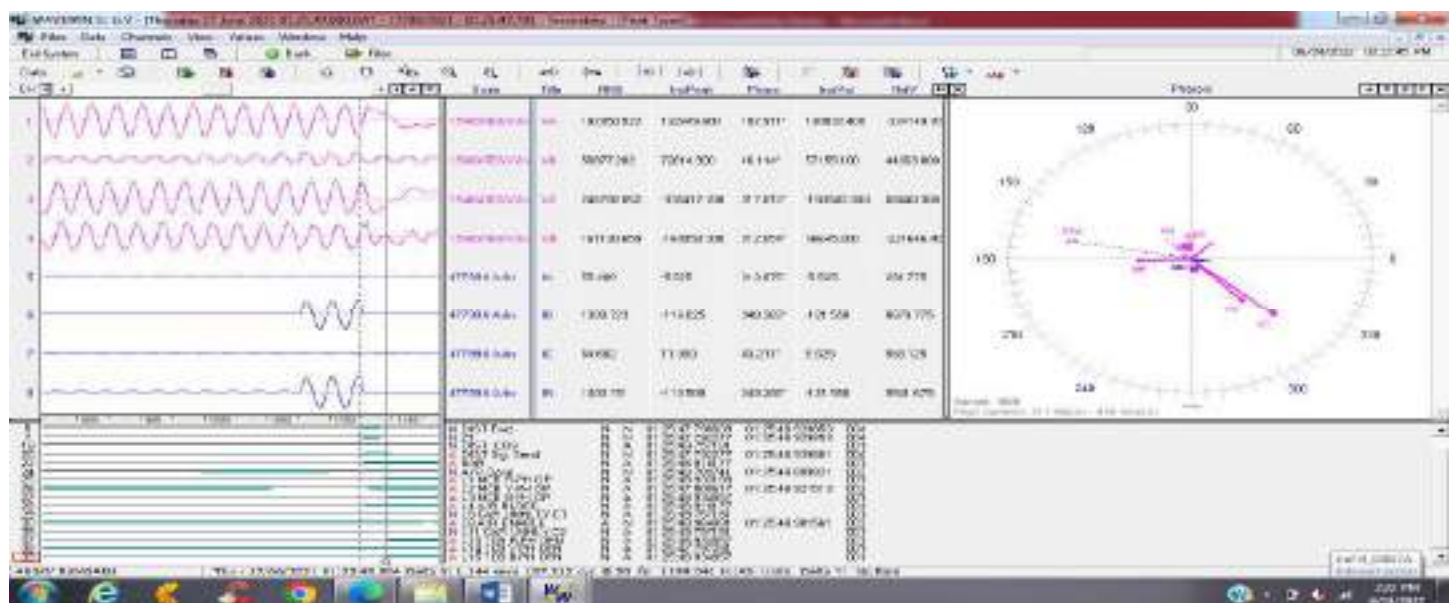
### 400 KV Ramgarh-Akal-I tripping initiation DR

At ramgarh end for both Akal circuits, faulty Y phase pole tripped in zone-1 and tried reclosing after 1 sec but 3 phase occurred as fault was existing on lines.

400 KV Ramgarh-Akal-I, 3 phase tripping after trying reclose; breaker opened in 1.144 sec.

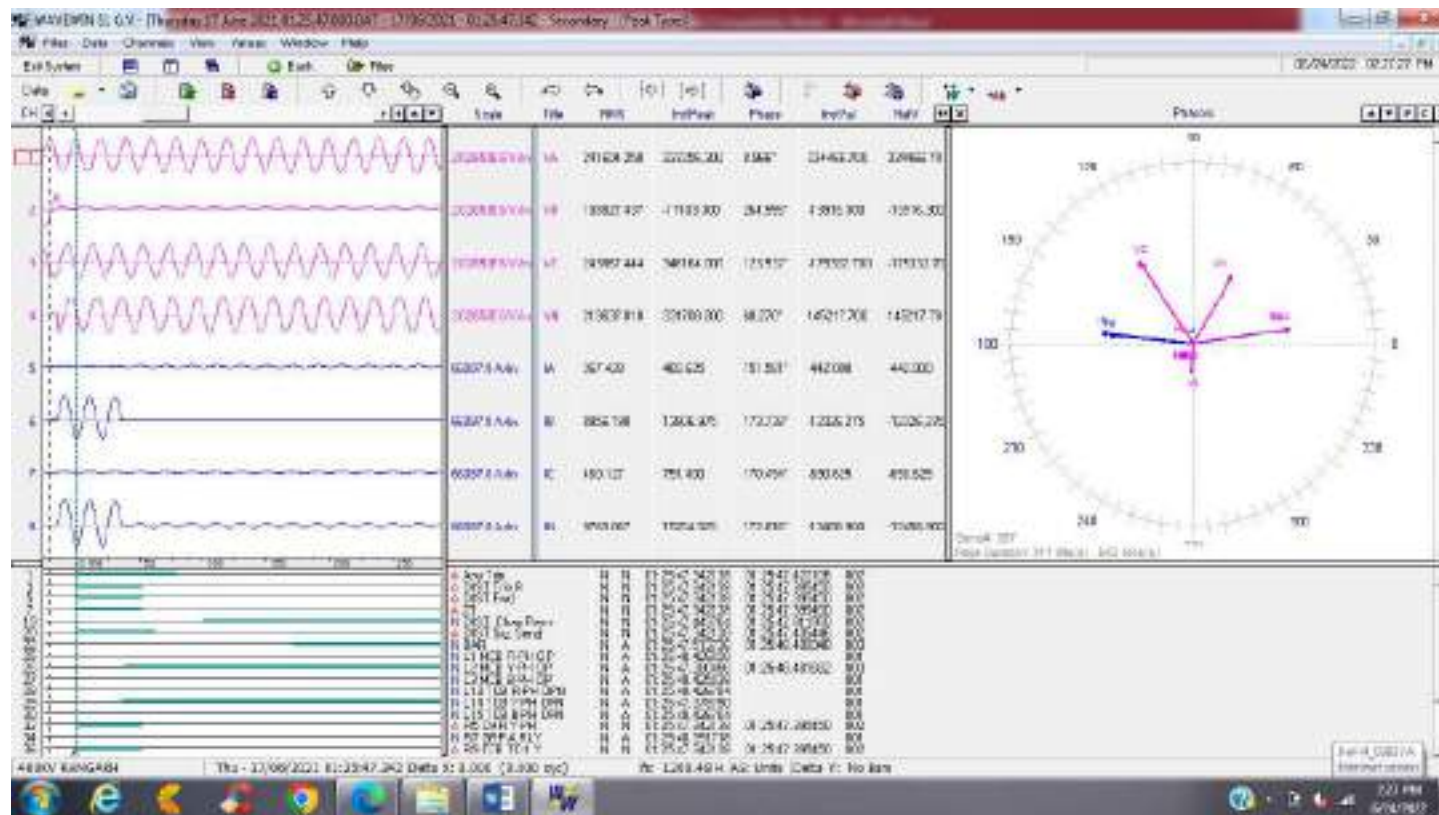
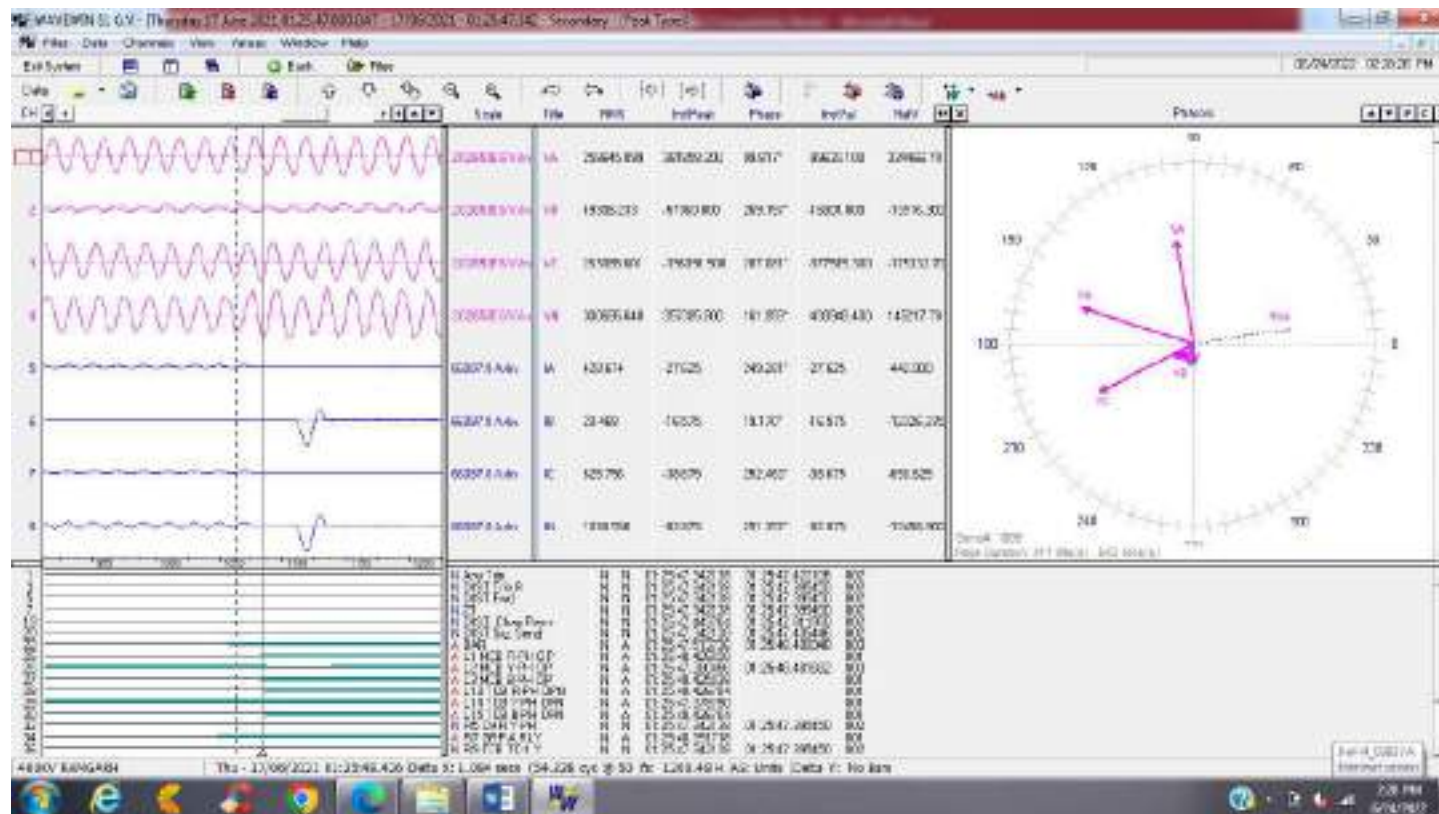
# 400 KV Ramgarh-Akal-II tripping initiation DR

400 KV Ramgarh-Akal-II, 3 phase tripping after trying reclose; breaker opened in 1.084 sec.

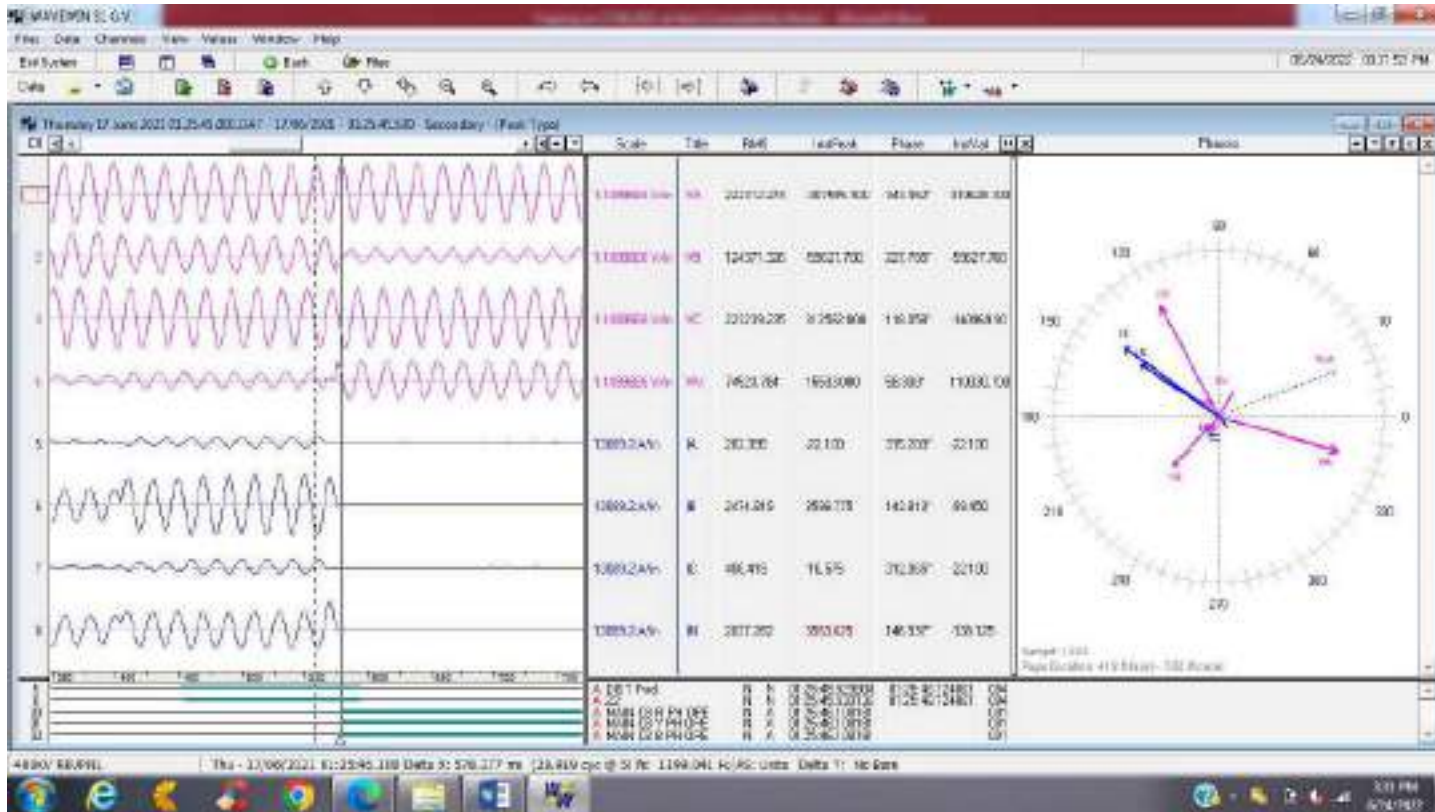
- At akal end for Ramgarh-I line, relay picked up in z2 but only Main CB tripped with delayed time of 578 ms. Tie breaker did not opened.

3. At the end DC source-1 was already out of circuit due to battery cell issue. During this tripping DC source-2 battery charger contactor created a problem due to which sufficient DC current was not pumped to the breaker trip coil to operate the breaker.
4. Both the DC sources have been attended and are running healthy.

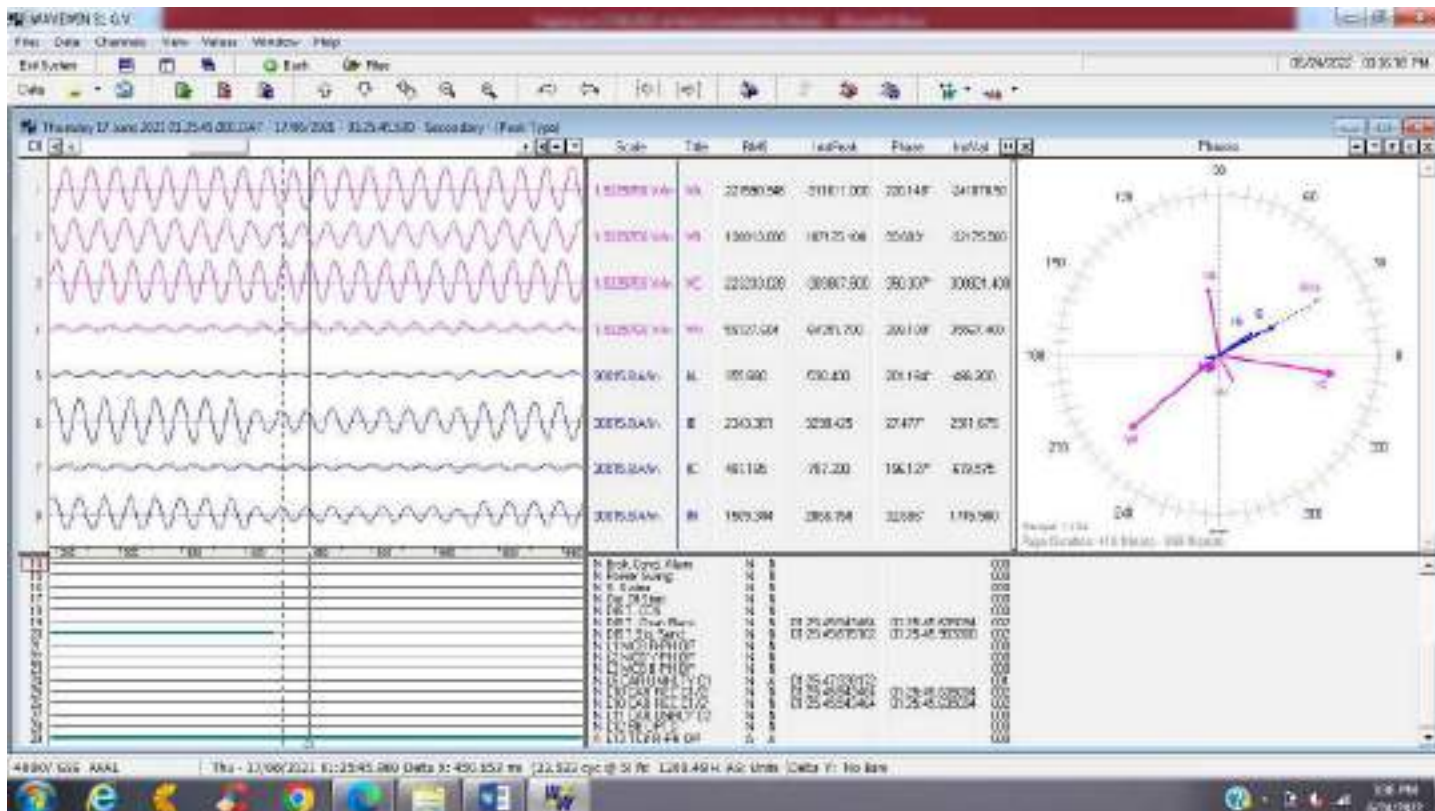
As for Ramgarh-II line, main and tie both breaker did not tripped. LBB also operated but breaker was not tripped.

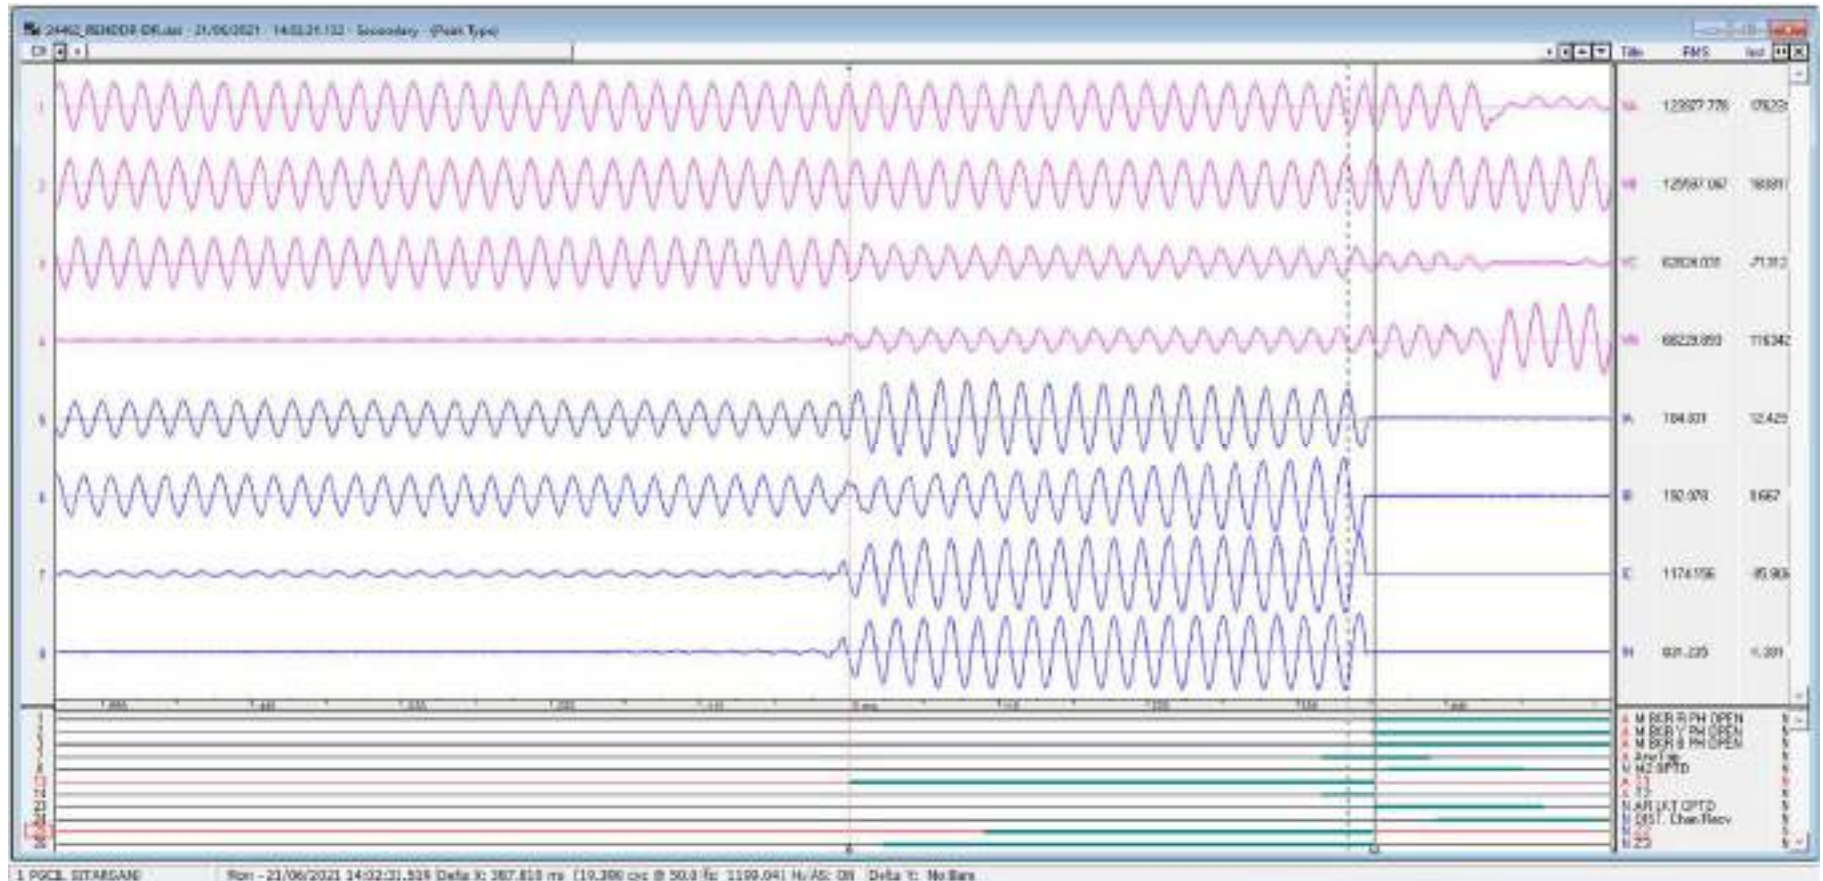
# DR of 220 kV Tanakpur(NH) – Sitarganj (End)-1

1. B-Earth fault visible in DR.
2. Line tripped in Zone-2 after a delay of 370ms.
3. AR under Lockout inspite of Carrier receive from remote end.

**The carrier fail indication persisted during the fault. Accordingly AR did not happen and line tripped after Zone-2 time delay.**

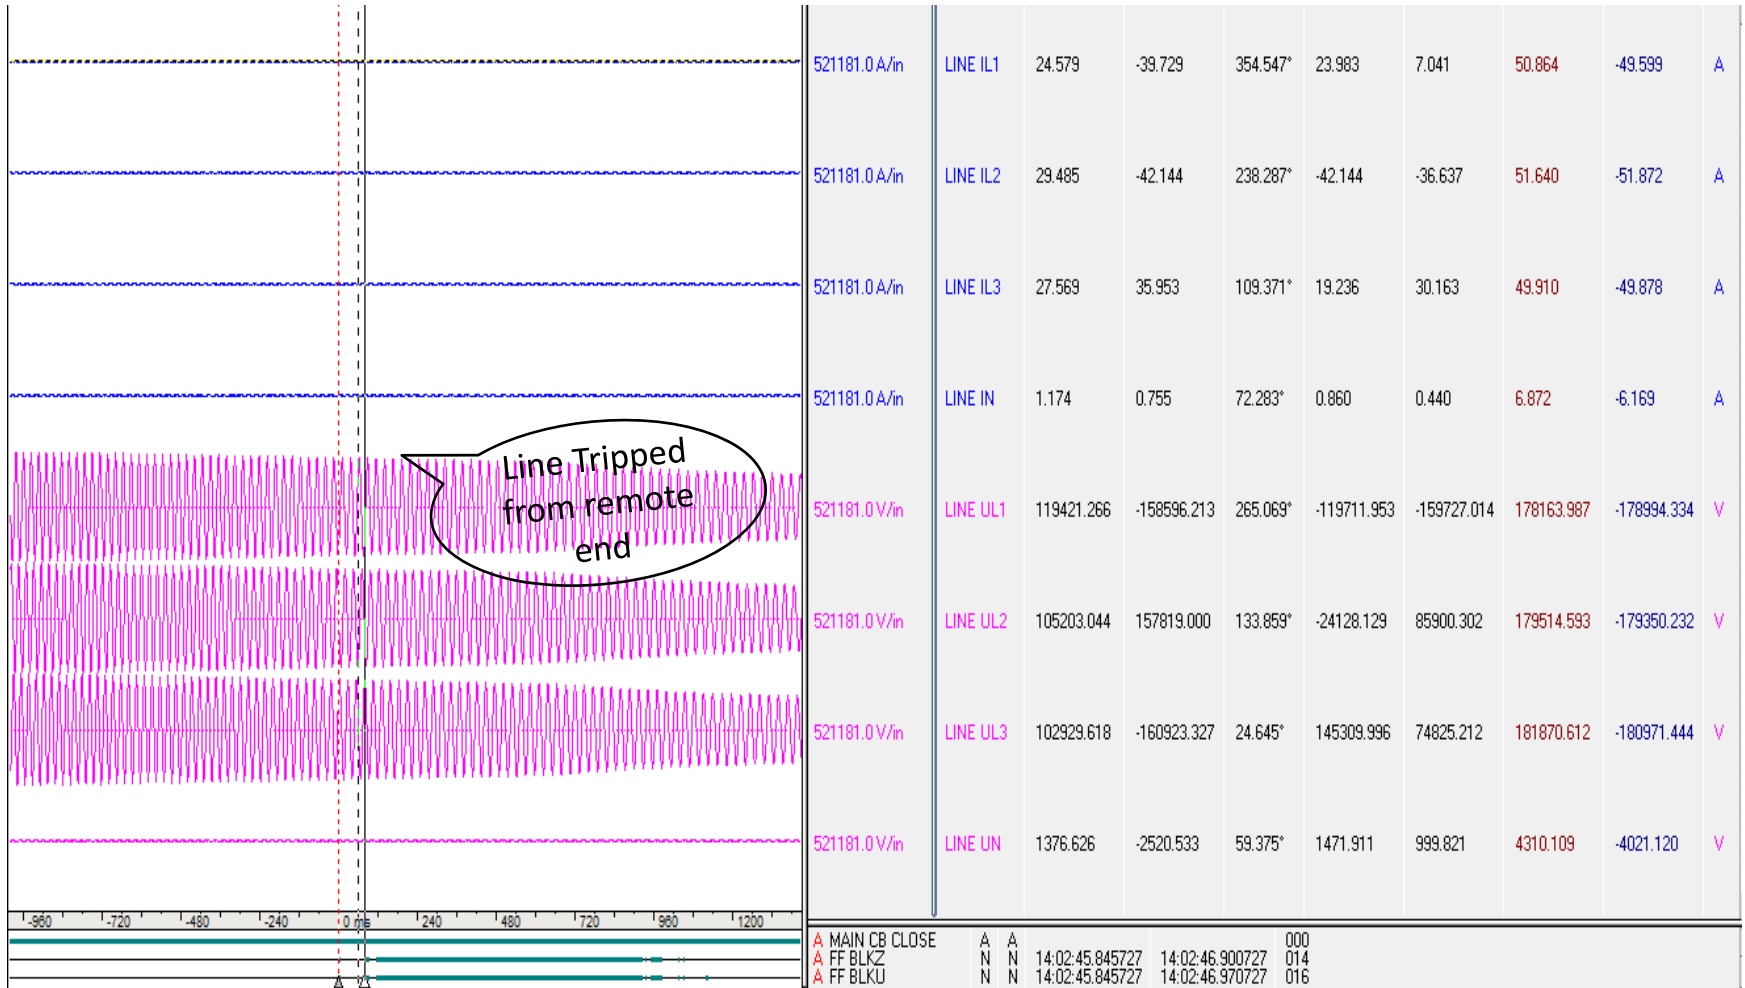
# Relay DR of Tanakpur-CBganj Line#1

Carrier fail

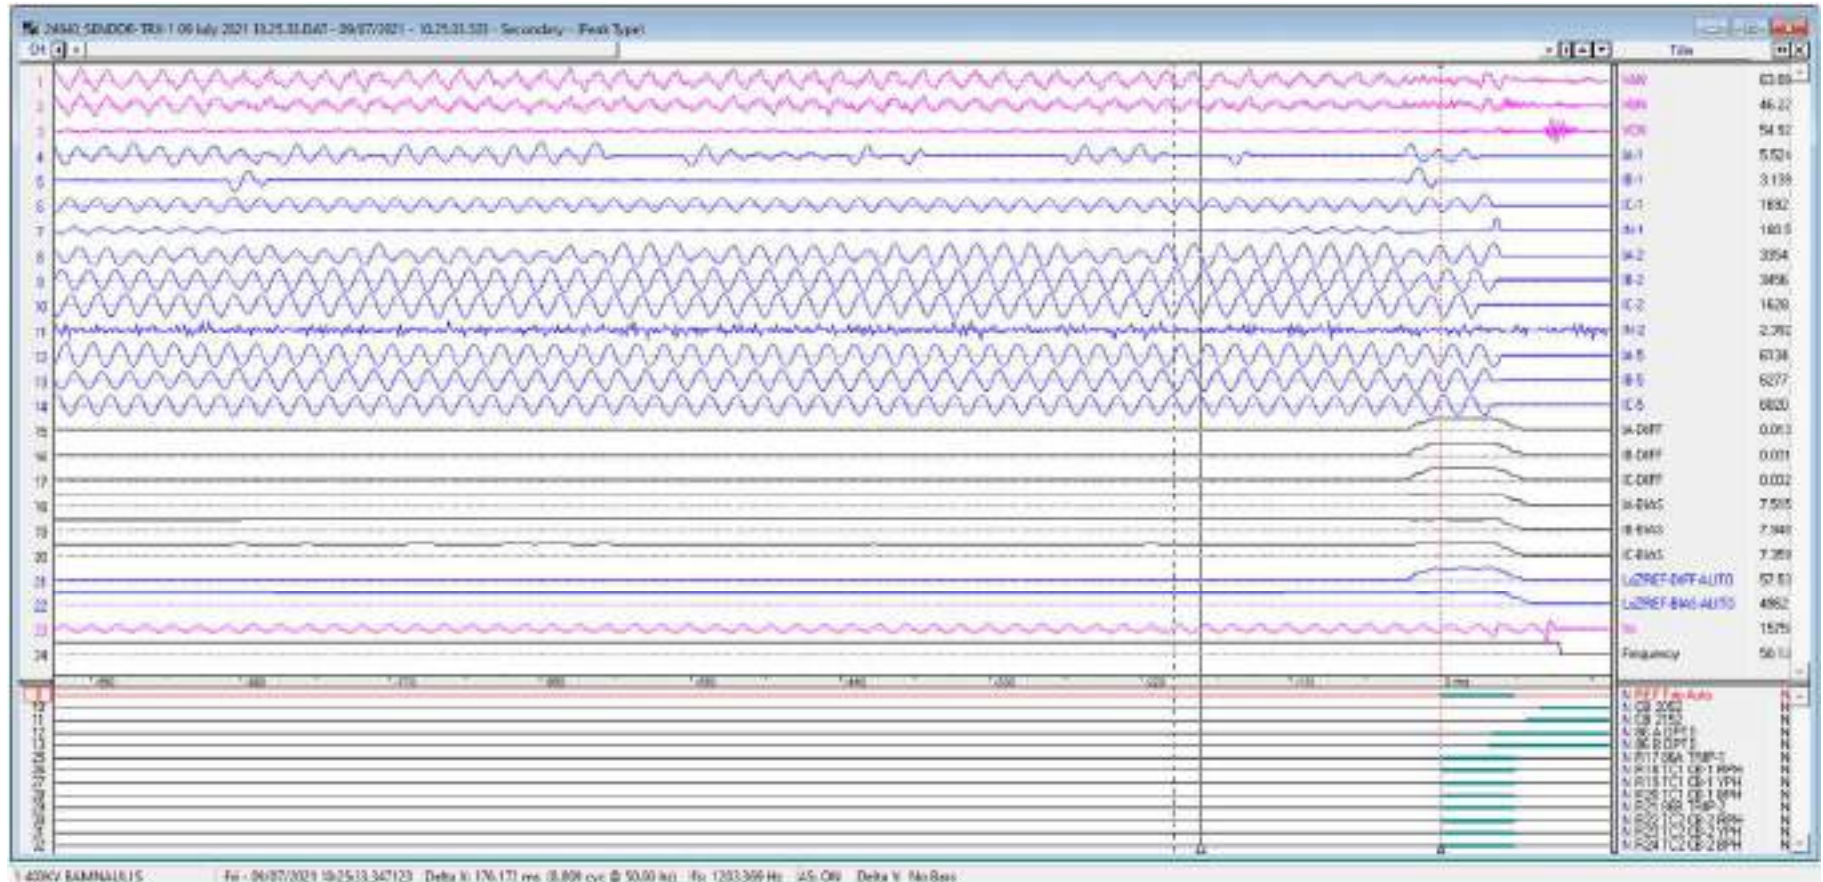
# DR of 315 MVA ICT-1 at Bamnauli

1. REF trip visible in DR.
