भारत सरकार  
Government of India  
विद्युत मंत्रालय  
Ministry of Power  
उत्तर क्षेत्रीय विद्युत समिति  
Northern Regional Power Committee

**विषय:** संरक्षण उप-समिति की 45<sup>वीं</sup> बैठक के कार्यवृत्त।  
**Subject:** Minutes of 45<sup>th</sup> Protection Sub-Committee Meeting.

## ***Minutes of 45<sup>th</sup> Meeting of Protection Sub-committee***

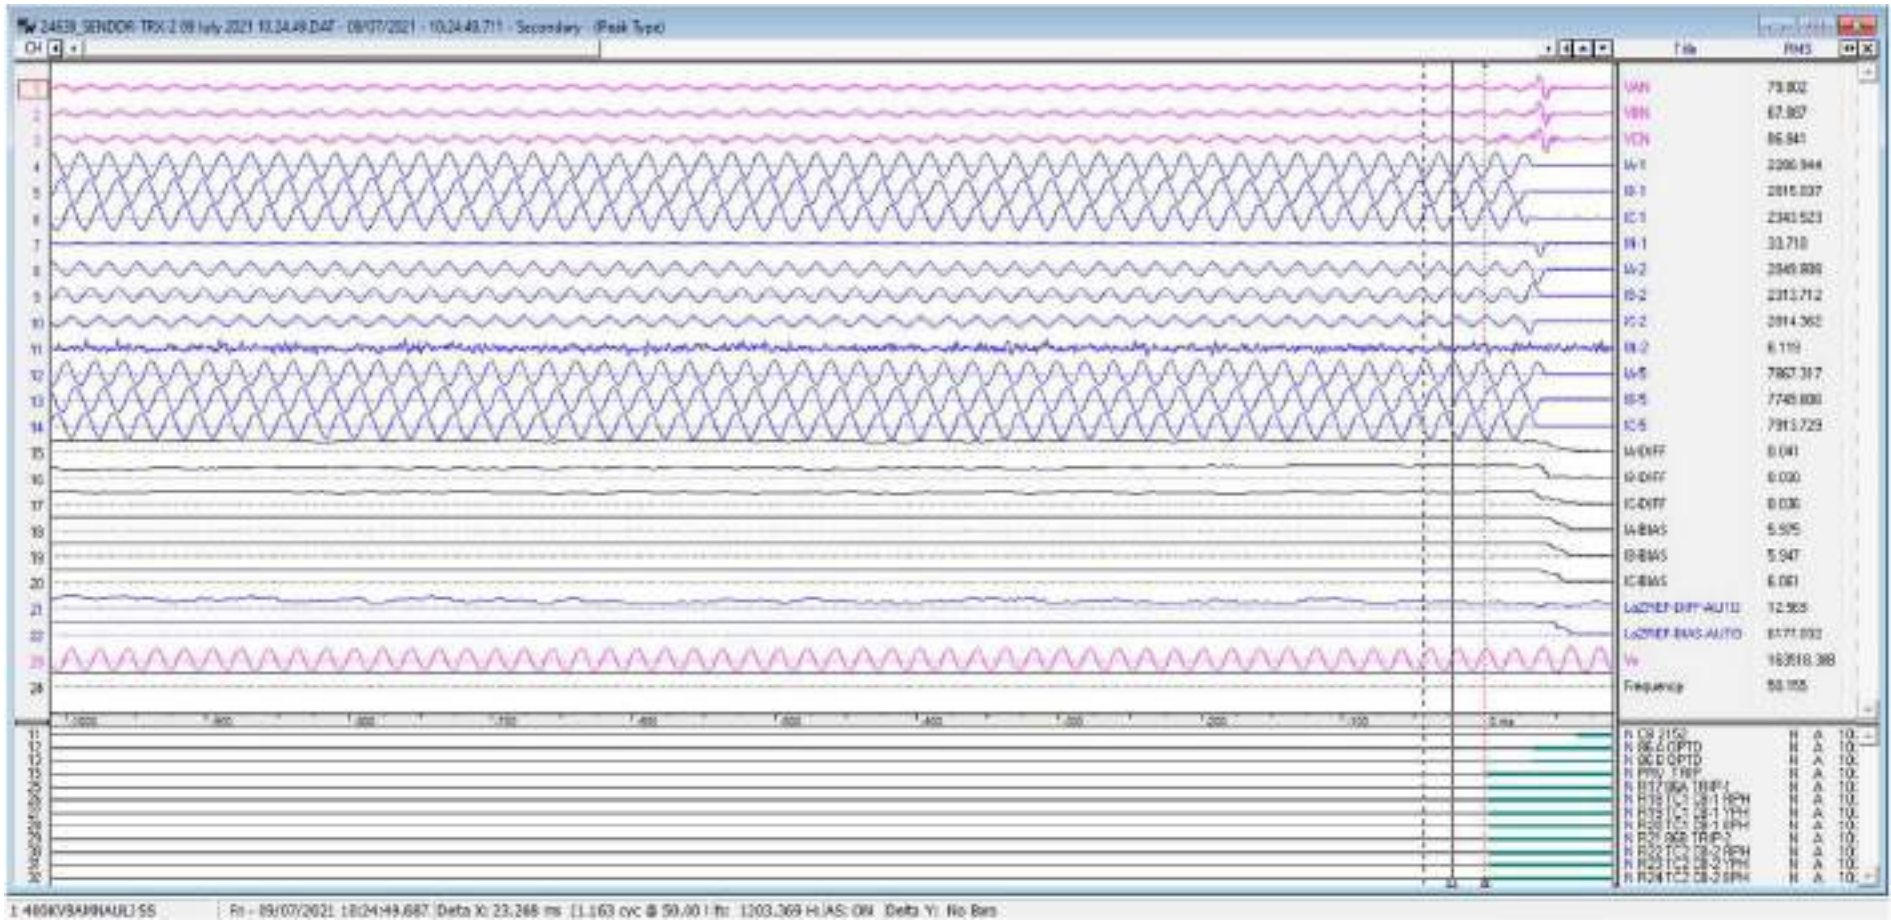
# DR of 500 MVA MVA ICT-2 at Bamnauli

1. PRV trip visible in DR.

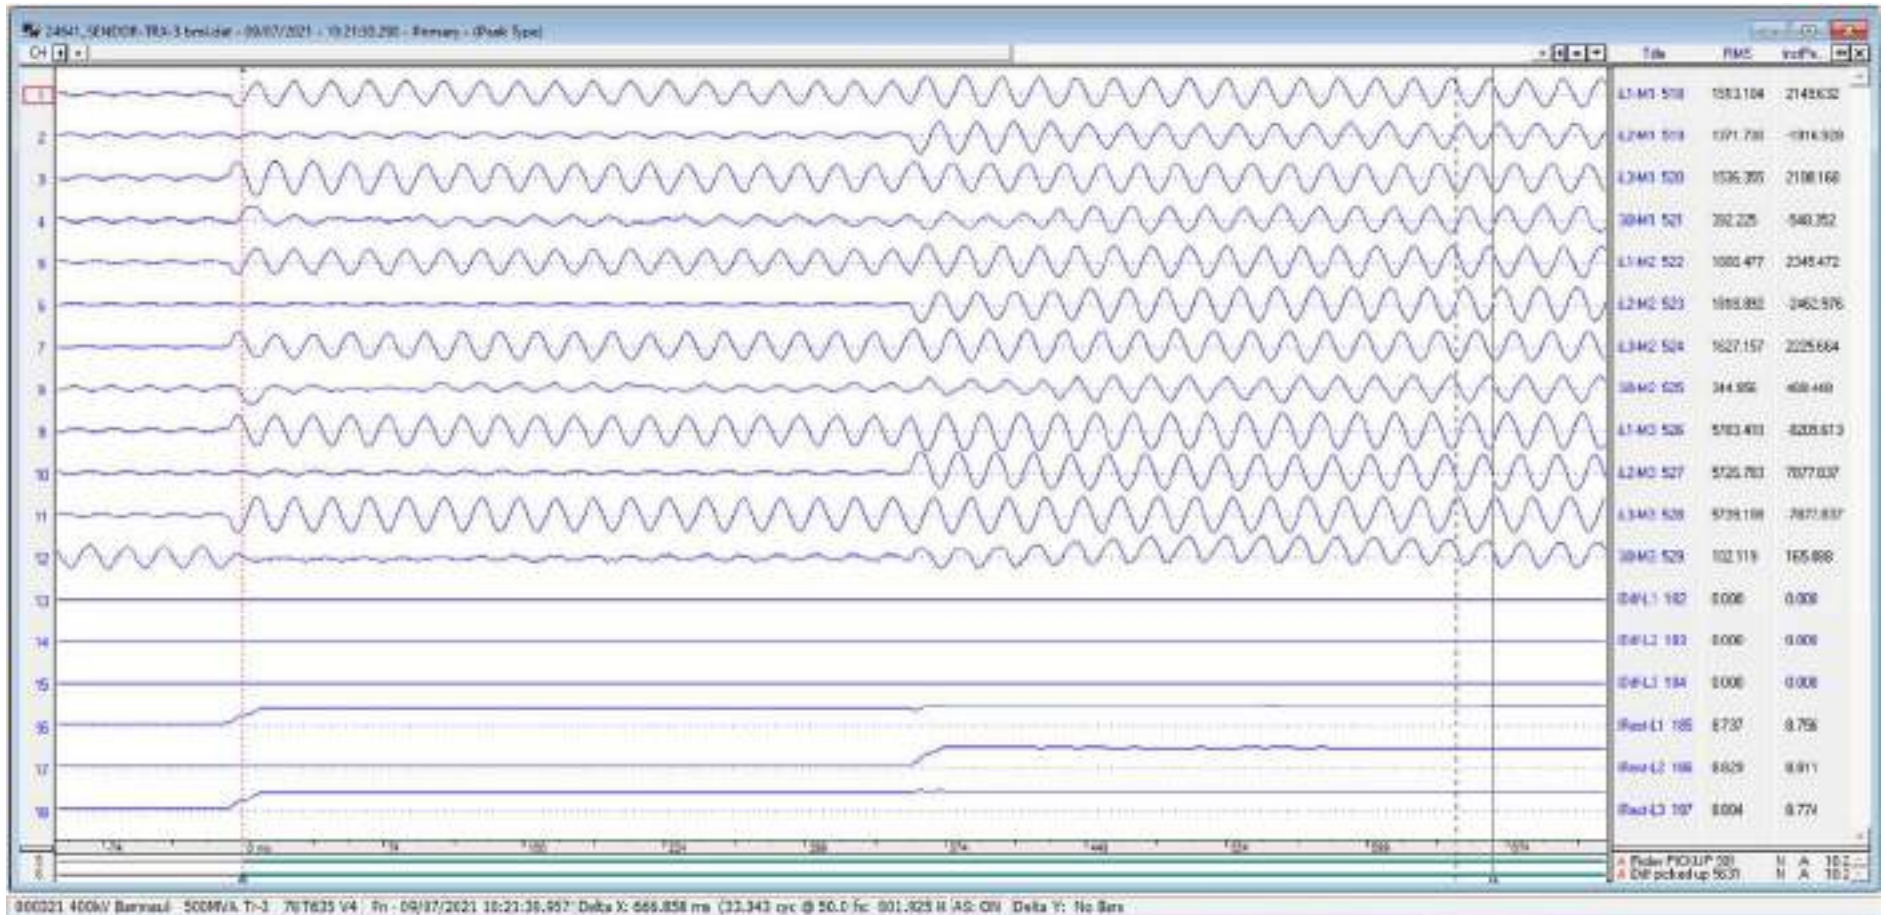
# DR of 500 MVA MVA ICT-3 at Bamnauli

1. Differential start visible. No trip signal.

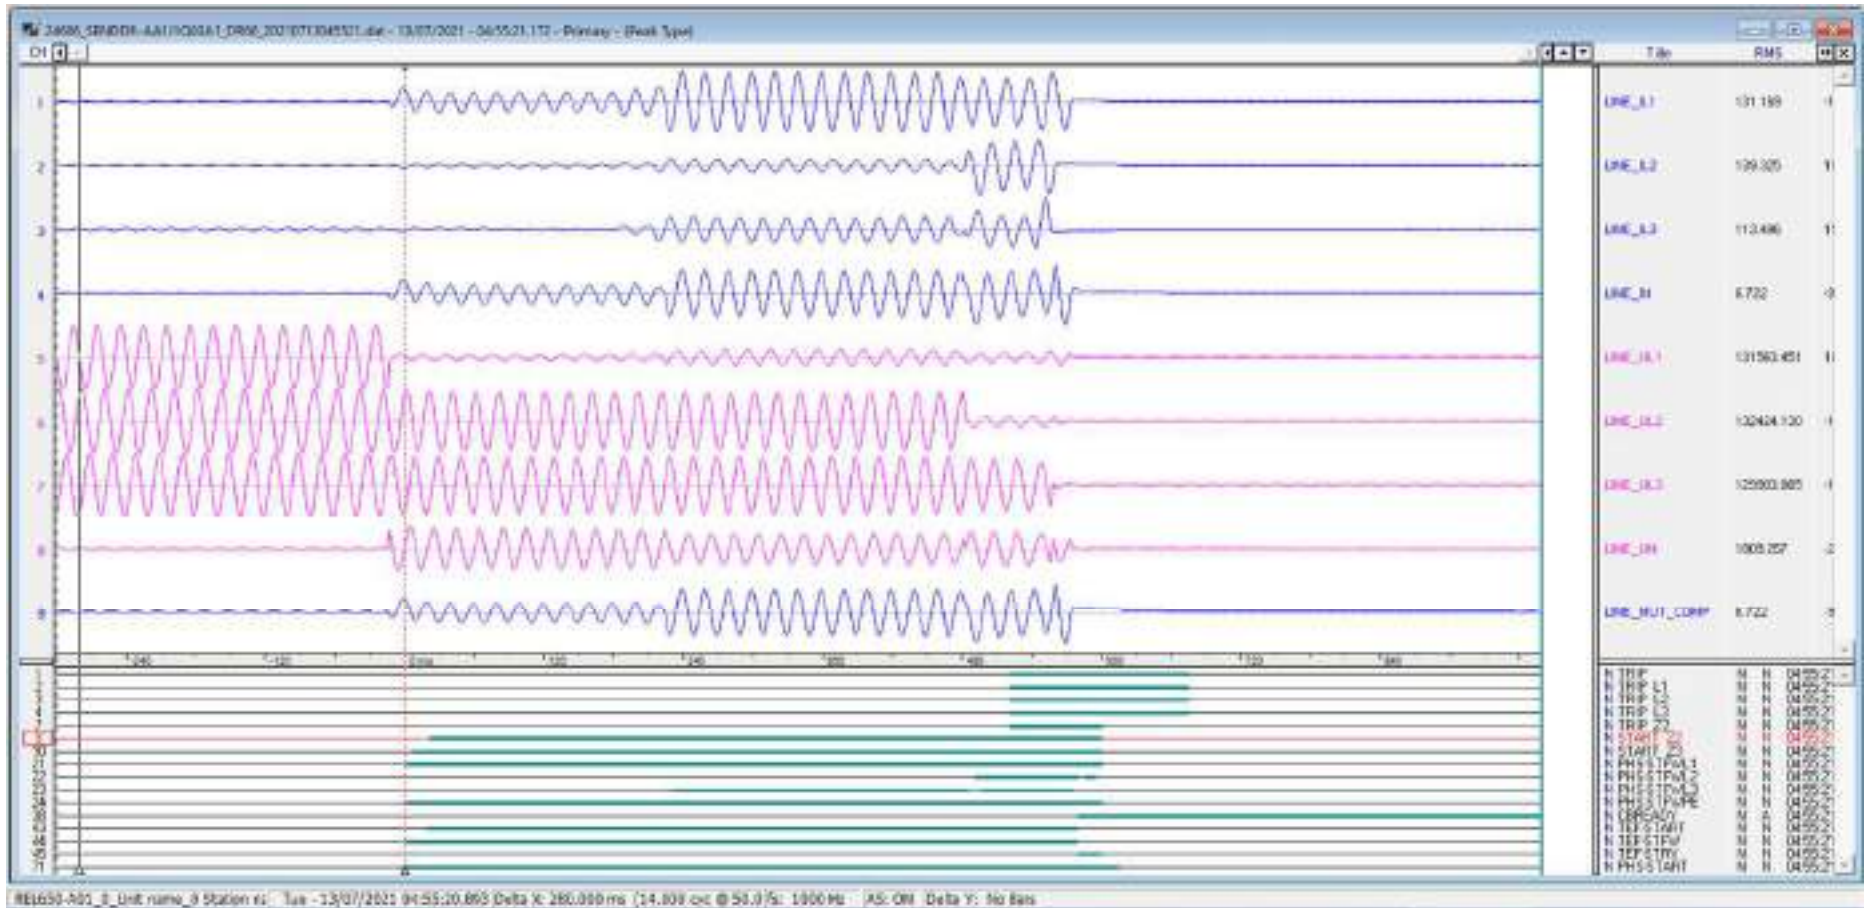
# DR of 220 kV Ballabgharh (End) – Samaypur - 3

1. Line tripped in Zone-2 from Ballabgharh. Timer=610ms, What is the Zone-2 timer?

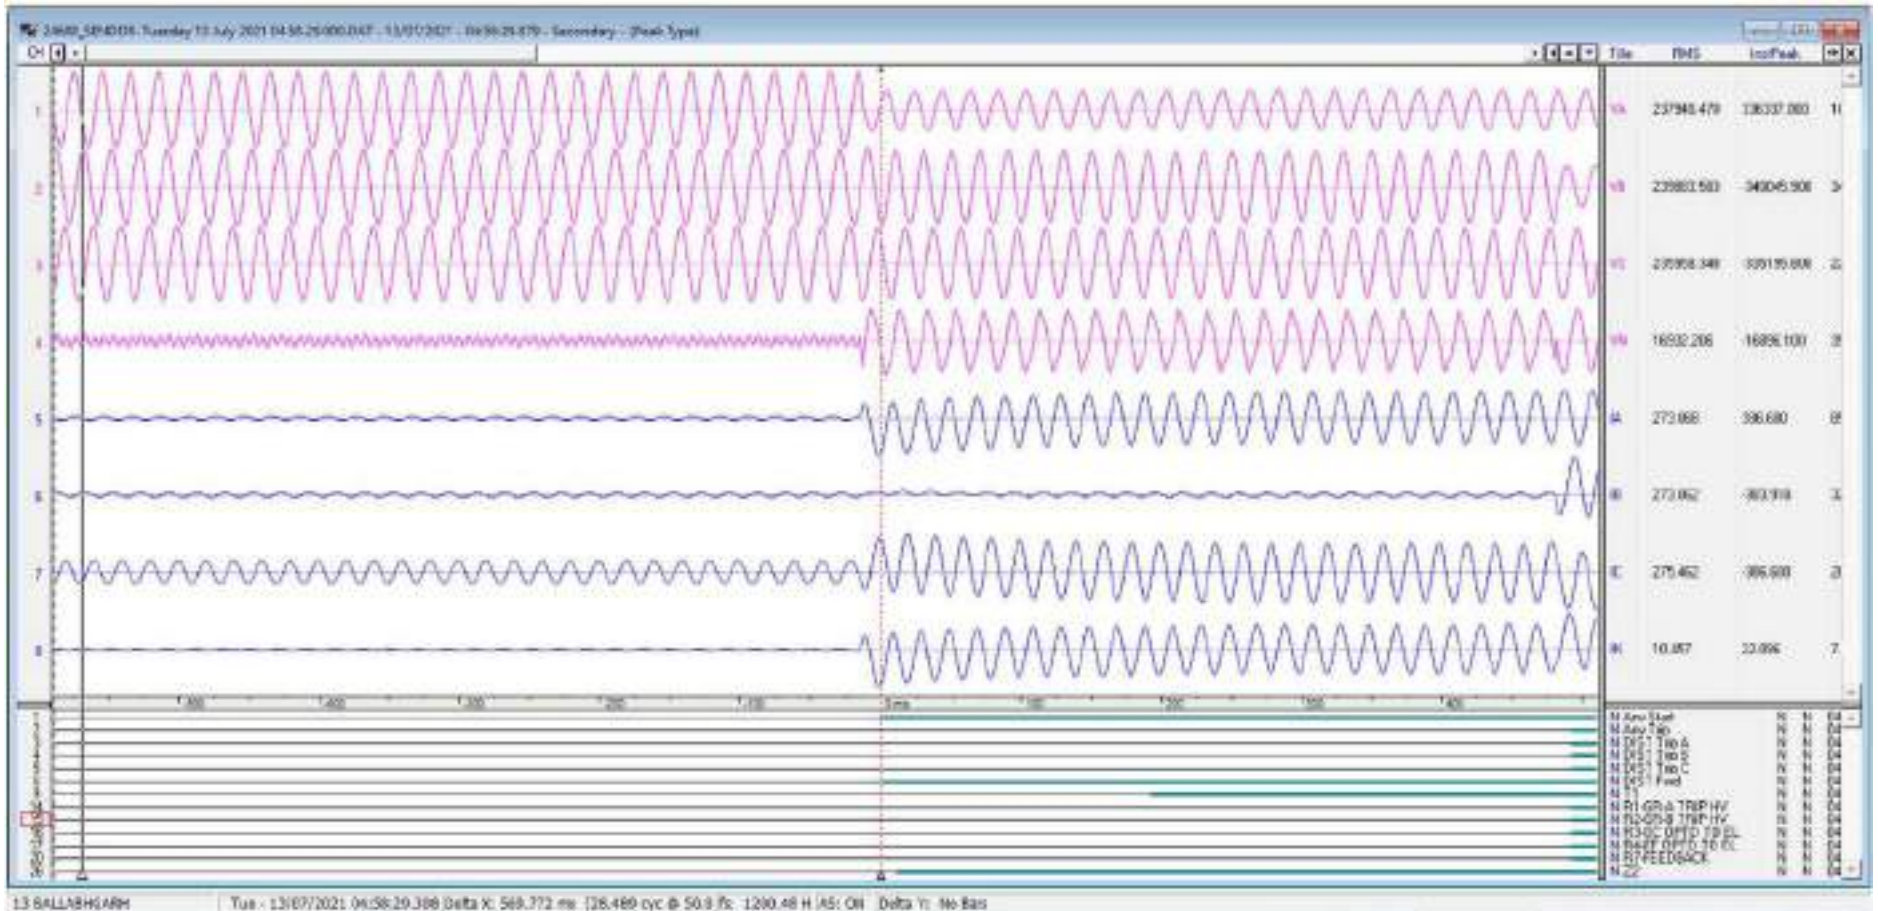
# DR of 500 MVA ICT-2 at Ballabhgarh

1. R-E fault visible.
2. ICT-2 tripped on Backup impedance.

1. DR channels are not properly configured in 220 kV Ballabgarh – Samaypur – 1.
2. The 220 kV Faridabad-Samaypur ckt-1 DR is faulty.
3. Status of Busbar protection at 220 kV Samaypur?
4. As per SOE, opening of Bus sectionalizer is not observed and delay in opening of bus coupler is also observed which led to the tripping of all ICTs and 220V feeders.
5. Remedial action taken report needs to be shared.

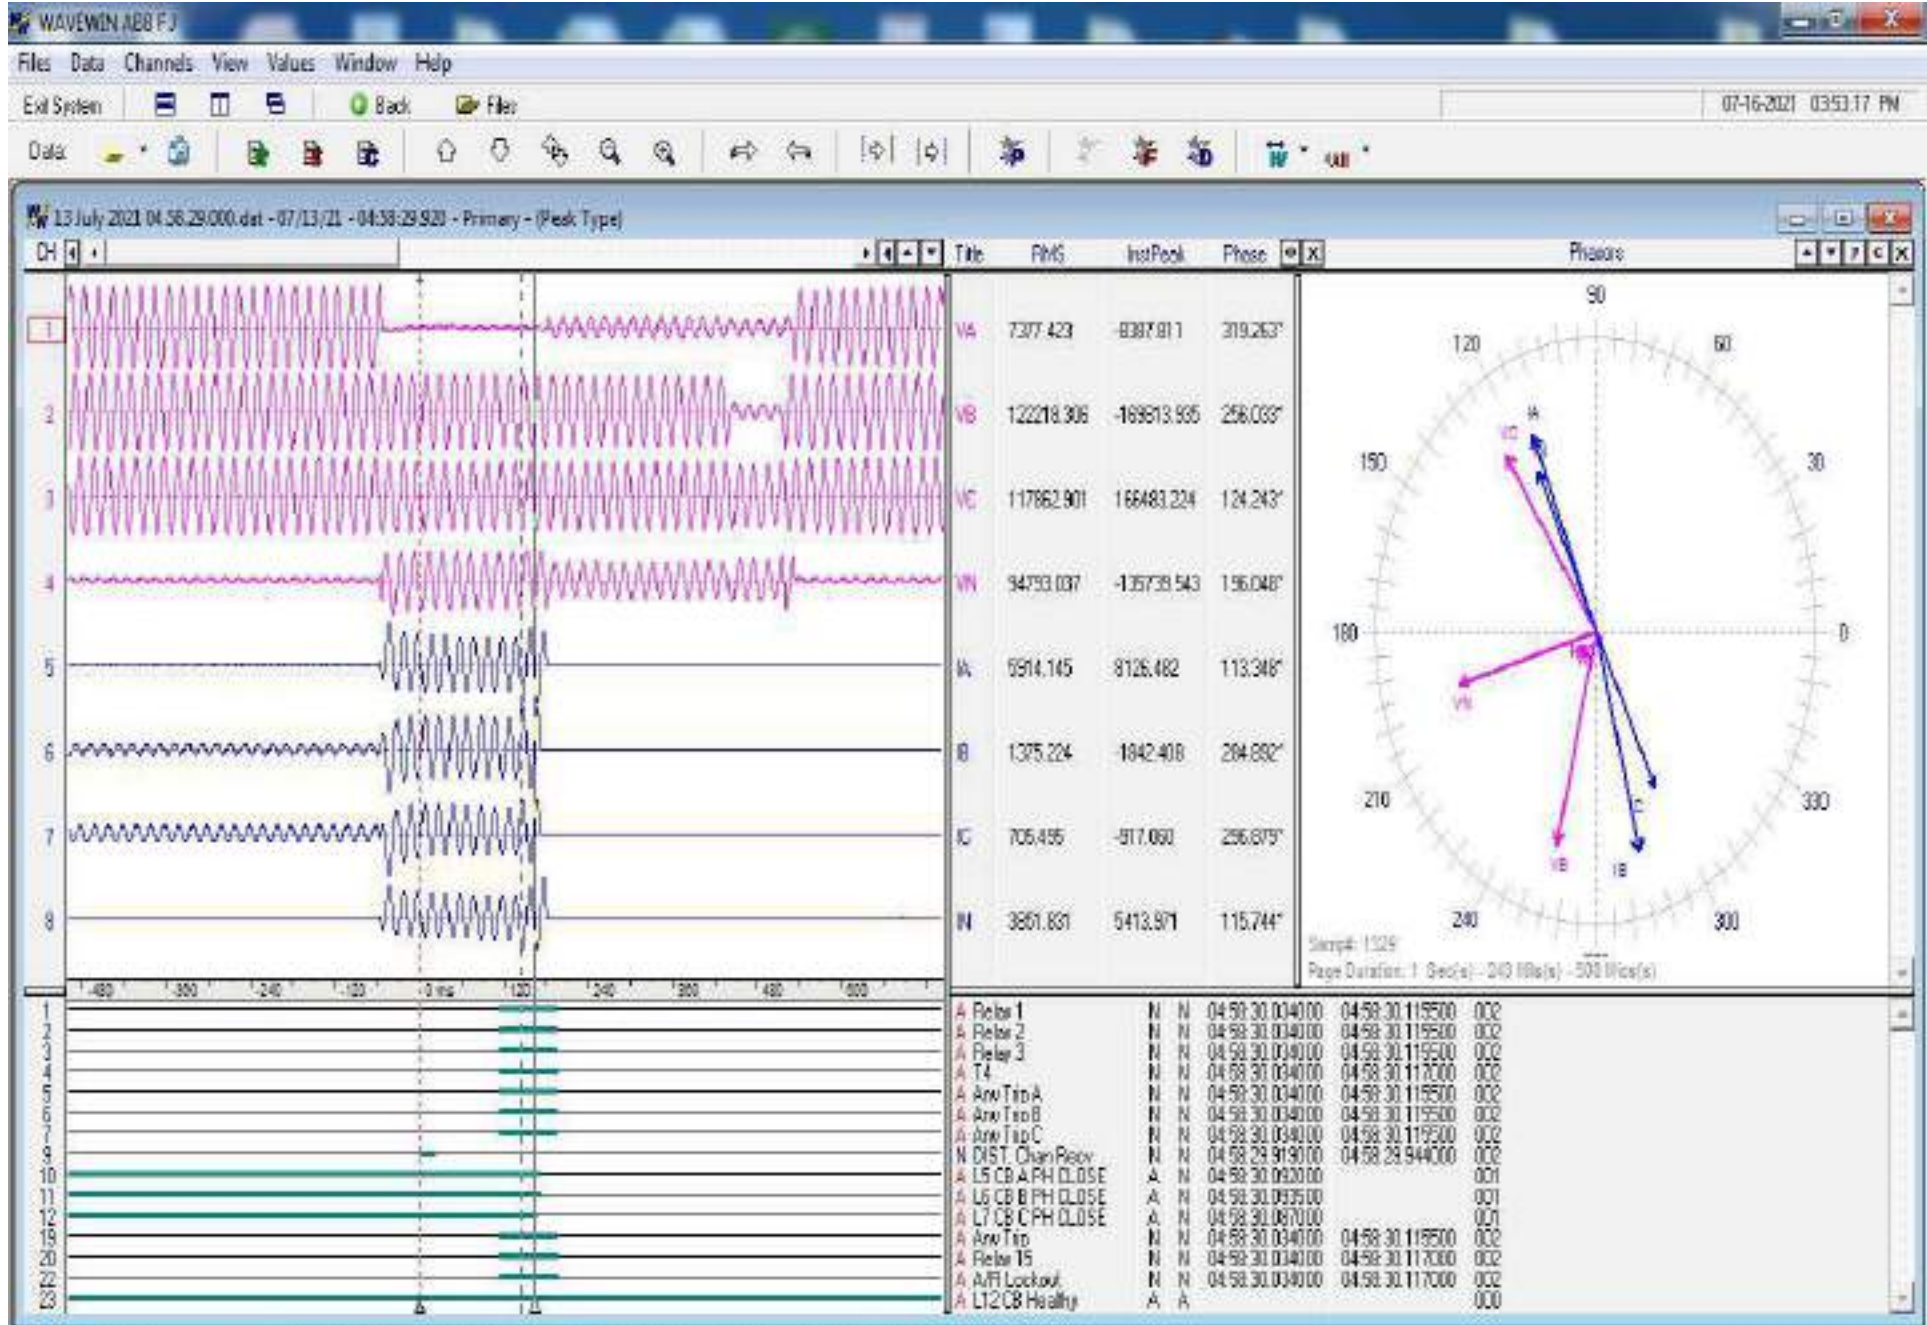
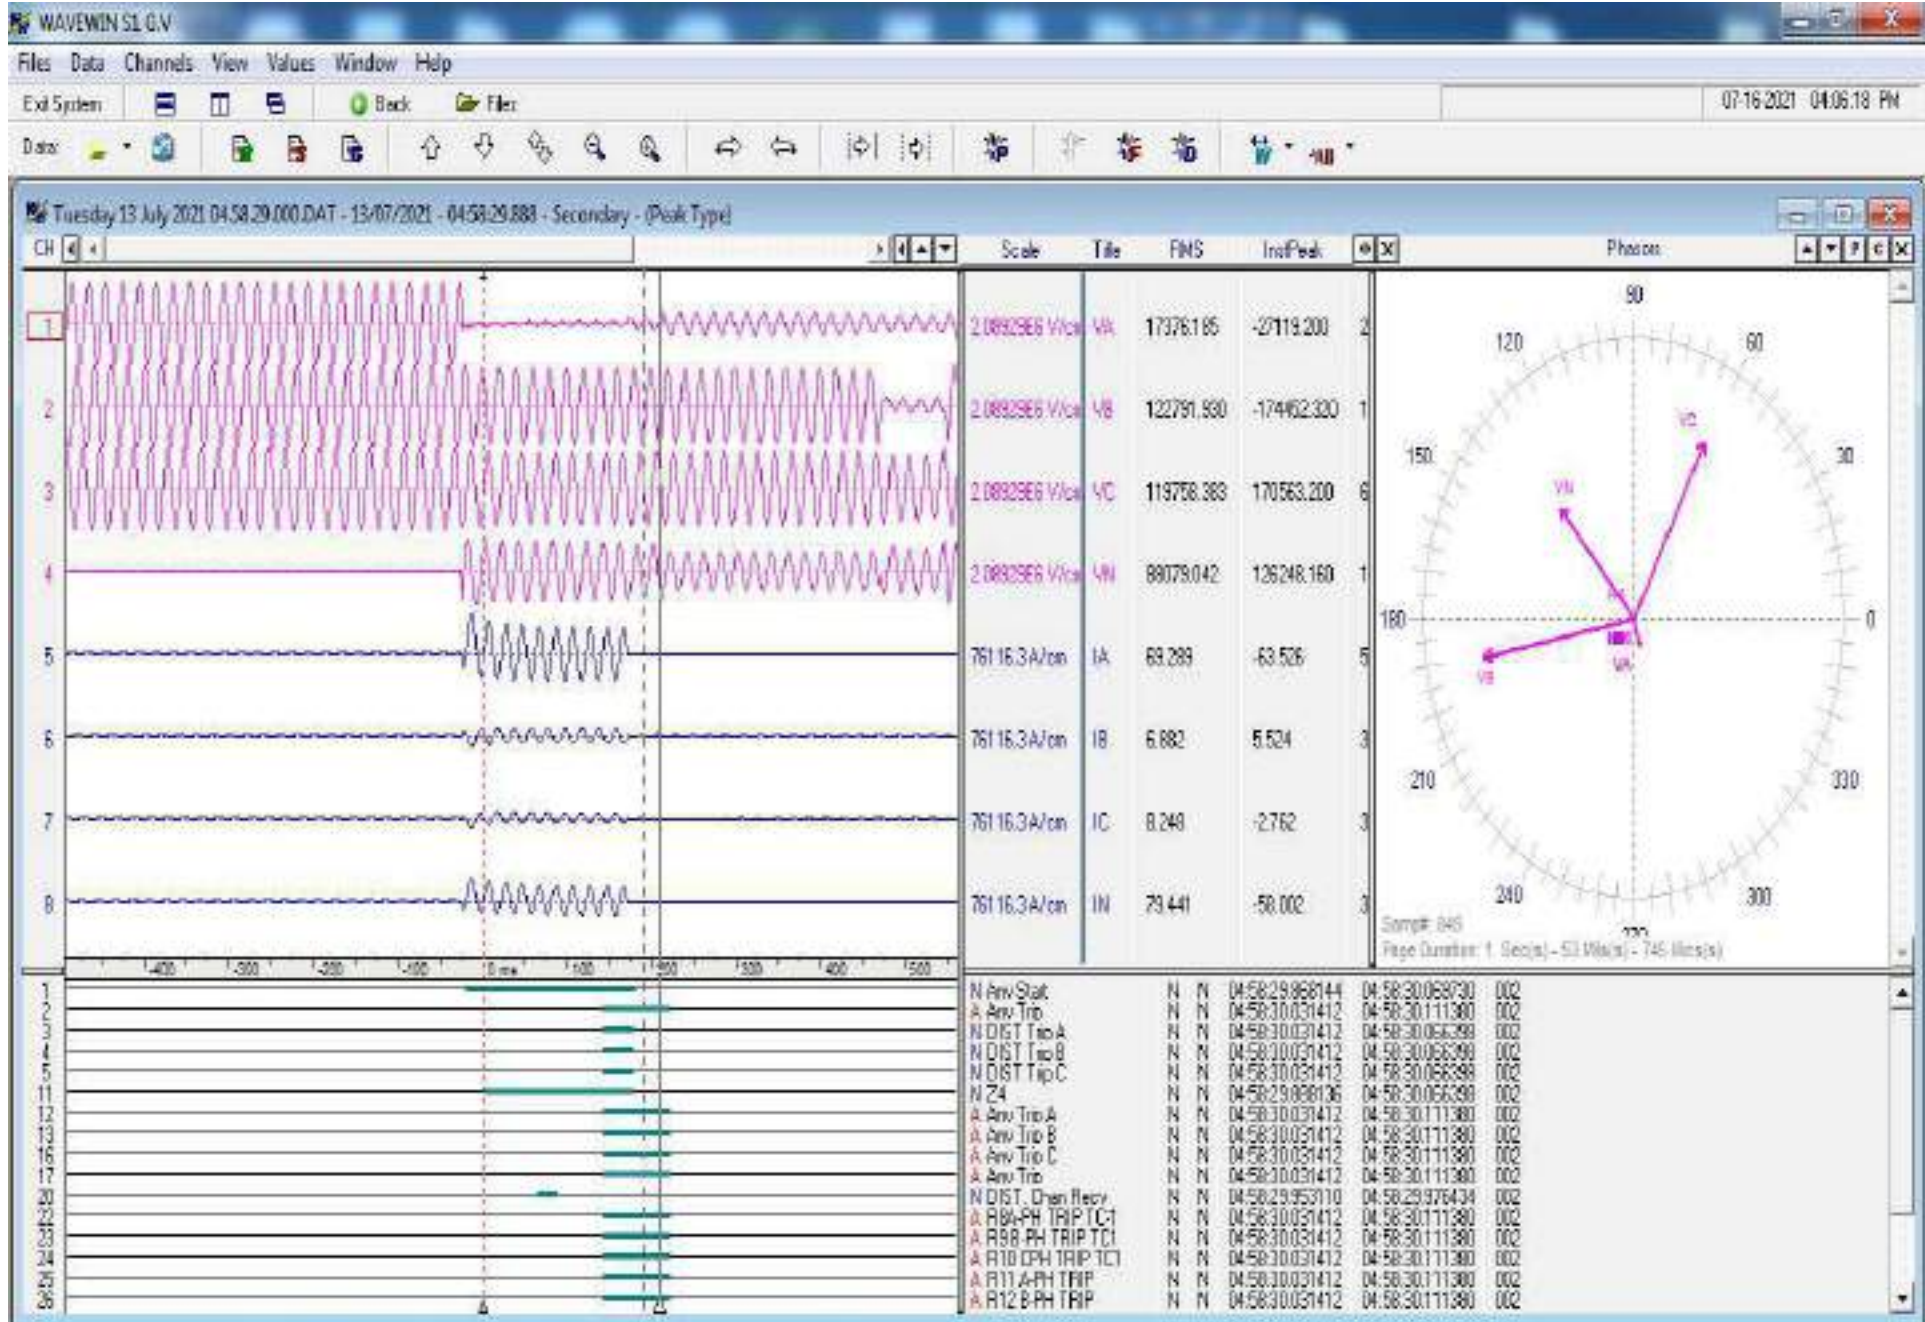
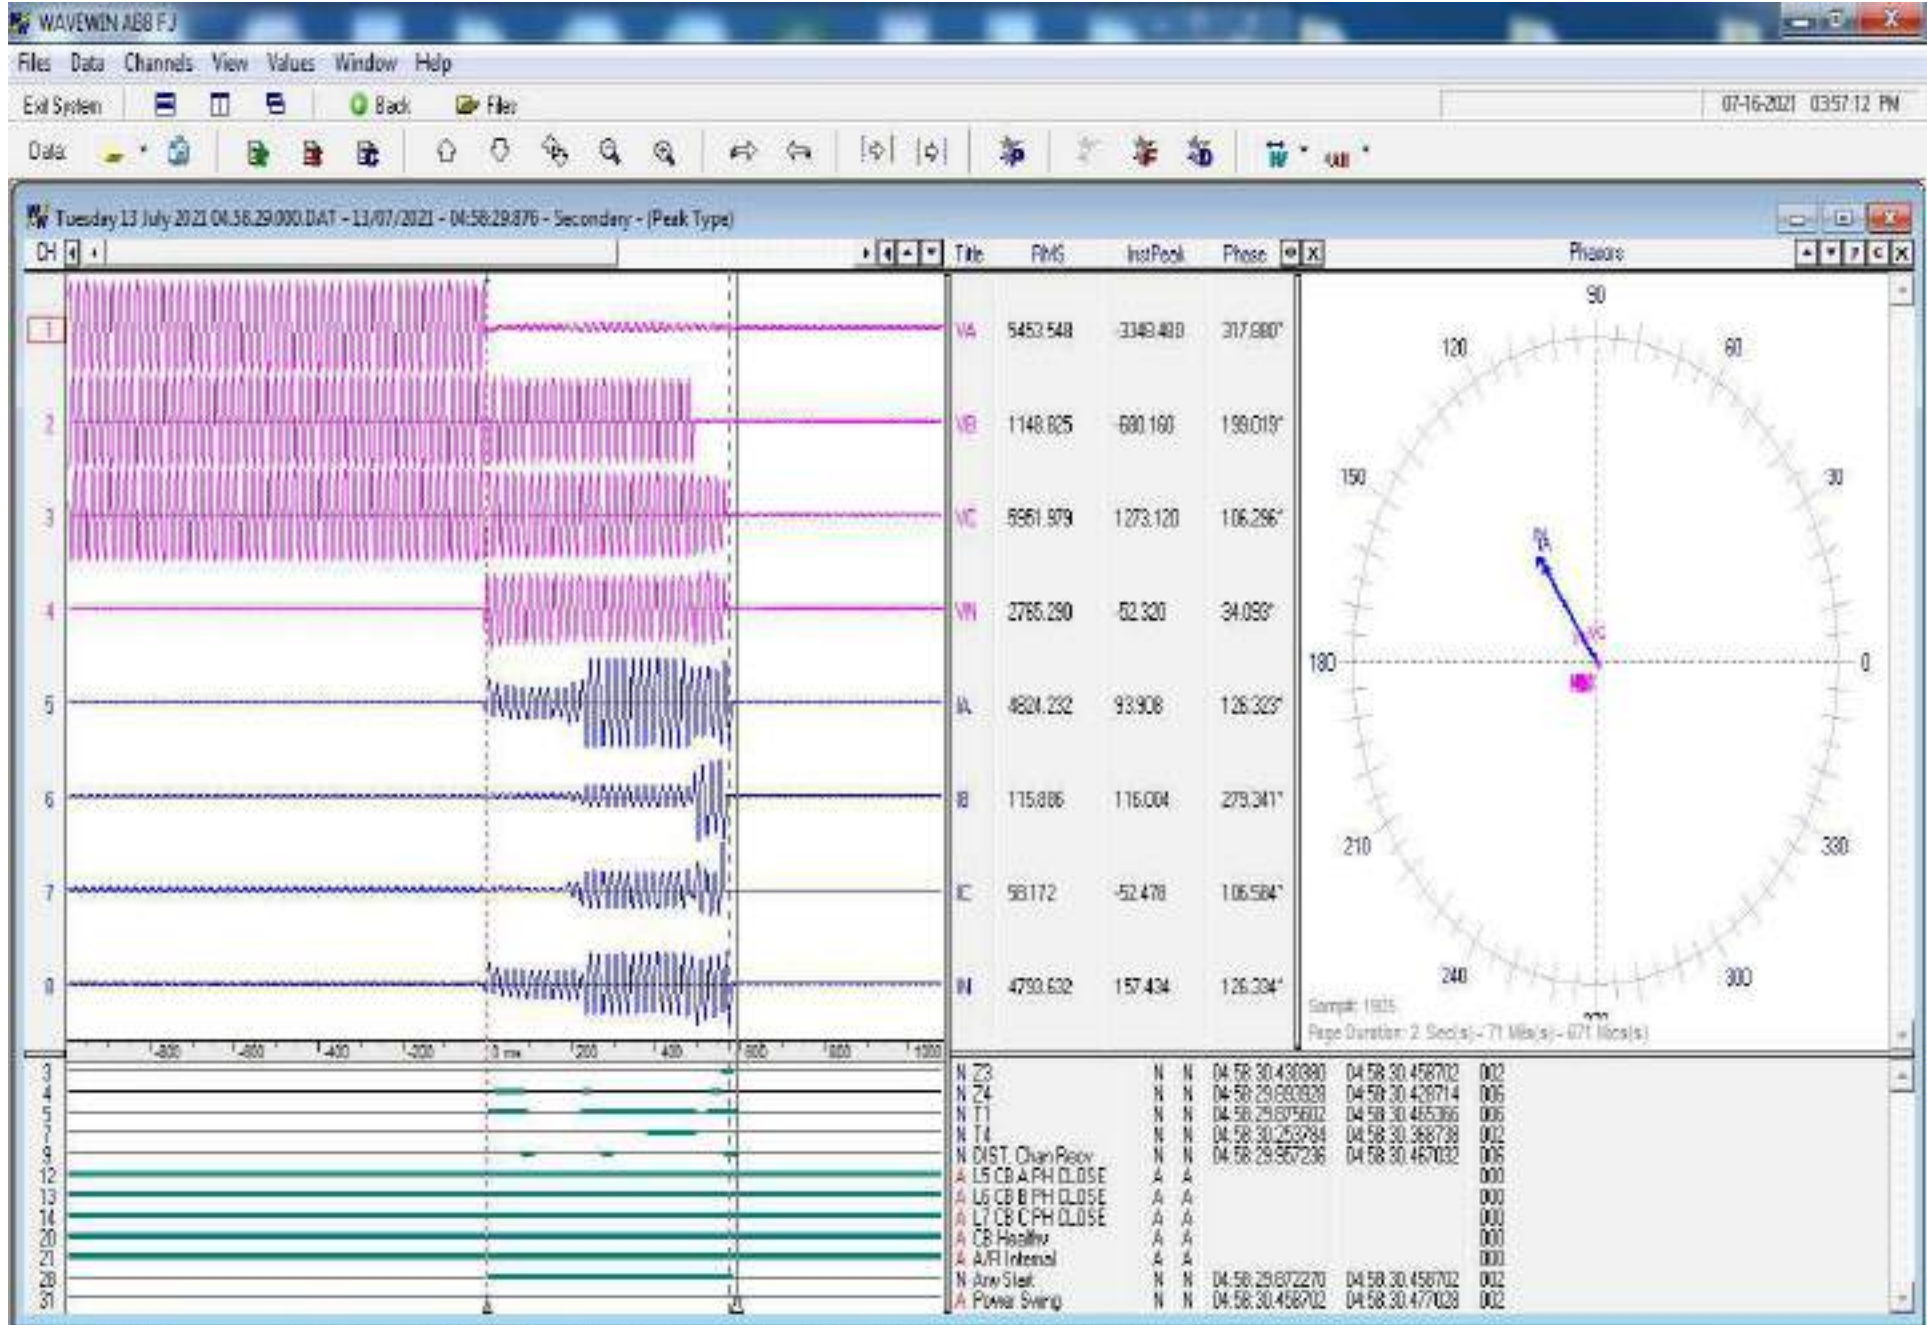
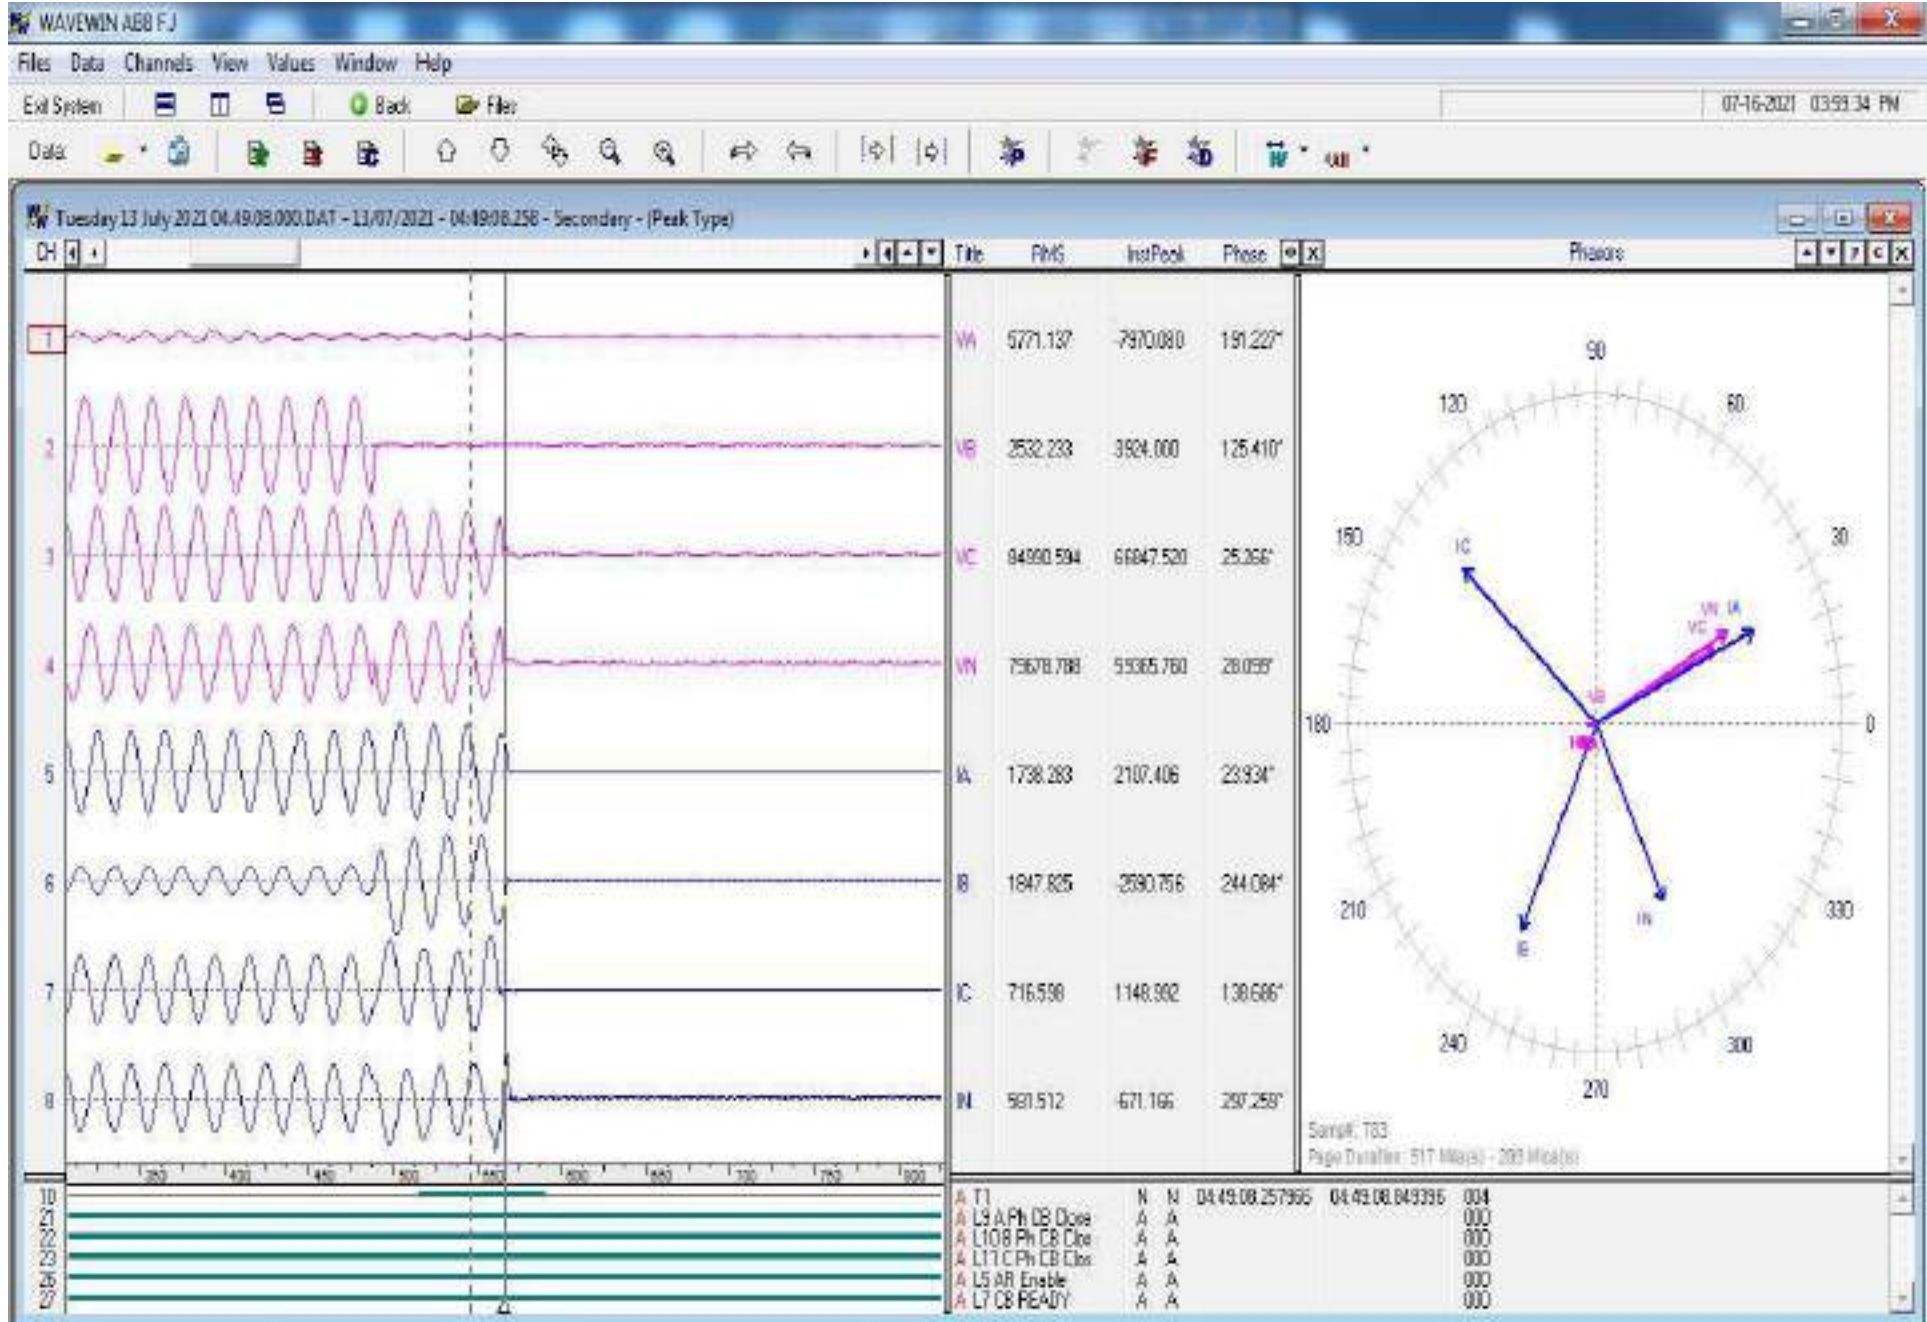
- **5. Location and type of fault:** - A heavy flash occurred on red phase isolator of ICT- 2 (Bus-1) in 220kV, BBMB, Samaypur switchyard resulting into high resistance Bus fault. All the four ICTs (400/220 KV, 500 MVA) tripped on Backup impedance protection as per the settings at PGCIL end.
- 
- **6. Flag Details, DR and EL for each affected element:**  
Attached
- **7. Appropriate Graphical Plot:** Including SCADA data/print out of DR and EL details: - DRs/Events files attached.
- 
- **8. Equipment failure (if any):-** Male female jaw of red phase Bus 1 isolator of ICT-2.

- 
  - 220 KV Ch. Dadri & B/Garh -3 tripped in Zone-2 at other end, the Z-2 timing of other end being 500ms. As per the DRs, Z-4 of these feeders was found to start & reset (three times) before the existing 160ms time setting & there after PSB appeared, as such Z-4 didn't operate by DP Scheme of these feeders.

- **2. Special finding/ issues identified during restoration: - Nil**
- **F. Remedial Action:-**
- **1. Remedial Action Taken:** The damaged male-female contacts of the isolator of ICT-2 have been replaced with new. Hotspot of red phase CT of Bus 2A side of Bus Coupler-1 has been attended. Hotspot on red phase wave trap of Ballabgarh-3 feeder has been attended.
- No other damage of Equipment was there at 220 KV Samaypur Substation.
- **2. Remedial Action to be taken along with time frame:** The defective CU of MiCOM P741 numerical differential BBP has been replaced with a new CU. This new CU has been re-commissioned by the firm engineer of M/S Alstom on **23.07.2021**.

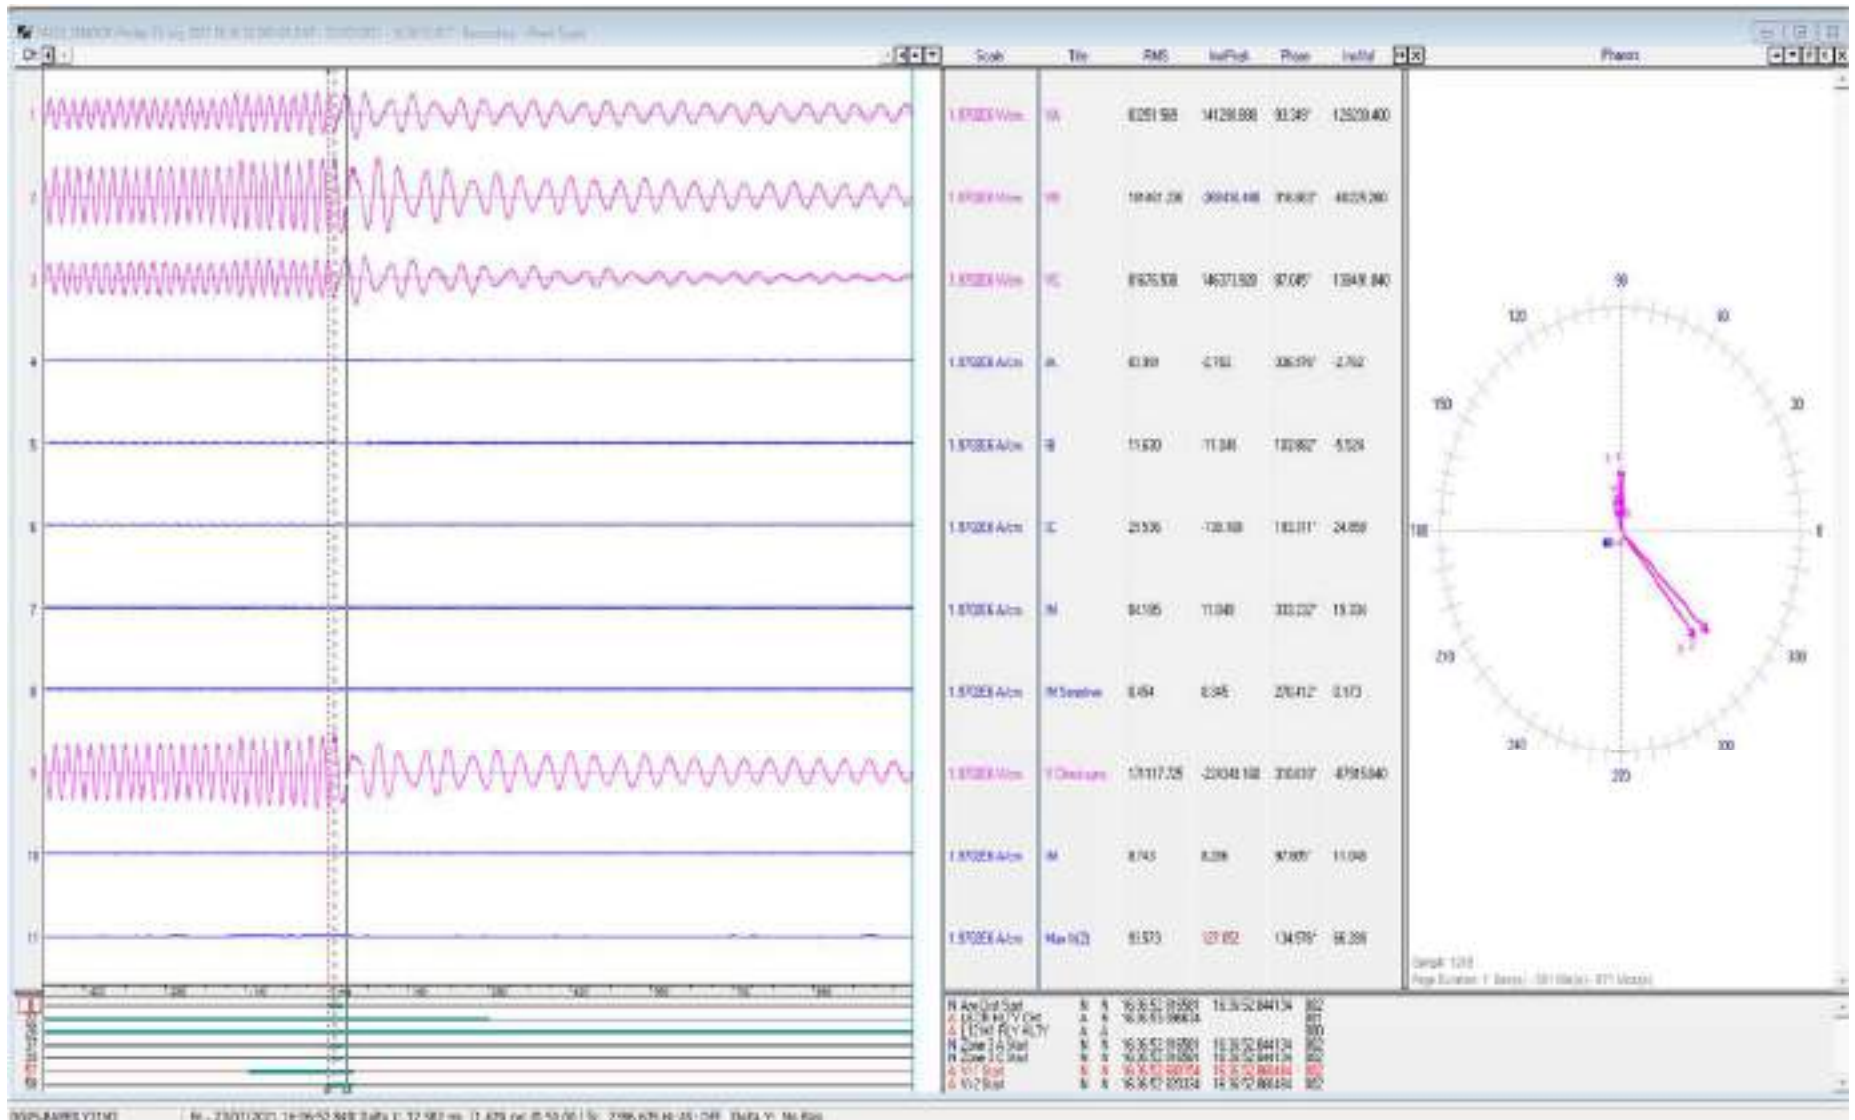
# DR of Dhauliganga-Bareilly (Dhauliganga end)

Line tripped within 50ms of OV stage-2 start, Time delay setting of OV protection at Dhauliganga NHPC needs to be reviewed.

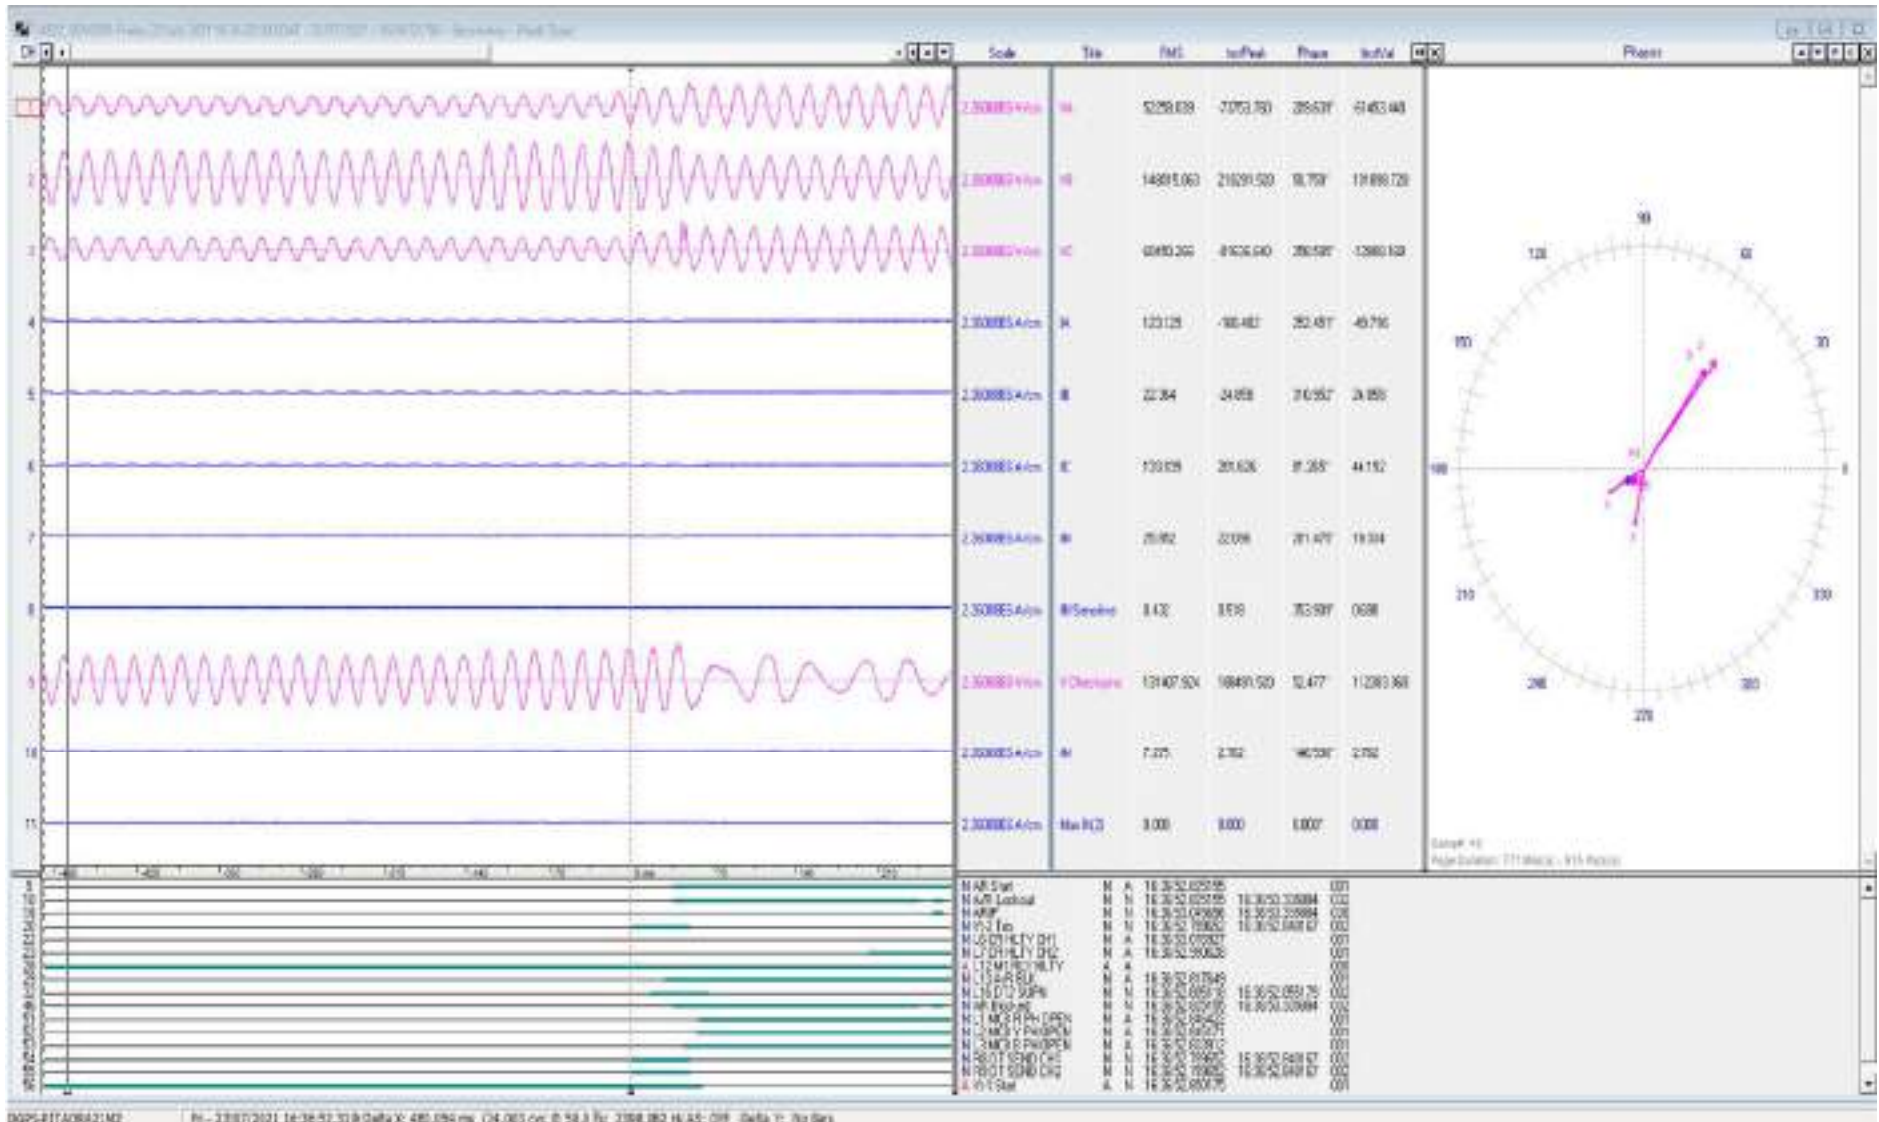
# DR of Dhauliganga-Pithoragarh (Dhauliganga end)

Line tripped within 50ms of OV stage-2 start, time delay setting of OV protection at Dhauliganga NHPC needs to be reviewed.
