भारत सरकार  
Government of India  
विद्युत मंत्रालय  
Ministry of Power  
उत्तर क्षेत्रीय विद्युत समिति  
Northern Regional Power Committee

**विषय:** संरक्षण उप-समिति की 45<sup>वीं</sup> बैठक के कार्यवृत्त।  
**Subject:** Minutes of 45<sup>th</sup> Protection Sub-Committee Meeting.

## ***Minutes of 45<sup>th</sup> Meeting of Protection Sub-committee***

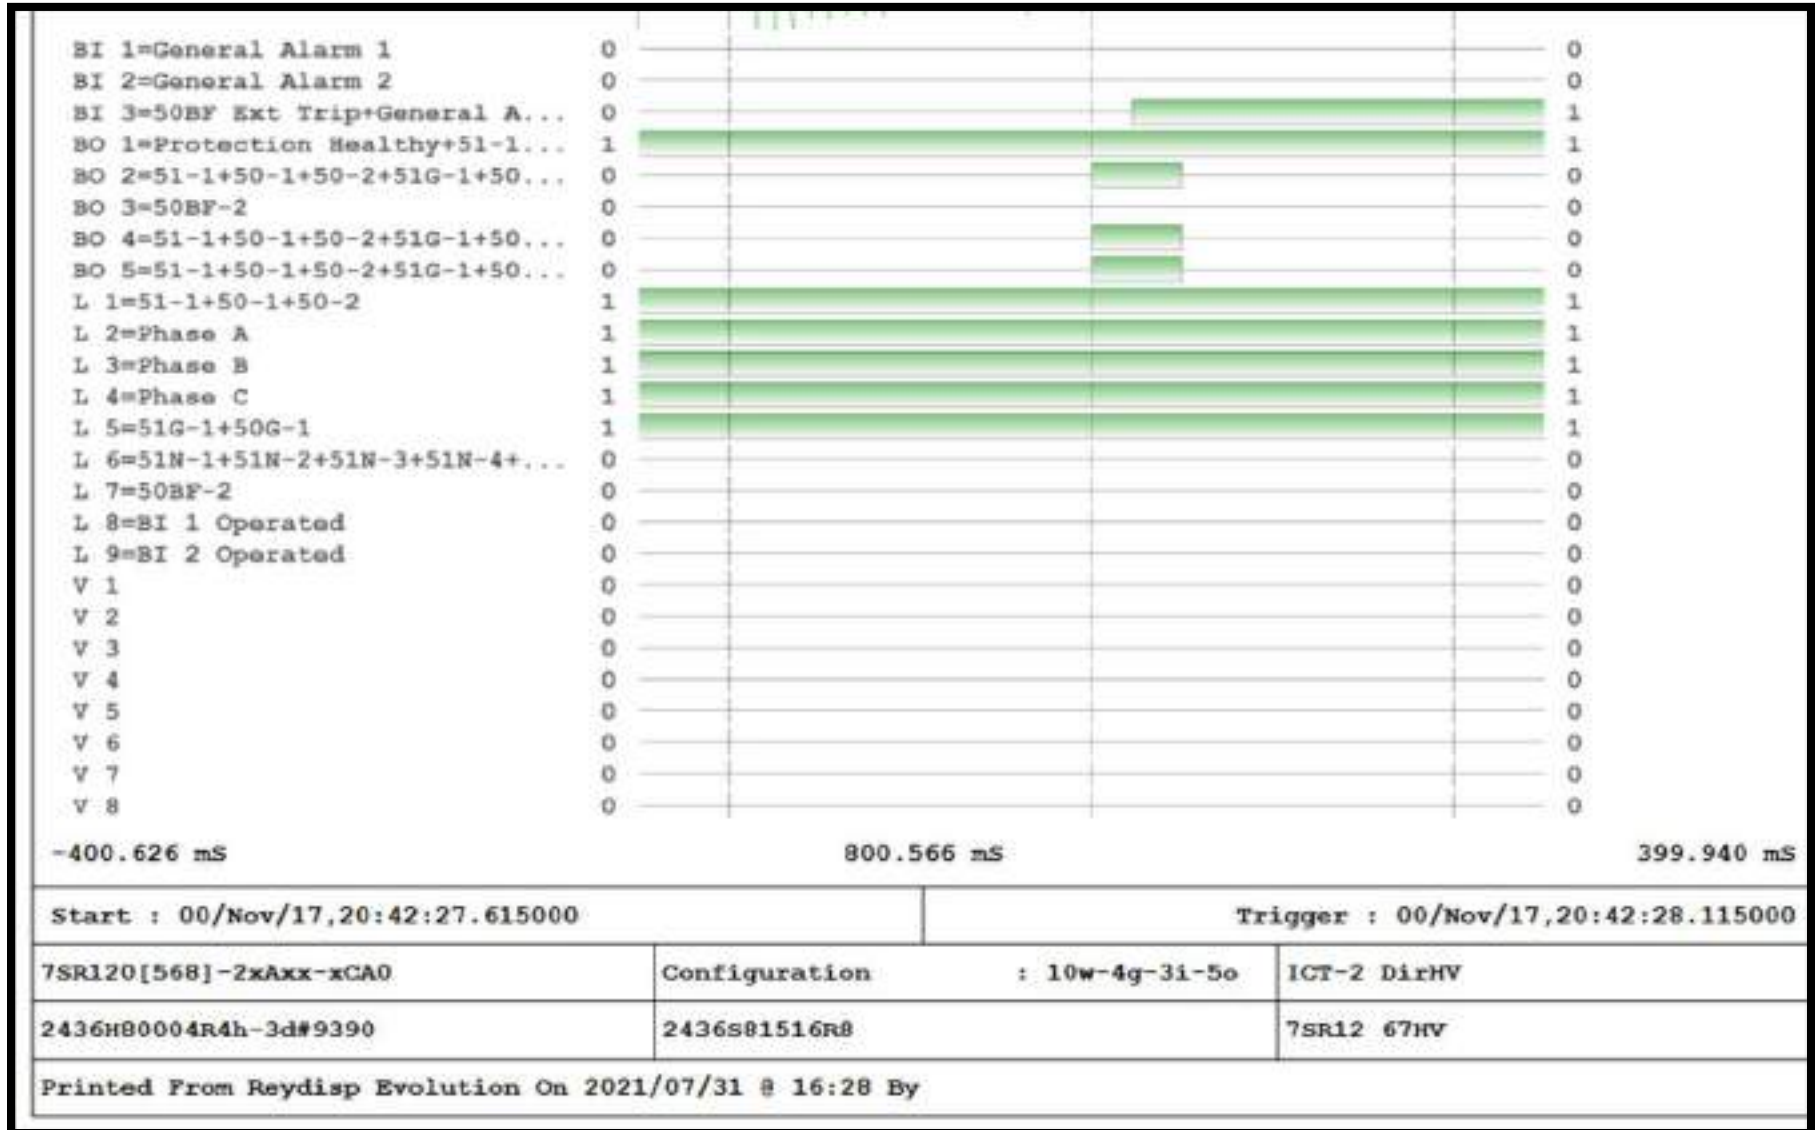
# DR of 400/220kV ICT-2 at Bareilly(UP)

Earth fault protection operated

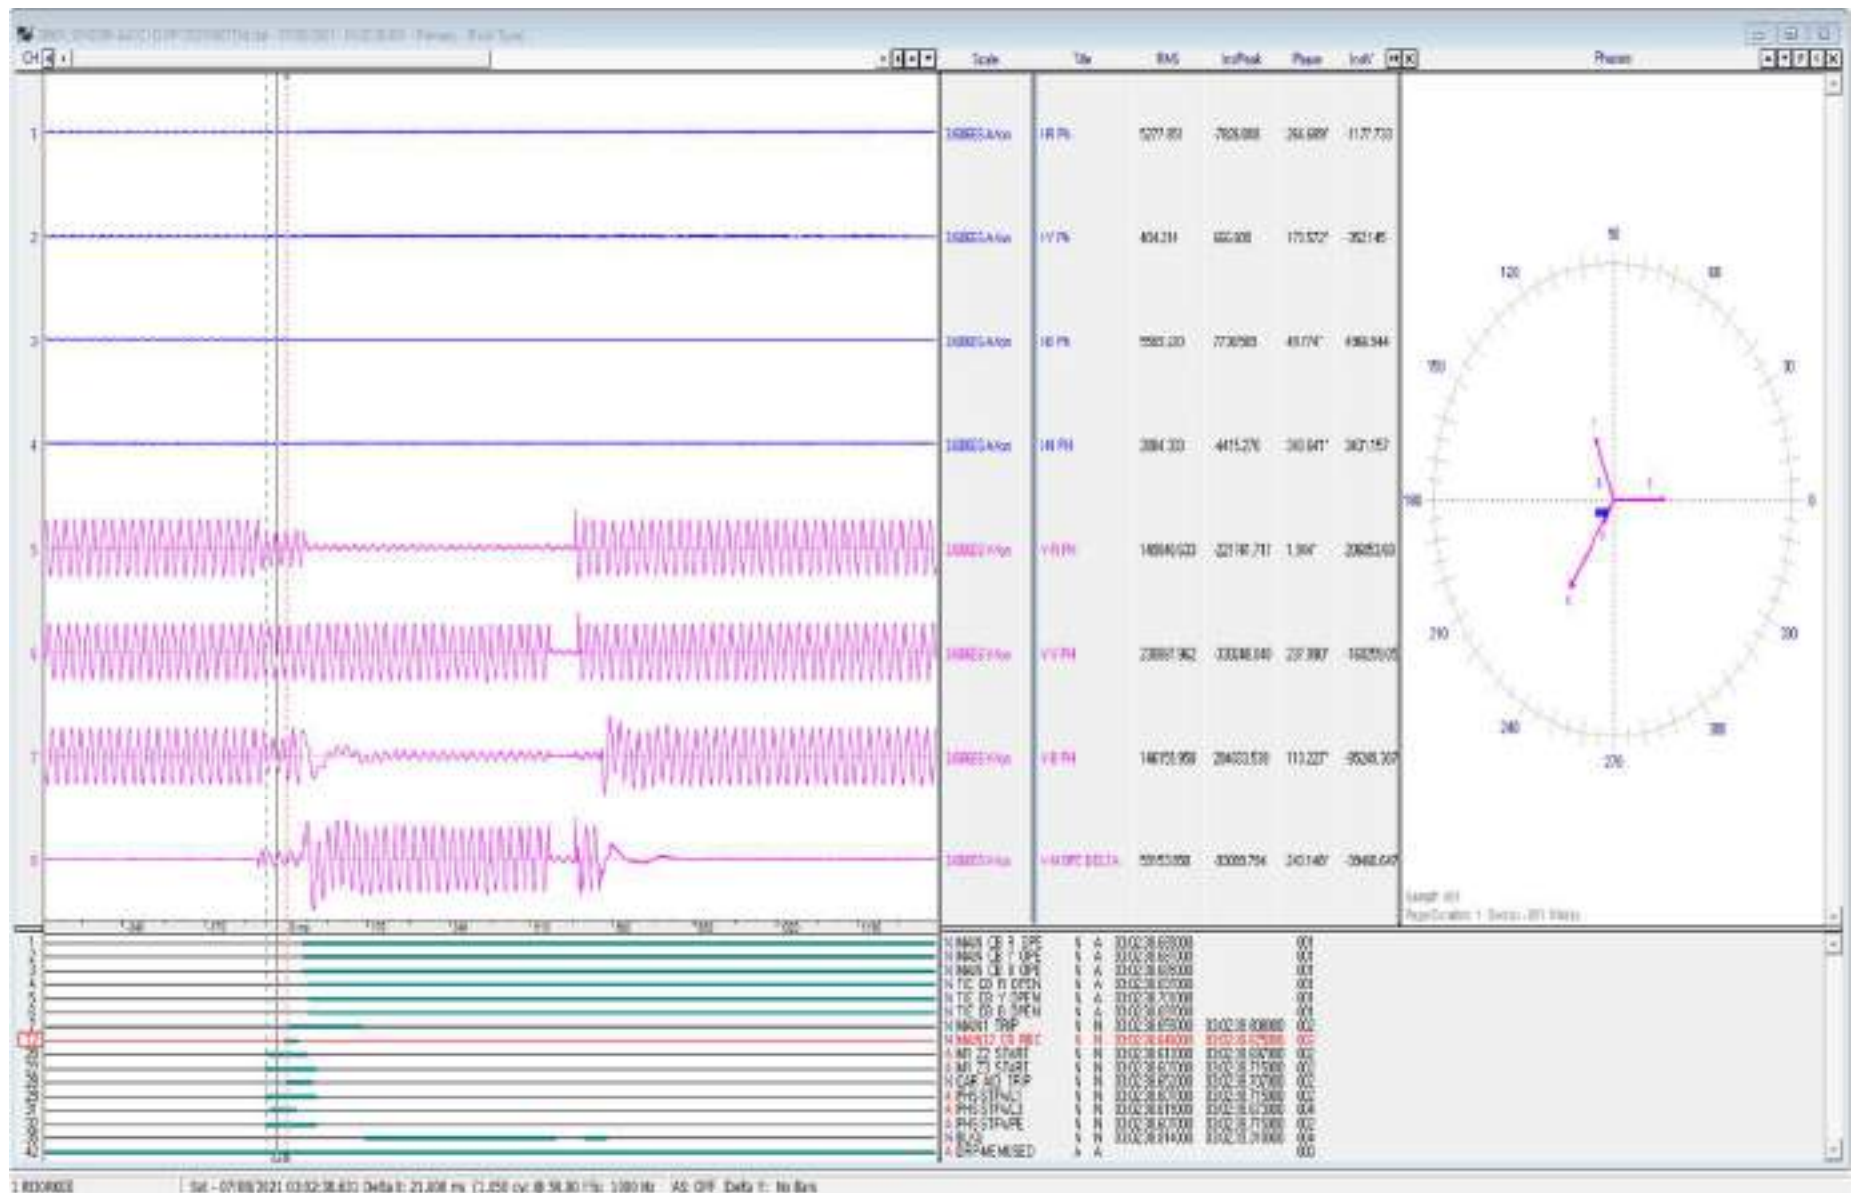
# DR of 400kV Muzaffarnagar-Roorkee ckt (Roorkee end)

R-B fault, Z-2 from Roorkee end, three phase trip from Roorkee end on carrier received.

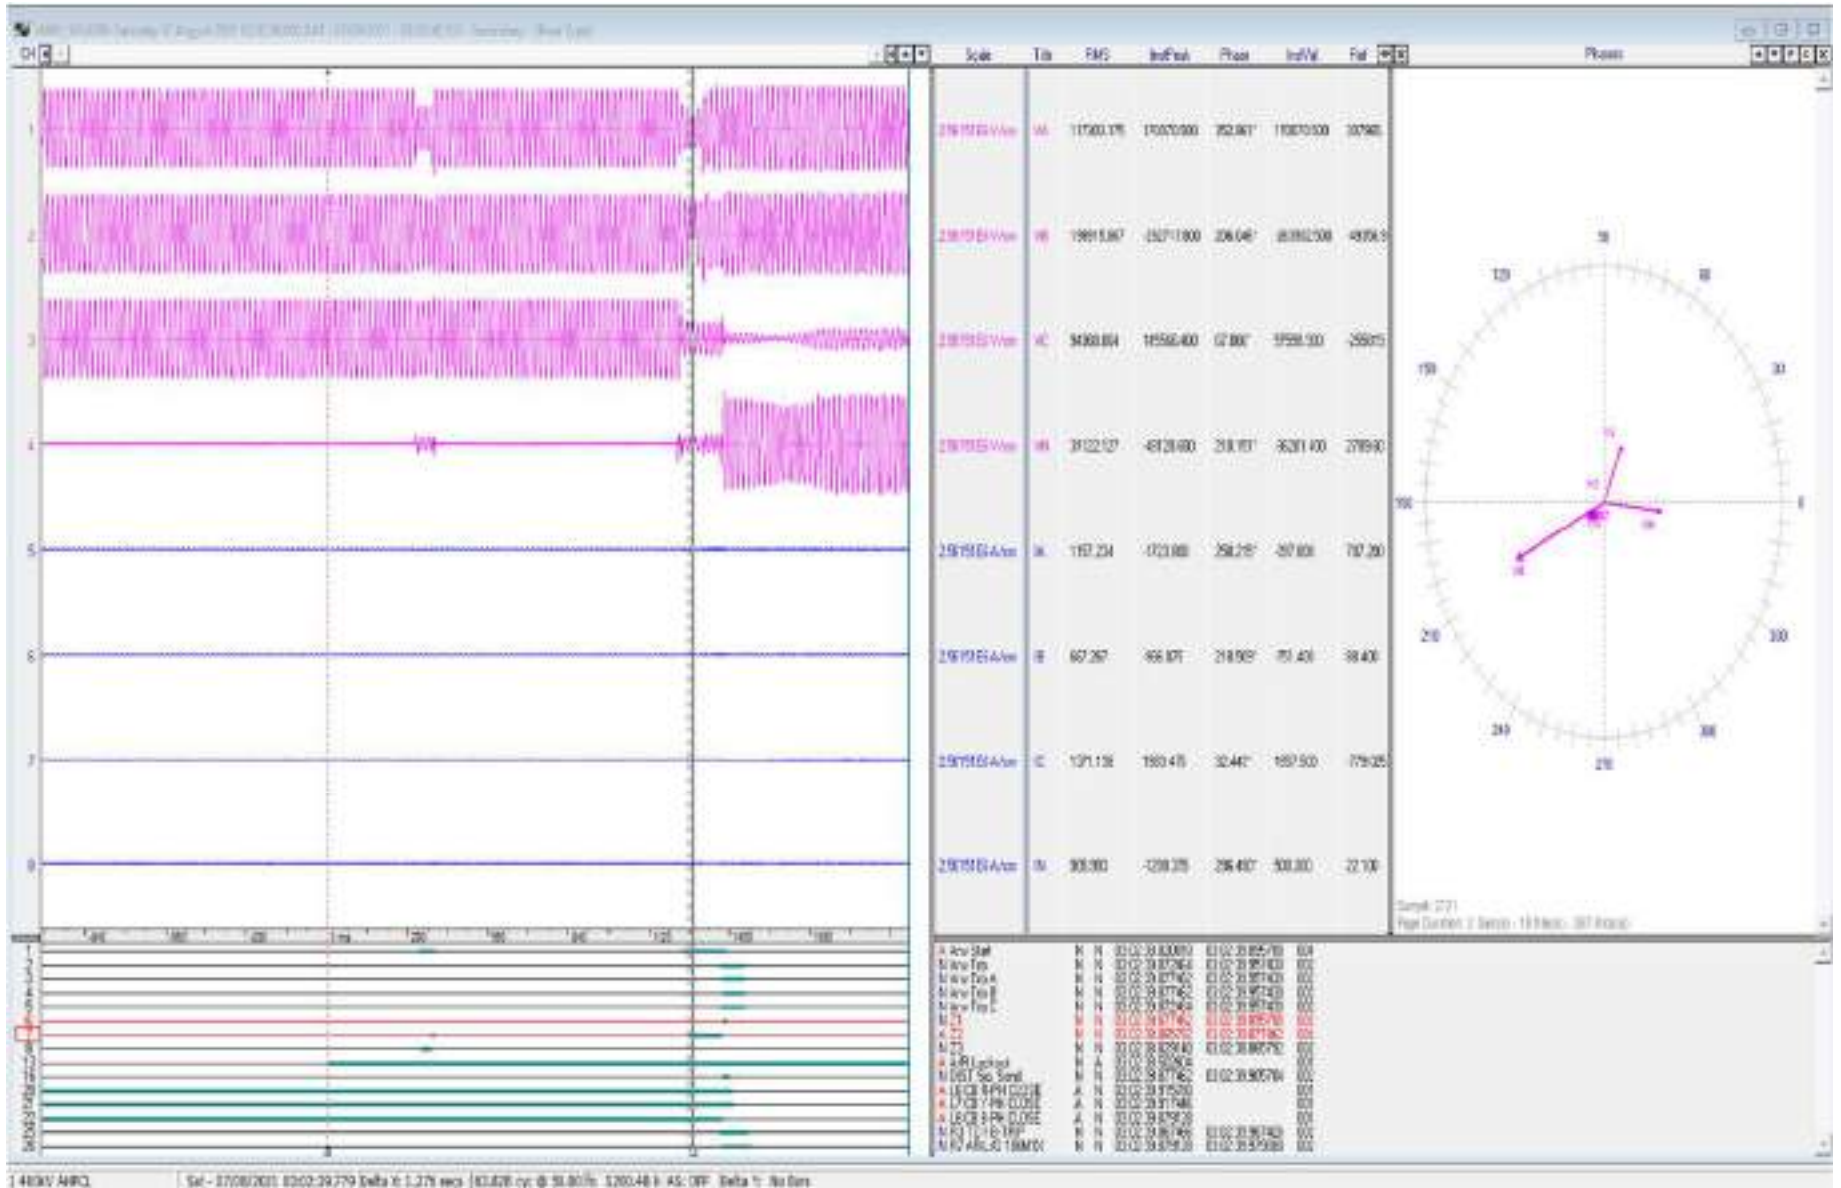
# DR of 400kV Muzaffarnagar-Alkanda ckt (Alkanda end)

Fault was in Z-2 from Alaknanda end

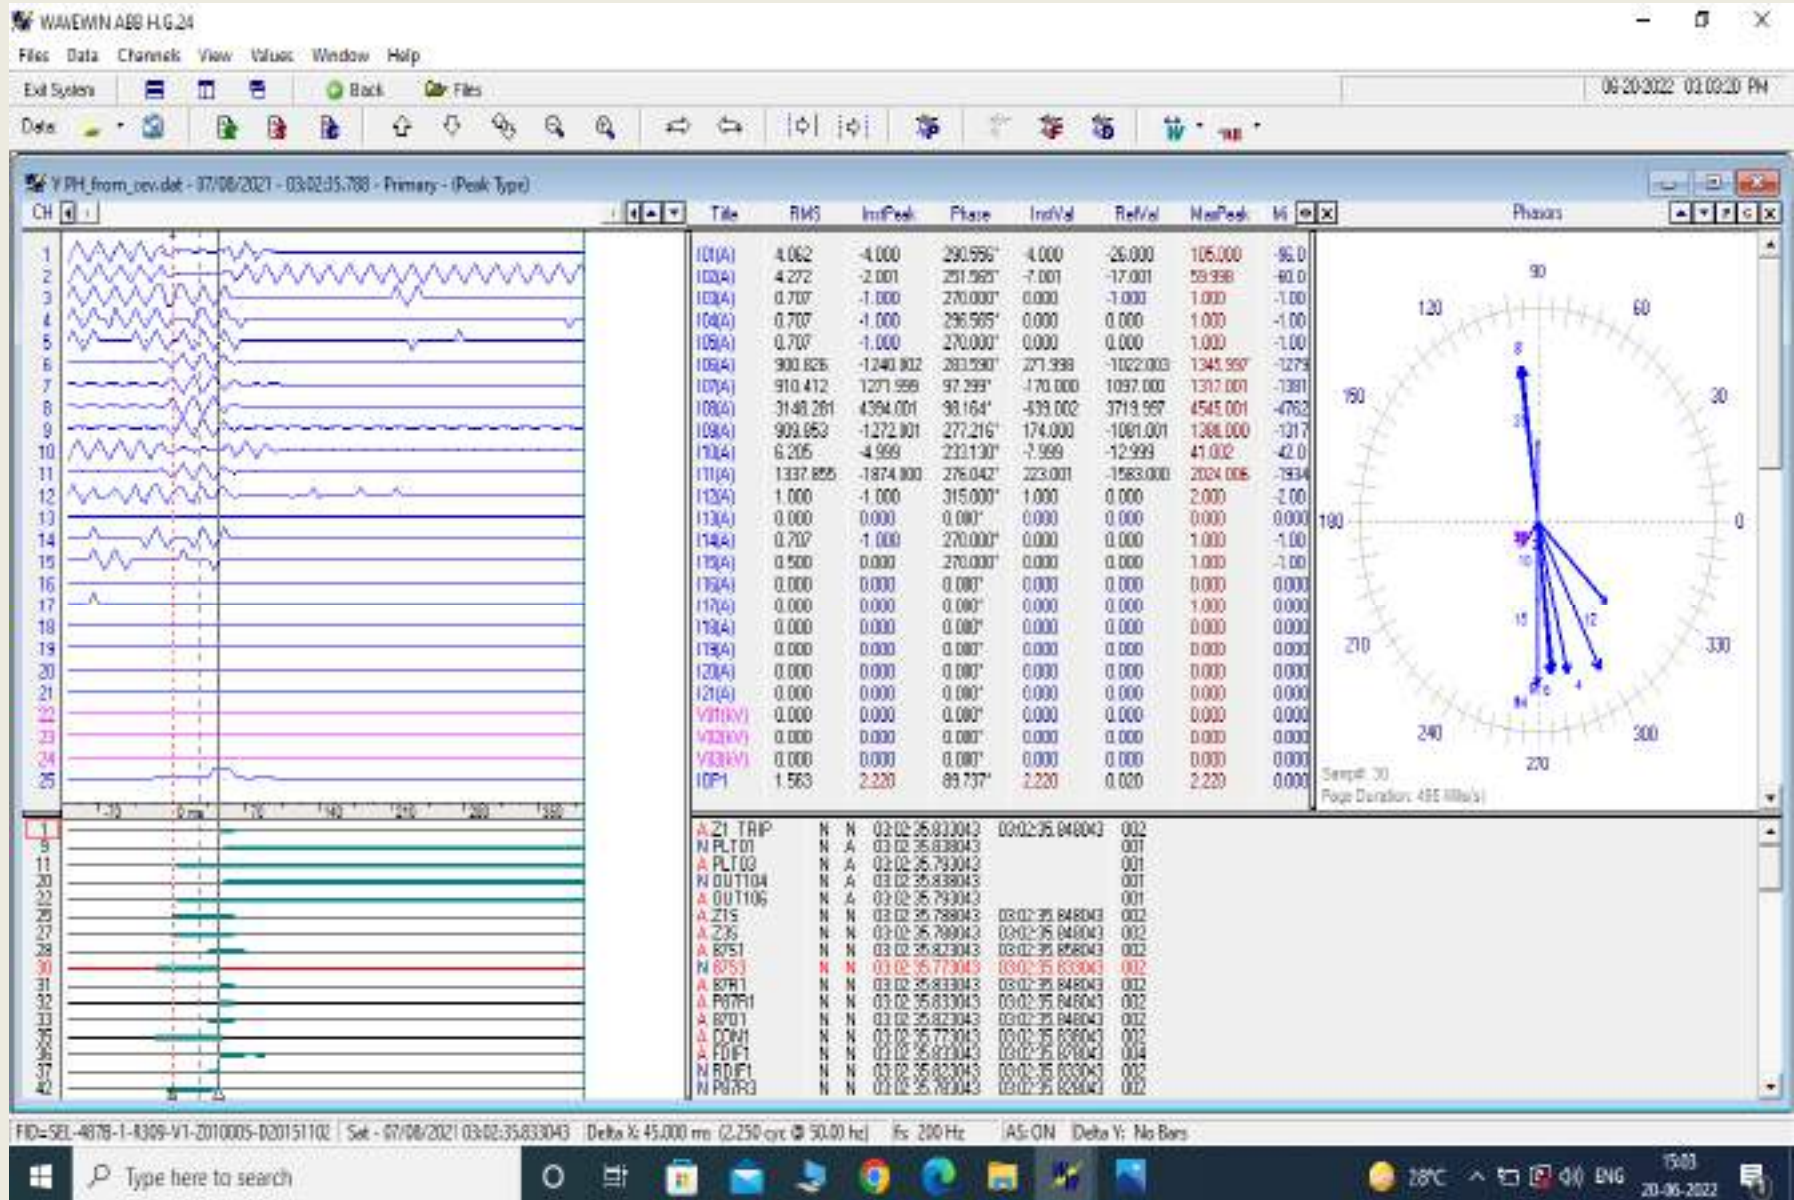
# DR OF BUS BAR RELAY

- At 03:02 hrs , R phase CT blasted of 400 /220 KV ICT 3 resulting into differential protection operation of this ICT 3. Due to blasting of R phase CT ,R ph CT got fire and caused damages to the adjacent B phase CT of 400 KV Muzaffarnagar – Alaknanda line resulting into damage of this CT also.

- Remedial action taken report needs to be shared.
- Damaged CT's were replaced with new CT.

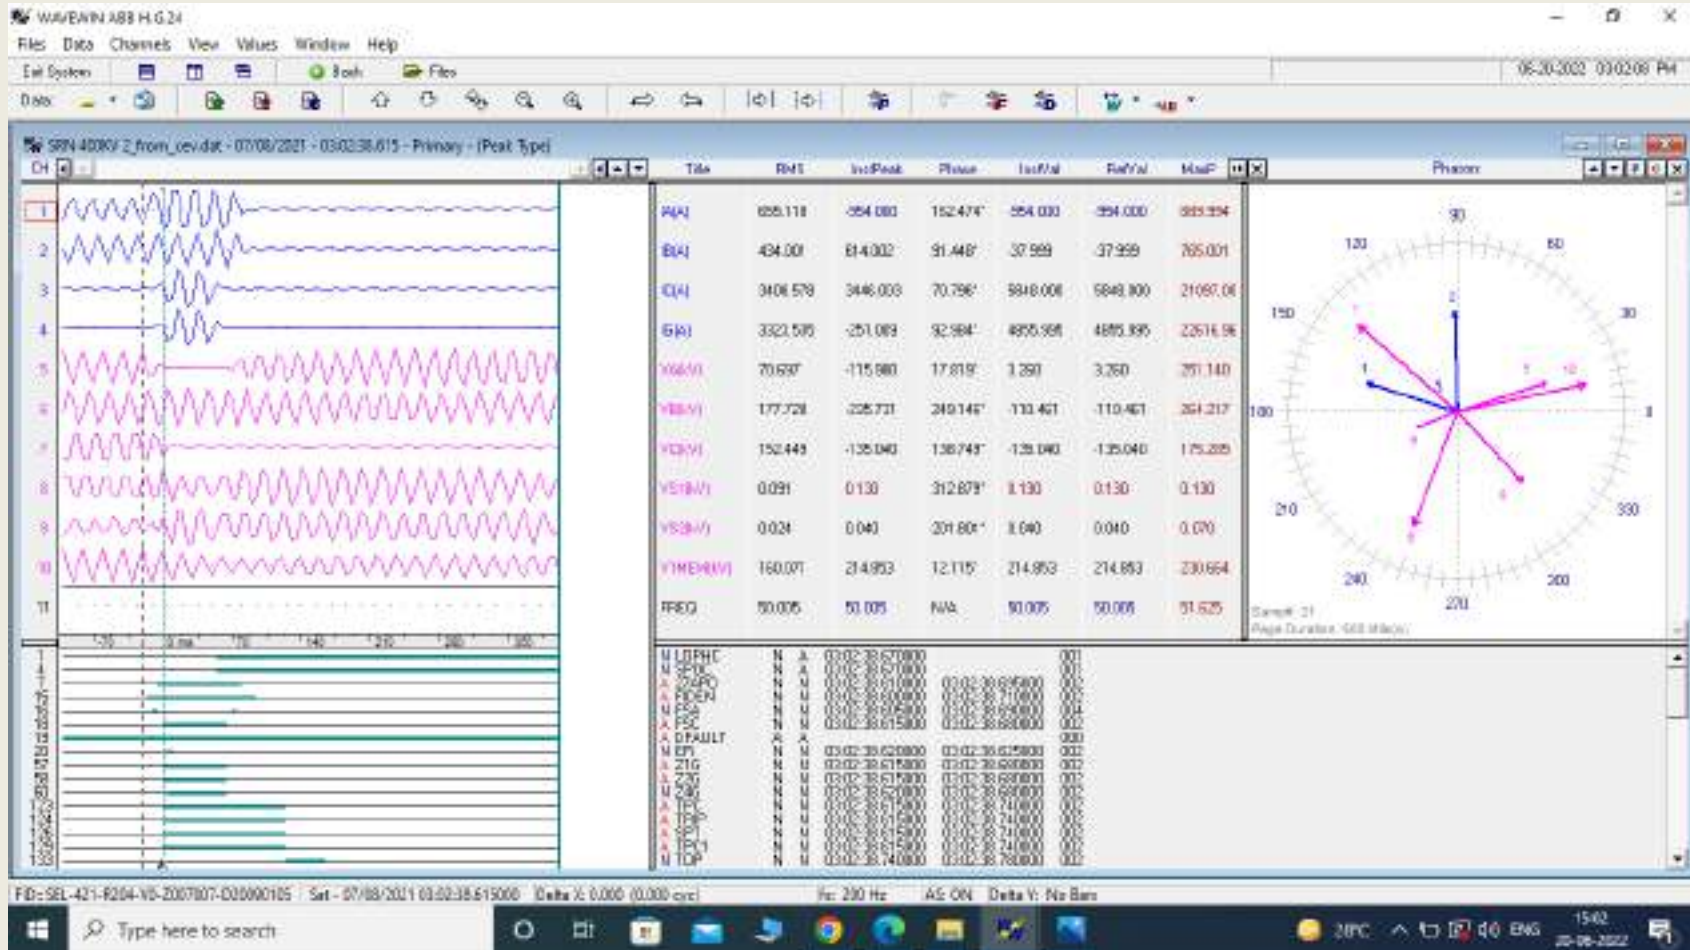
# DR OF 400 KV MZN- ALAKNANDA

- 400 KV Muzaffarnagar- Alaknanda line was tripped by distance relay.fault sense by relay at 03:02:38.615 and fault was cleared at 03:02:38.695 (fault cleared within 70 to 80 millisecond approx.)

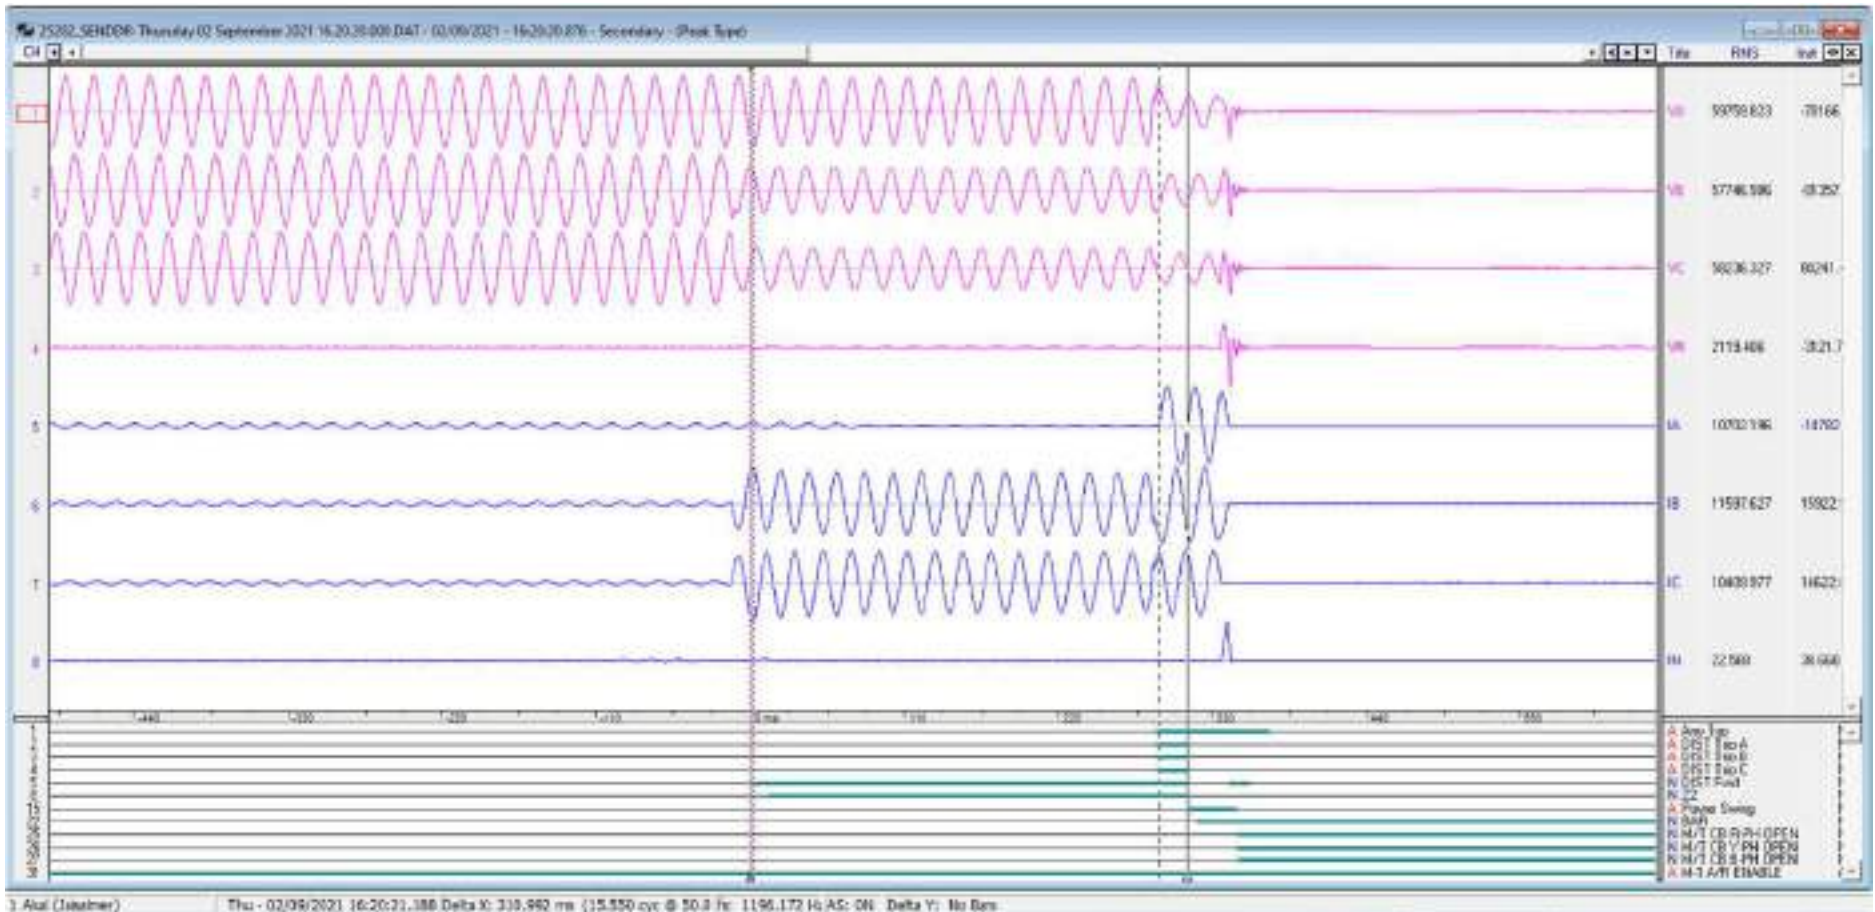
# DR of 220 kV Akal(End)-Bhu Ckt-1

1. Y-B phase fault visible.
2. Z-2 start and trip visible.
3. Relay time sync?

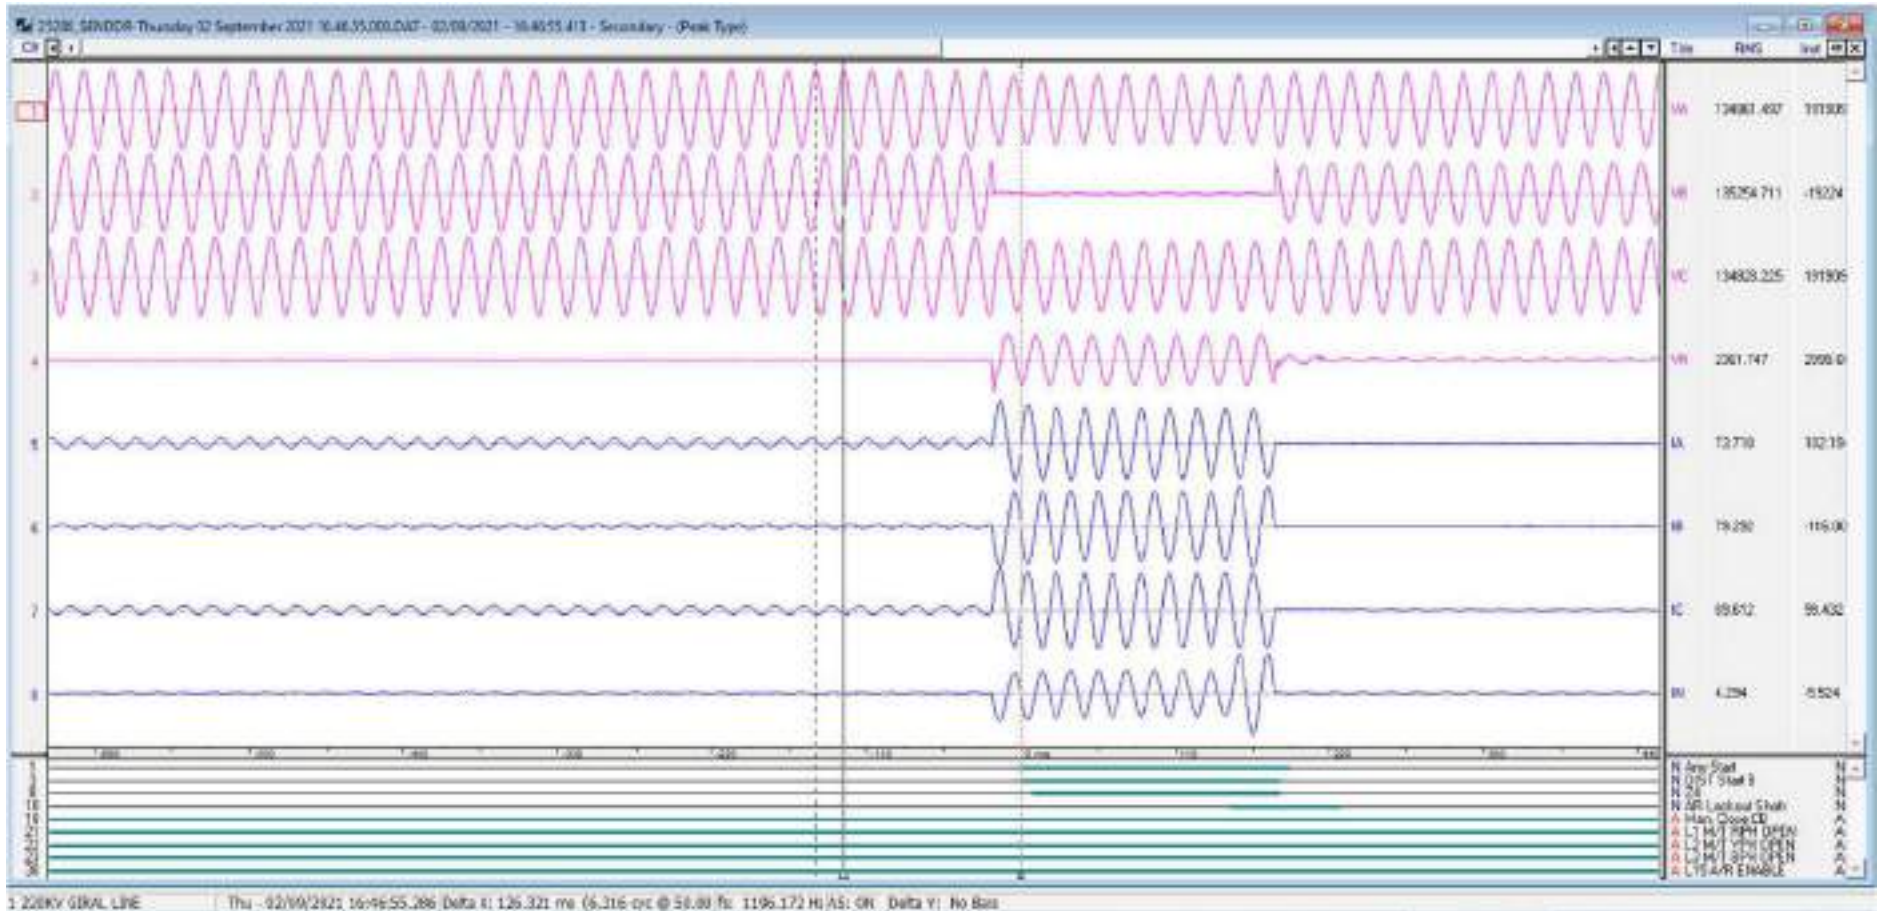
# DR of 220 kV Akal(End)-Giral Ckt-1

1. Y-B phase fault visible.
2. Z-4 reverse trip visible. Timer 170 ms?

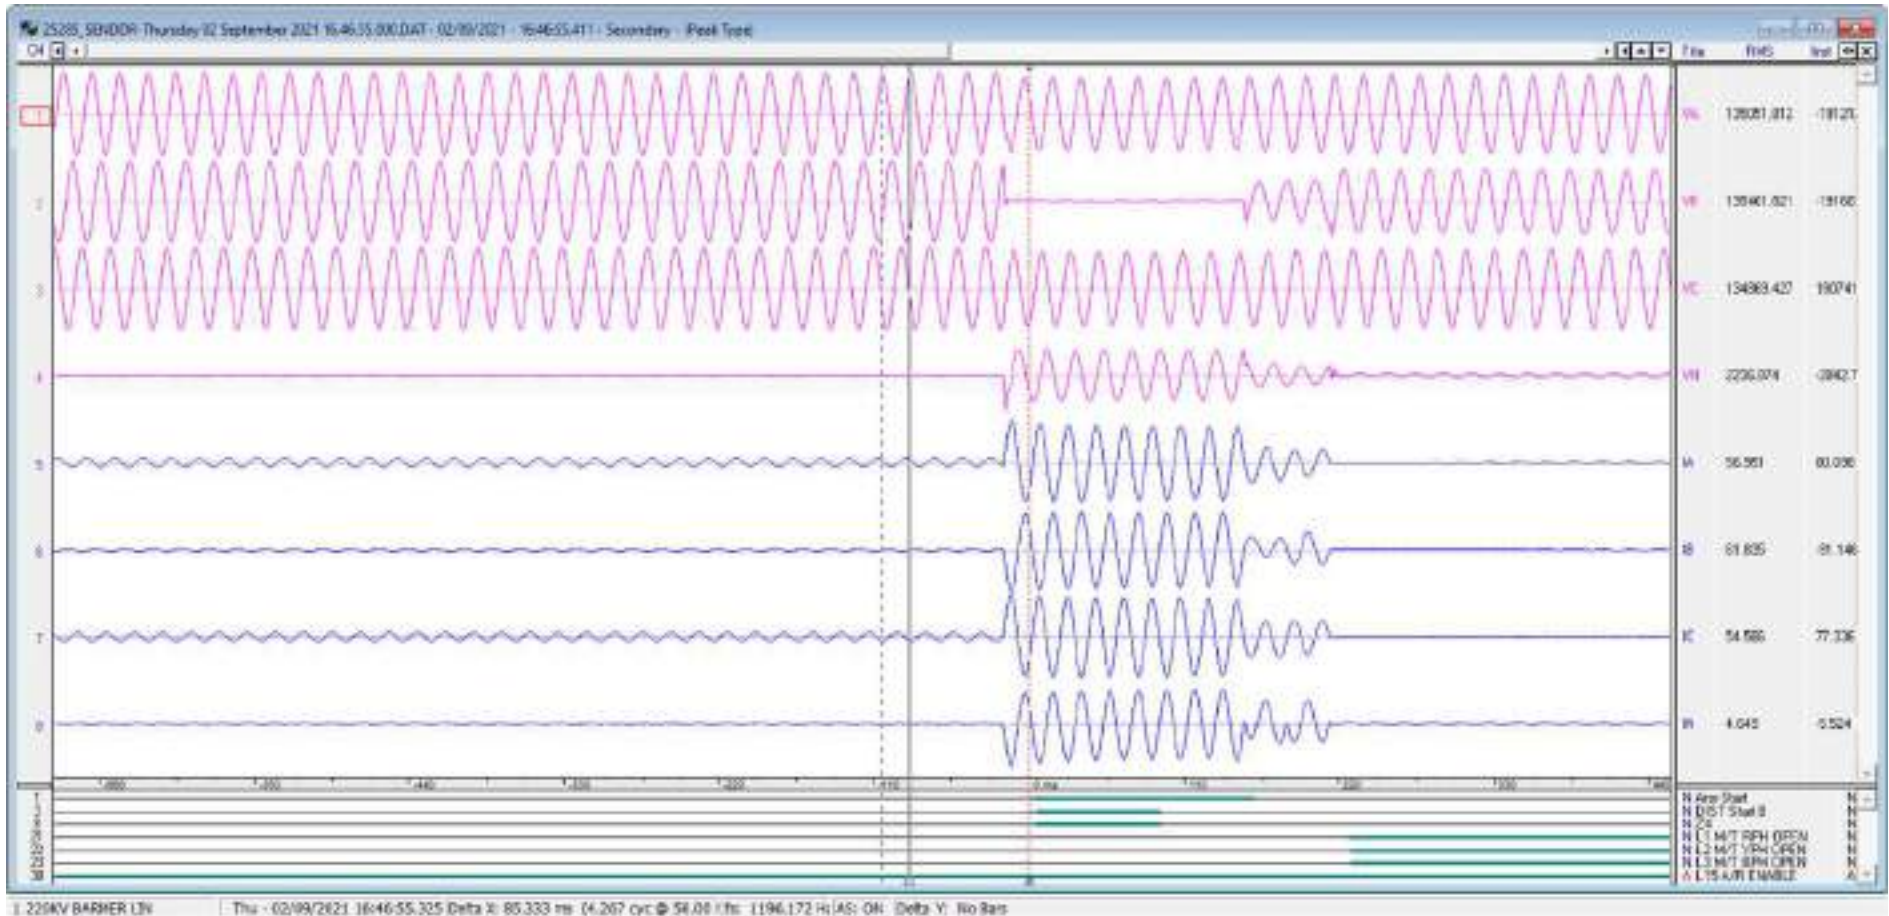
# DR of 220 kV Akal(End)-Barmer Ckt-1

1. Y-B phase fault visible.
2. Z-4 reverse trip visible. Timer 154 ms?

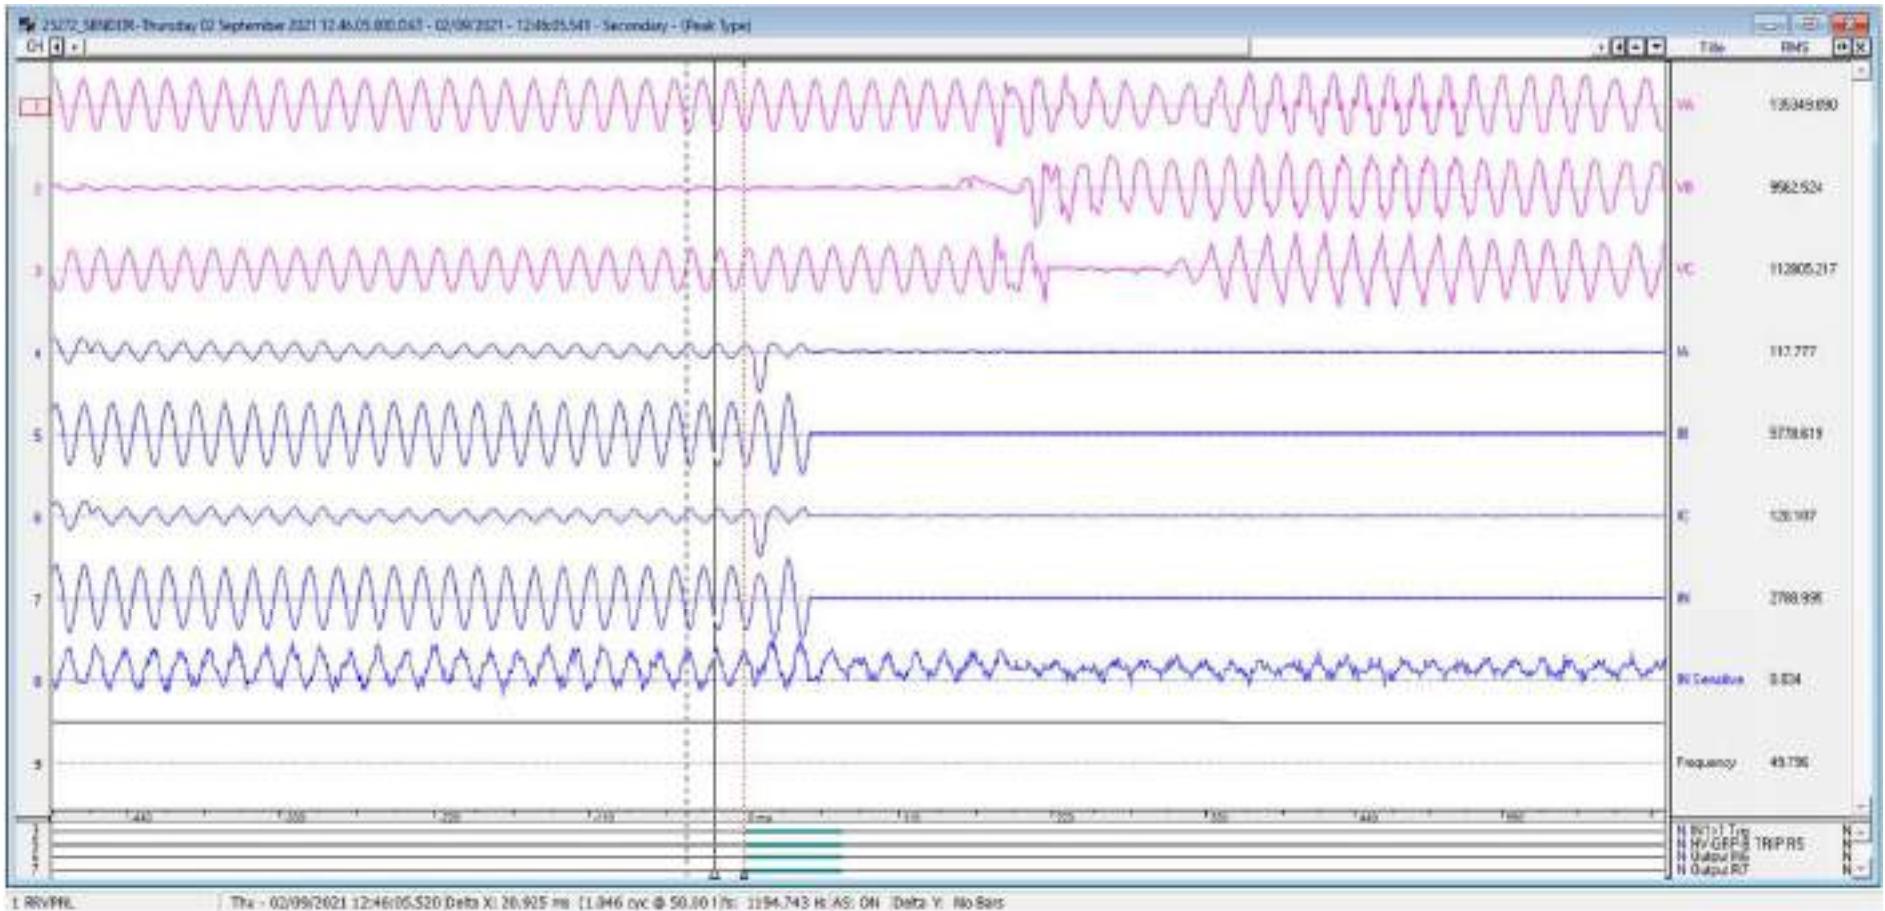
# DR of 500 MVA ICT-4

1. Y-B phase fault visible.
2. Relay time sync?

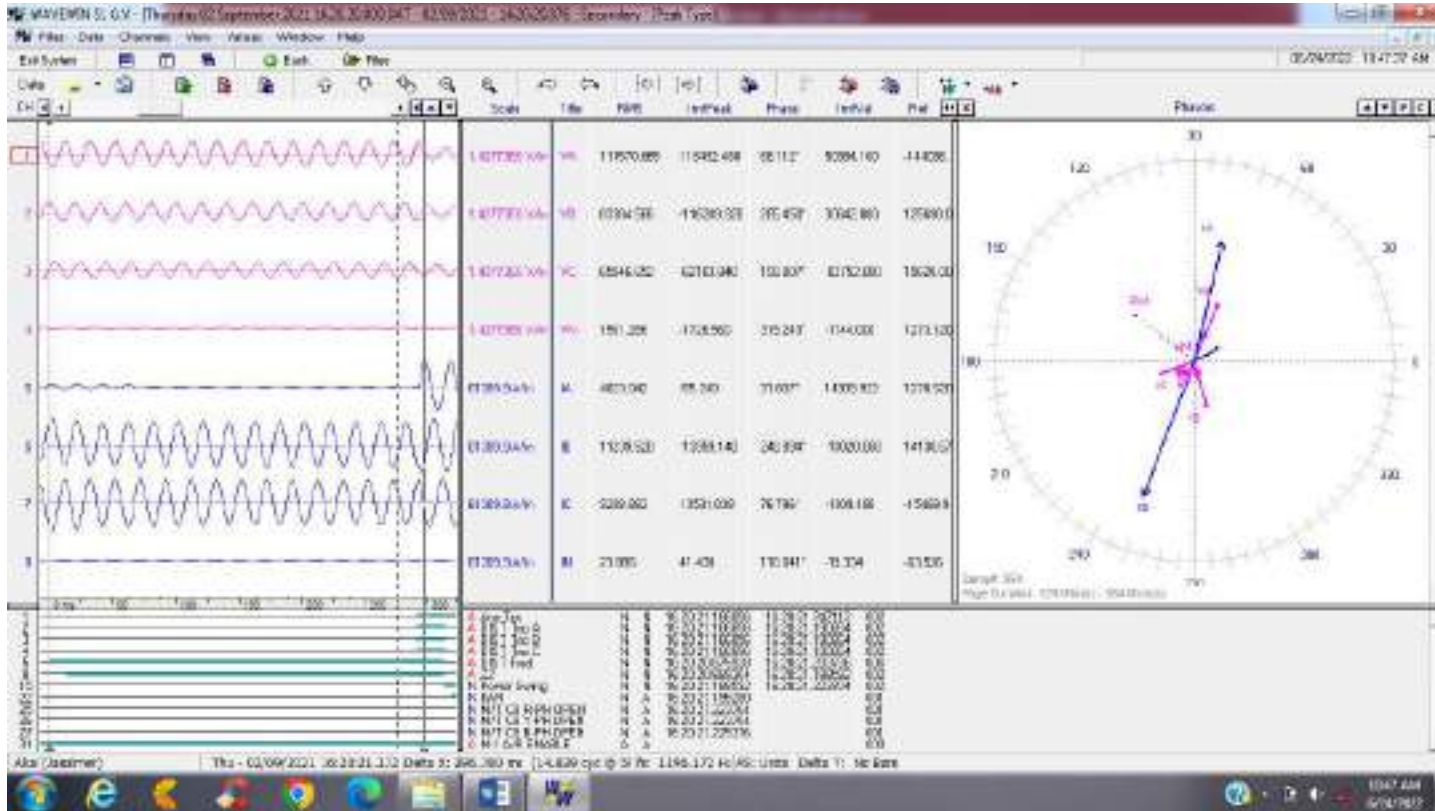
1. A, Y-B phase to phase fault occurred due to jumper snapping on 220 KV Akal-bhu-I line at 12.54 km distance from akal end (line length-13 km).

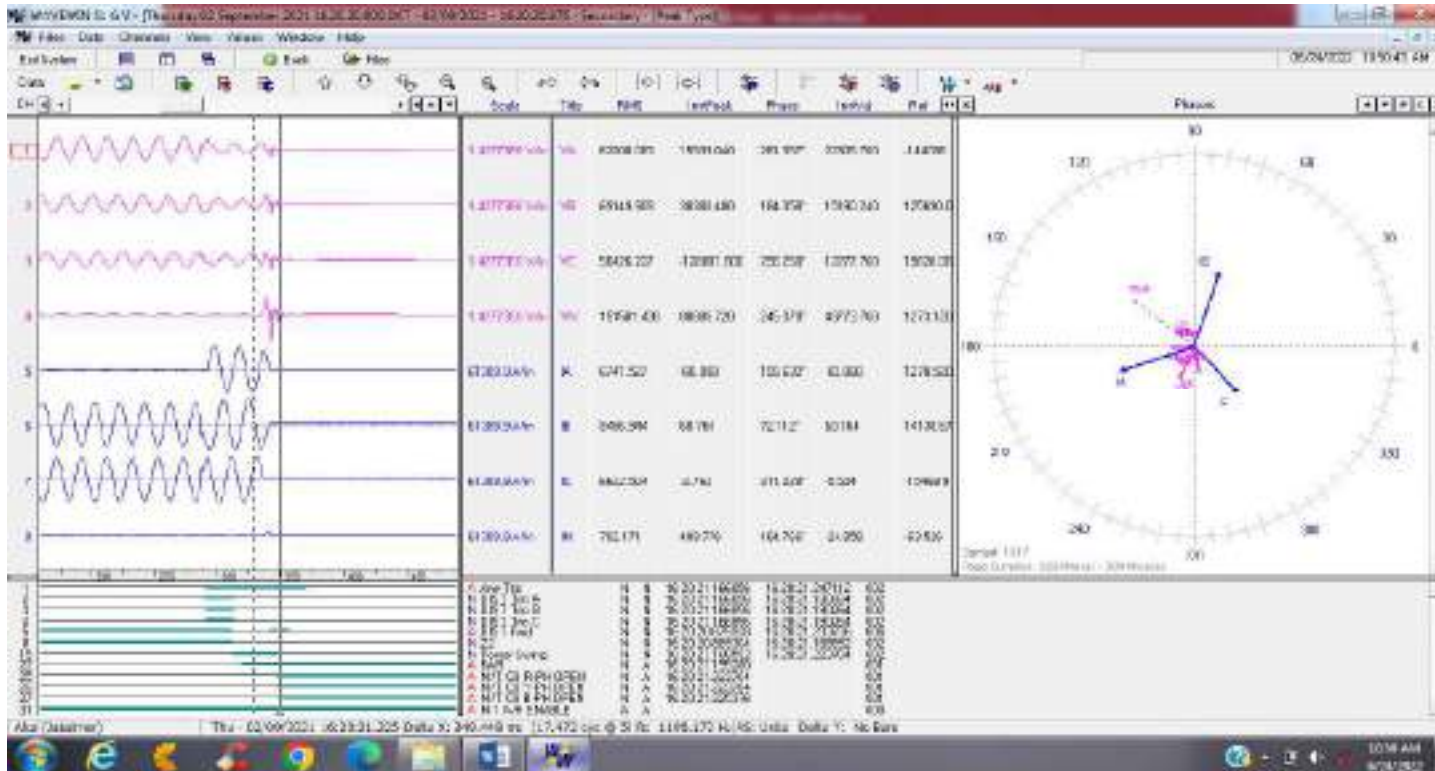
2. Distance relay issued trip command for this zone 2 fault and bhu-1 line breaker opened in zone 2+breaker opening timing of 350ms.

- During the Bhu-I line fault, the bus side jumper of Y-phase of 220 KV Bhu-I line snapped and created the bus fault.

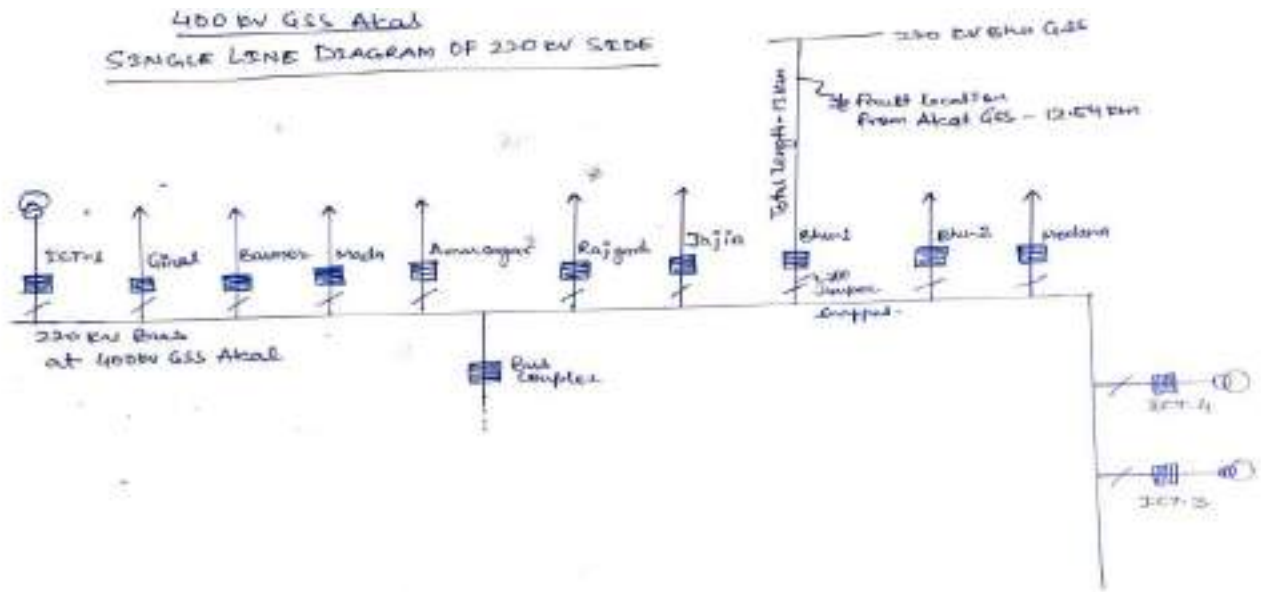
4.

As distance zone 4 timing was kept as 160ms due to outage of 220 KV Bus bar scheme, 220 KV feeders Bhu-2, Giral, Amarsagar, Mada, Barmer tripped on reverse zone 4 in 160 ms timing.

7. 220 KV amarsagar Line PU was defective at akal gss due to which the bus bar scheme was out of circuit but now the defective PU has been replaced and now 220 KV Bus bar scheme is healthy and in service.
8. Time synchronization issue has not yet been cleared as some of the Ethernet switches are still defective.

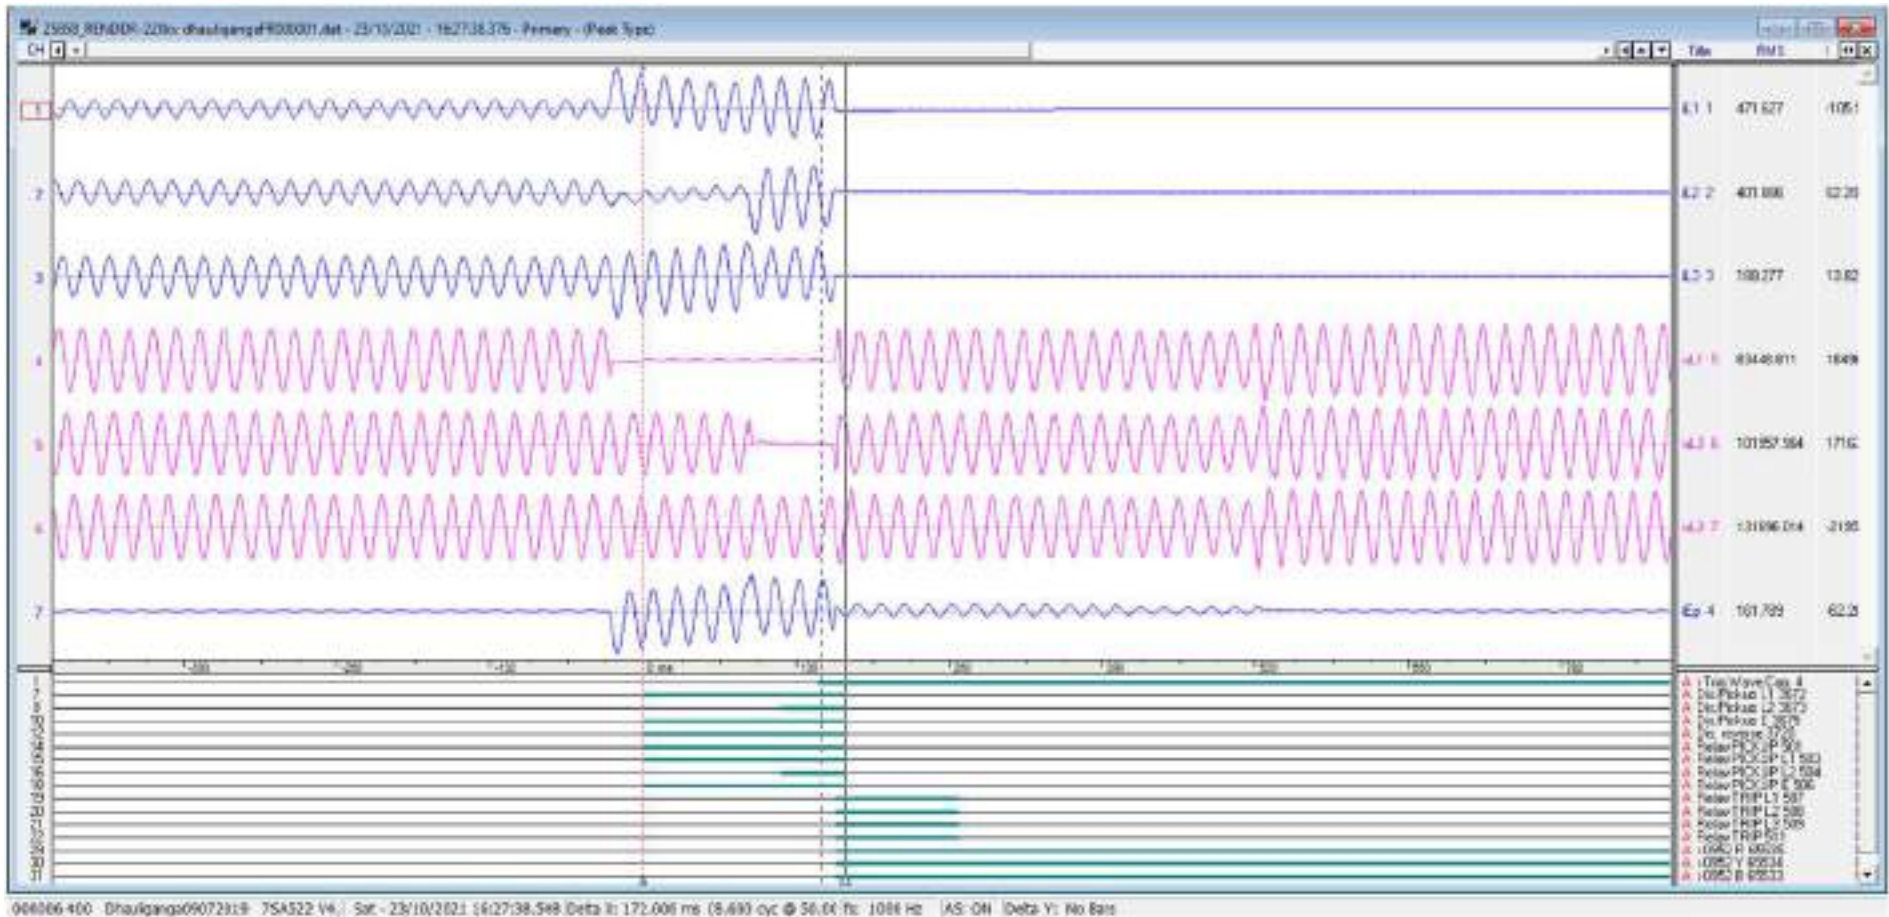
# DR of 220 kV Bareilly(End)- Dhauliganga

1. Fault in R and Y phases.
2. Zone-4 reverse operated.
3. Timer is around 170 ms.
