भारत सरकार  
Government of India  
विद्युत मंत्रालय  
Ministry of Power  
उत्तर क्षेत्रीय विद्युत समिति  
Northern Regional Power Committee

**विषय:** संरक्षण उप-समिति की 45<sup>वीं</sup> बैठक के कार्यवृत्त।  
**Subject:** Minutes of 45<sup>th</sup> Protection Sub-Committee Meeting.

## ***Minutes of 45<sup>th</sup> Meeting of Protection Sub-committee***

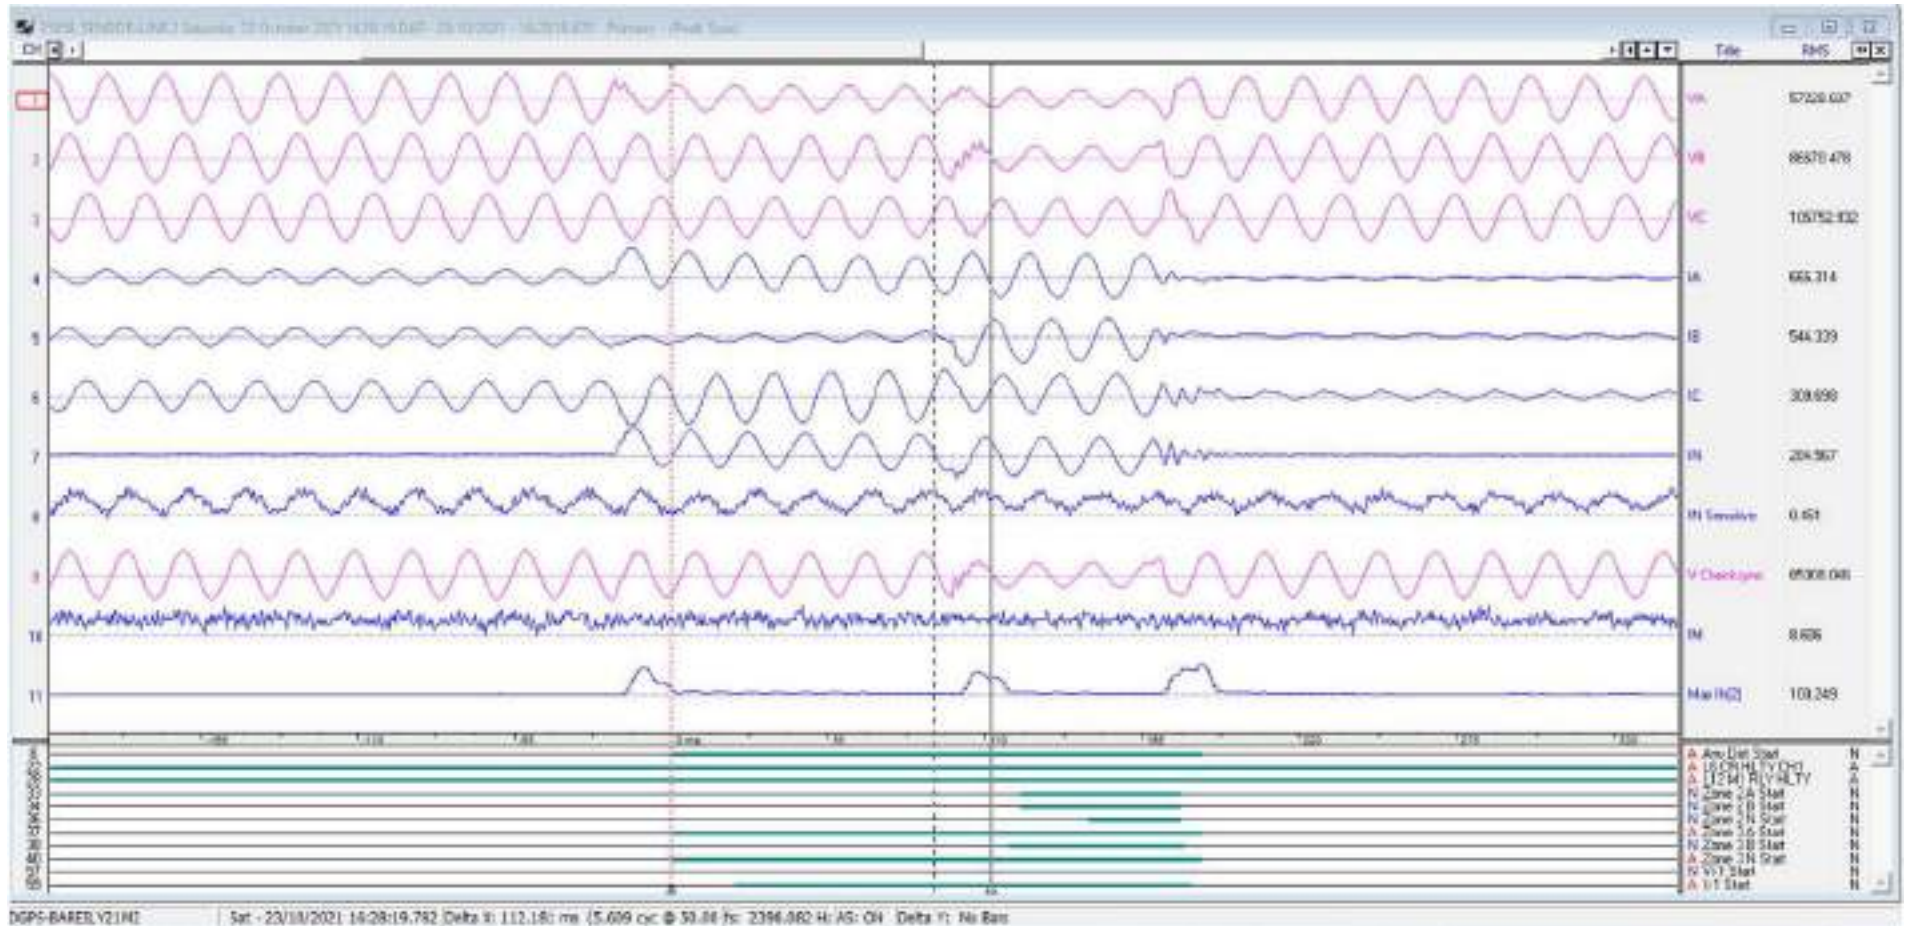
# DR of 220 kV Bareilly – Dhauliganga(End)

1. Zone-2 operated.

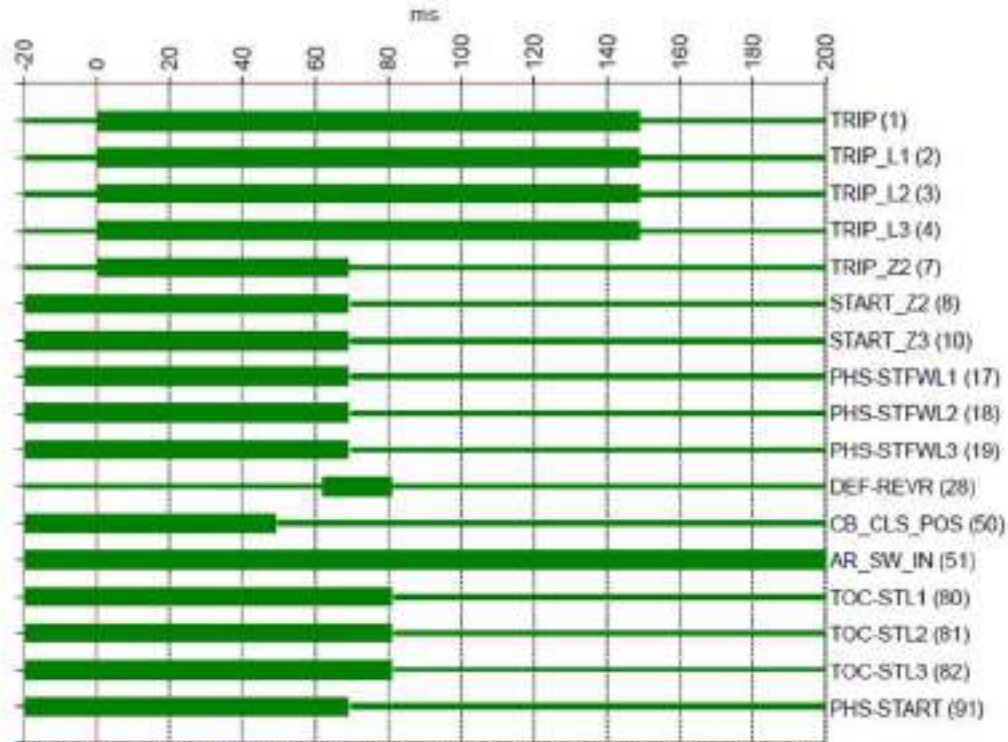
# DR of 220 kV Narela-Panipat(End) CKT-1

The reason for clearance of fault from remote end is 220kV Bus Bar protection relay at Narela got DC MCB tripped prior to fault due to some DC leakage to earth in switchyard which might be due to Bus isolator Motor box replacement work being carried out by BBMB in their switchyard and Bus Bar relay cables from BBMB transformer-1 bay were also to be dismantled and terminated to new motor box. Thus the fault cleared by remote end distance relays in their respective zone-2 timings.

1. Fault in Y-B phase.
2. Fault sensed in Z-2.

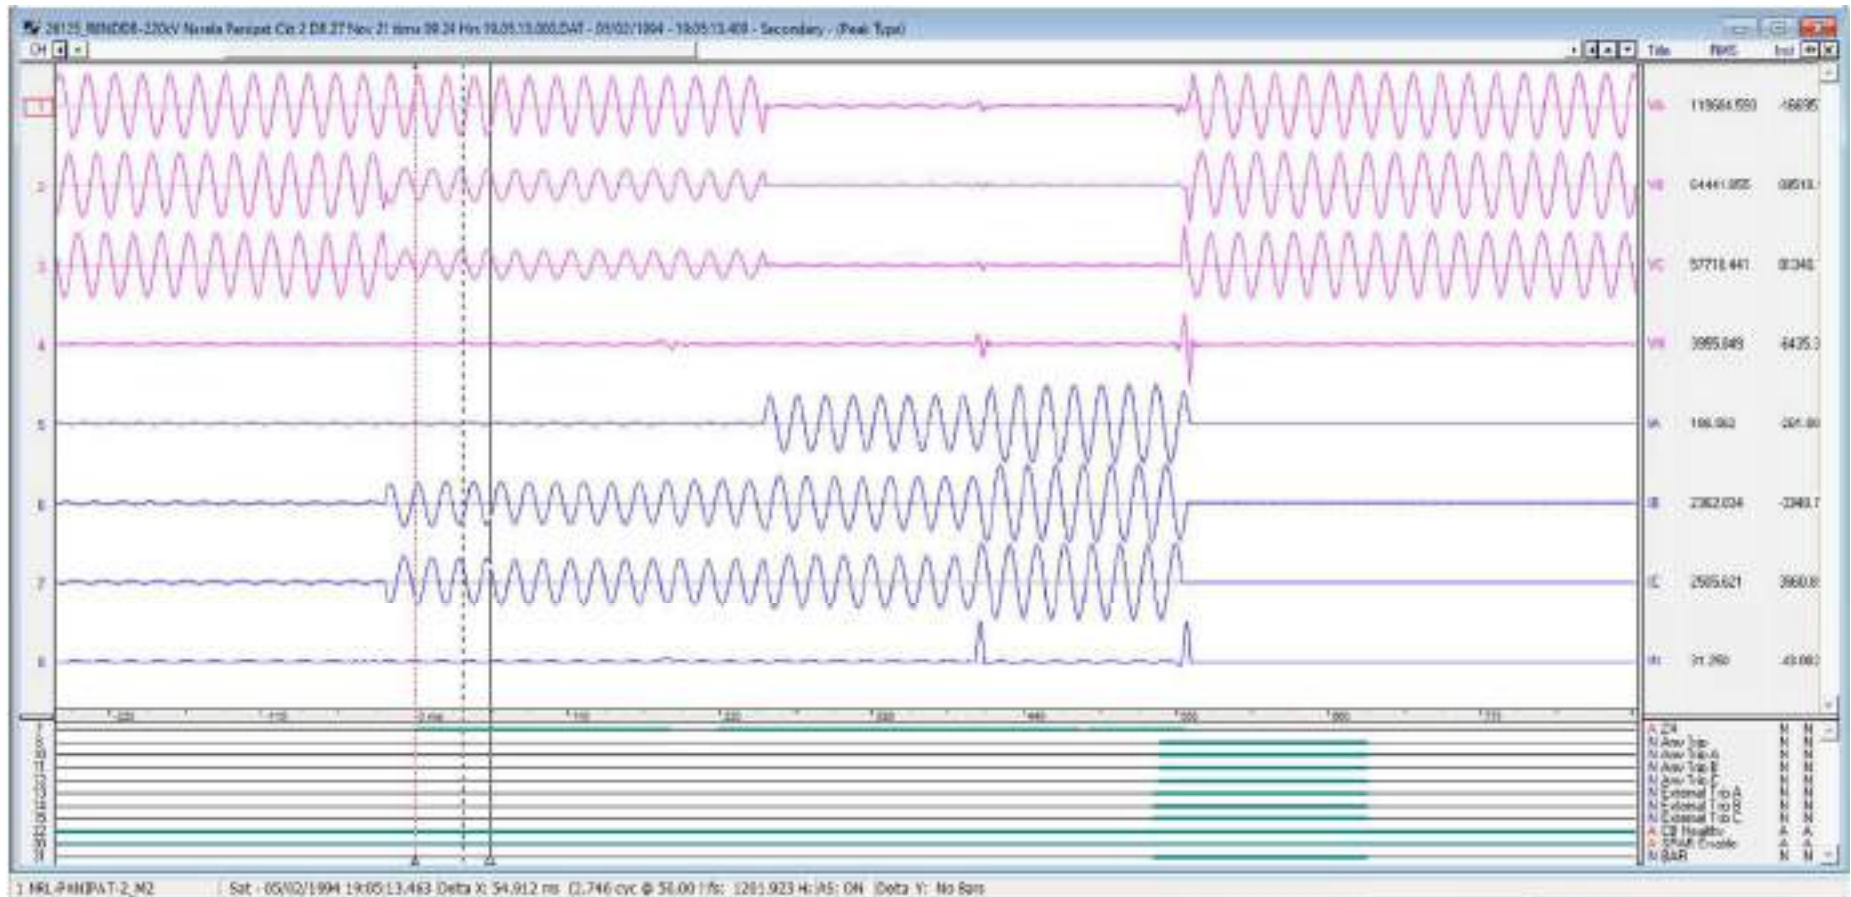
# DR of 220 kV Narela(End)-Panipat CKT-2

1. Fault in Y-B phase.
2. Fault sensed in Z-4 reverse.
3. Timer is 550 ms

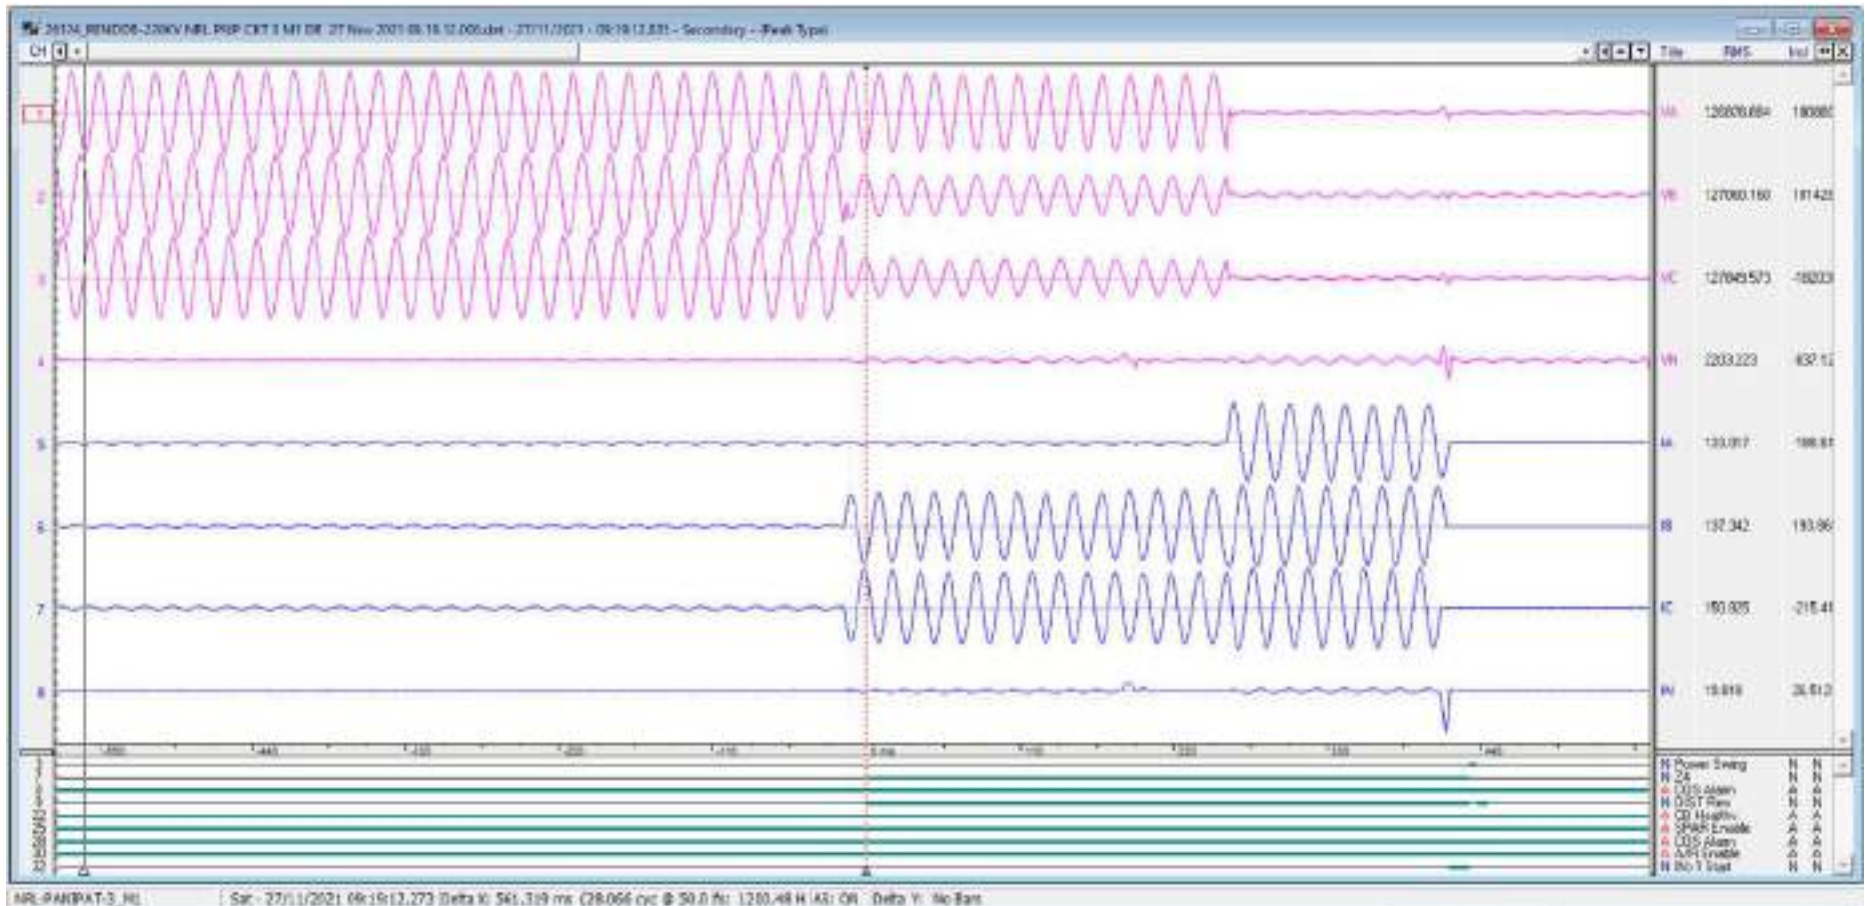
# DR of 220 kV Narela(End)-Panipat CKT-3

1. Fault in Y-B phase.
2. Fault sensed in Z-4 reverse.
3. Timer is 435 ms

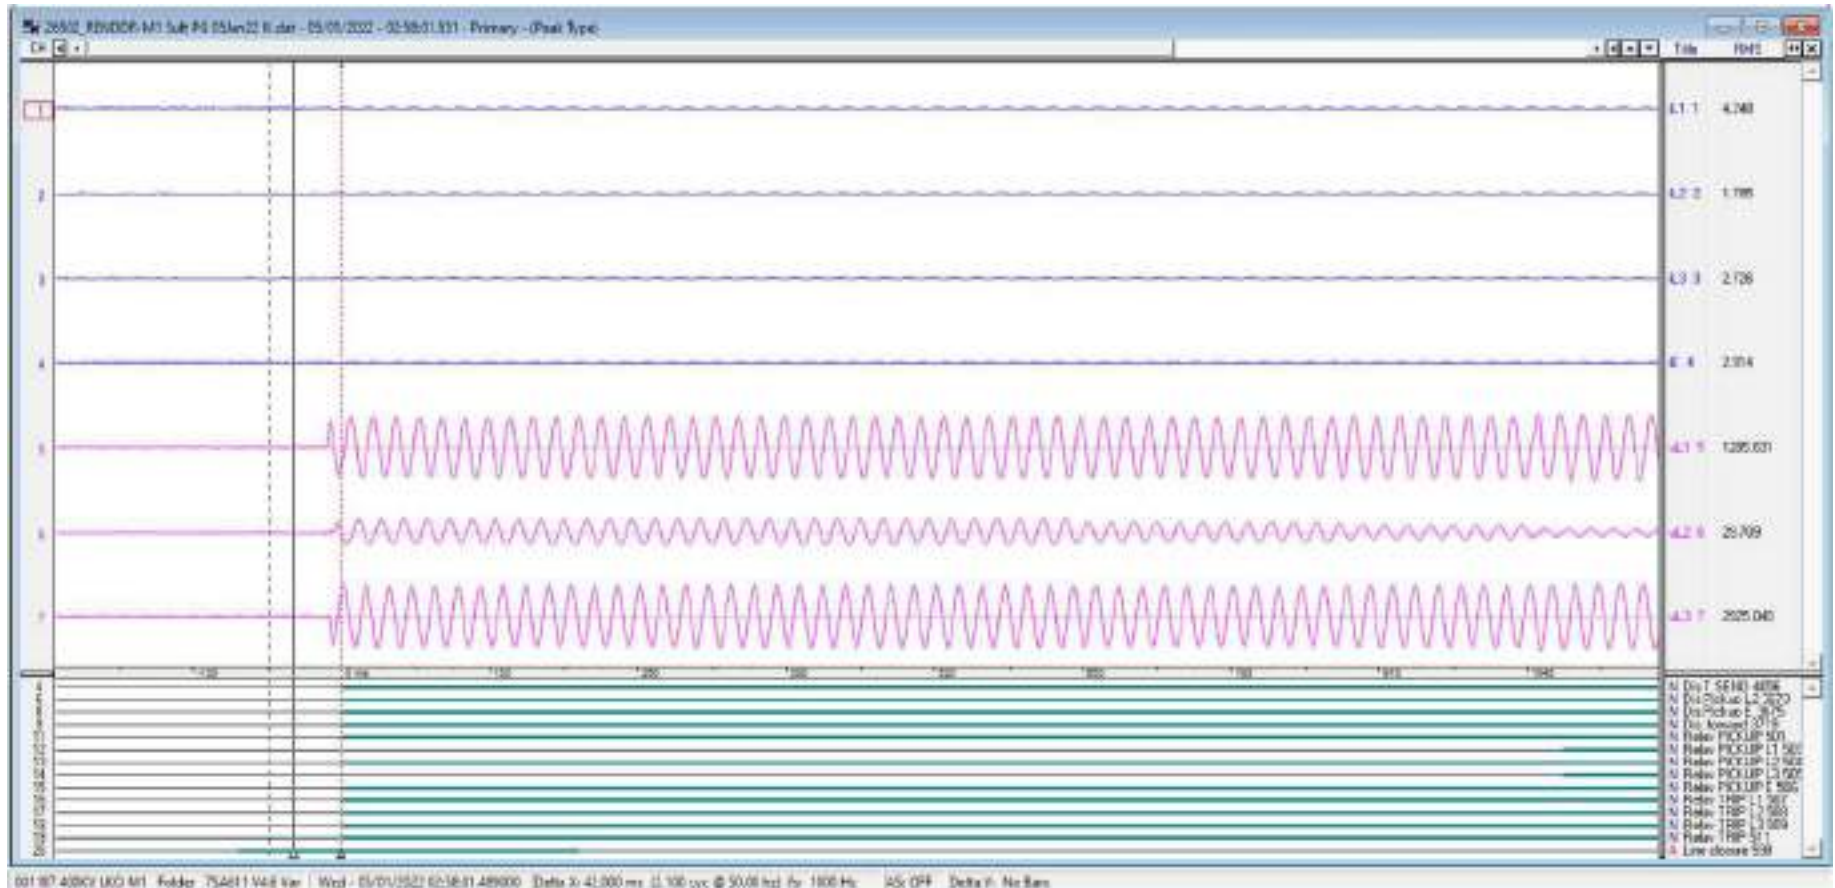
# DR of 400 kV LKW – Sultanpur (End)

1. Tripped on Z-1
2. Fault current is 3.1 KA.
3. Relay time sync faulty.

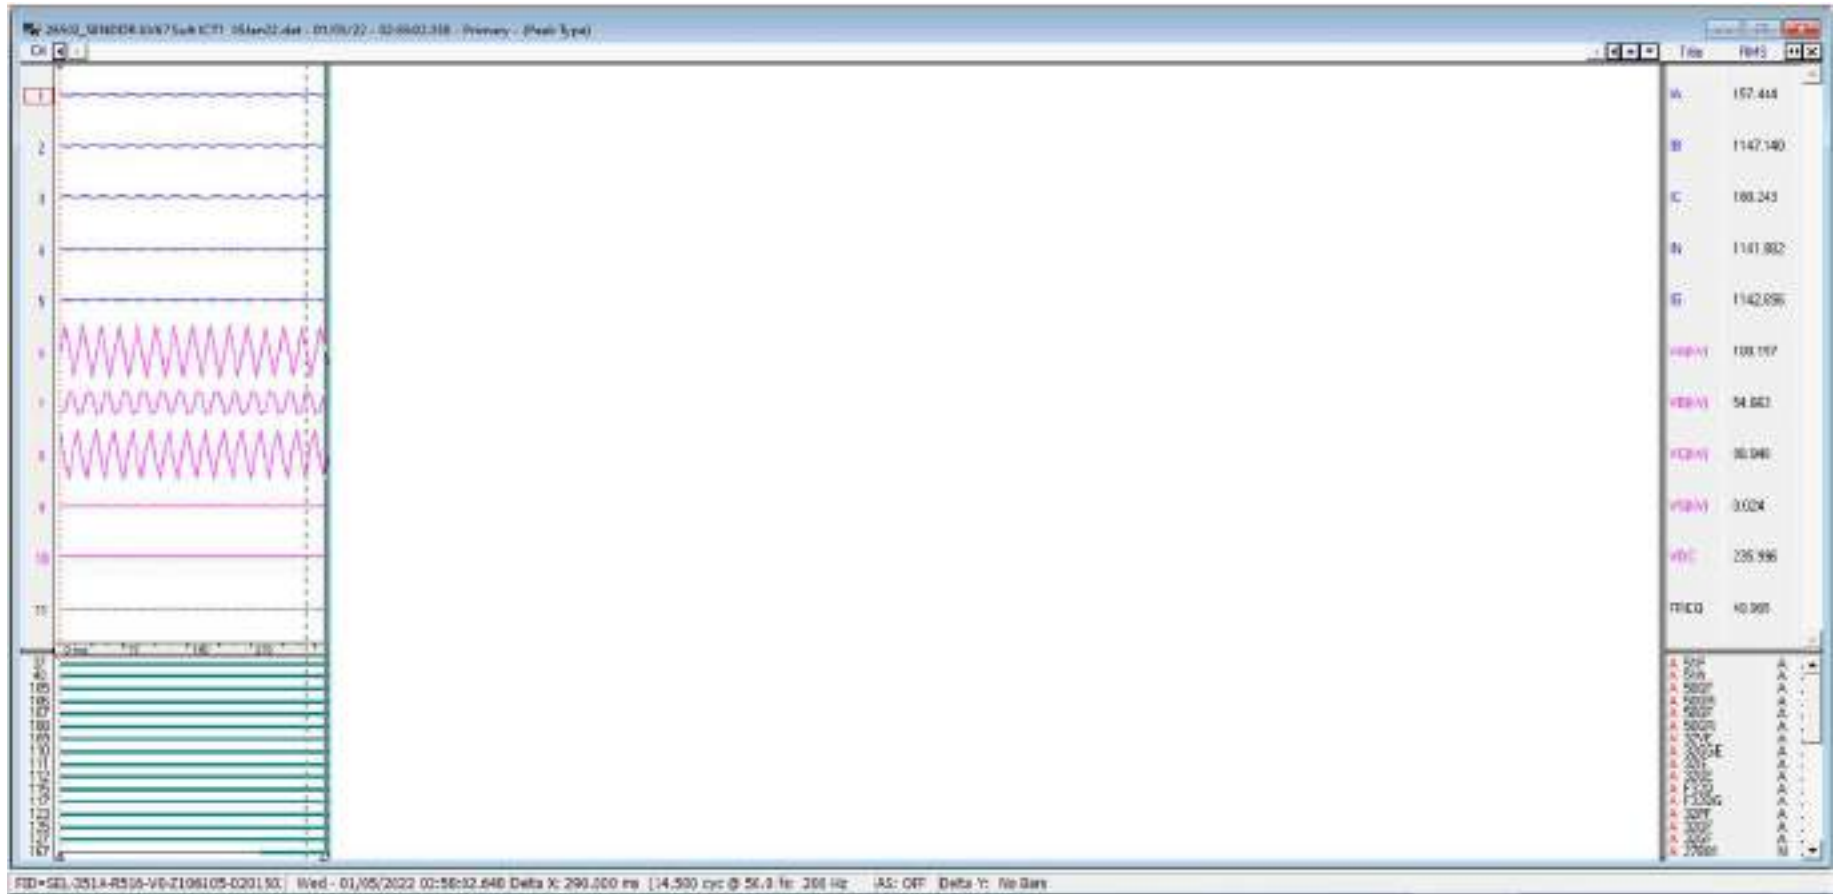
# DR of 400/220 Kv ICT-1

1. 51N Tripped.
2. Fault current 1142 amp in B-Phase.

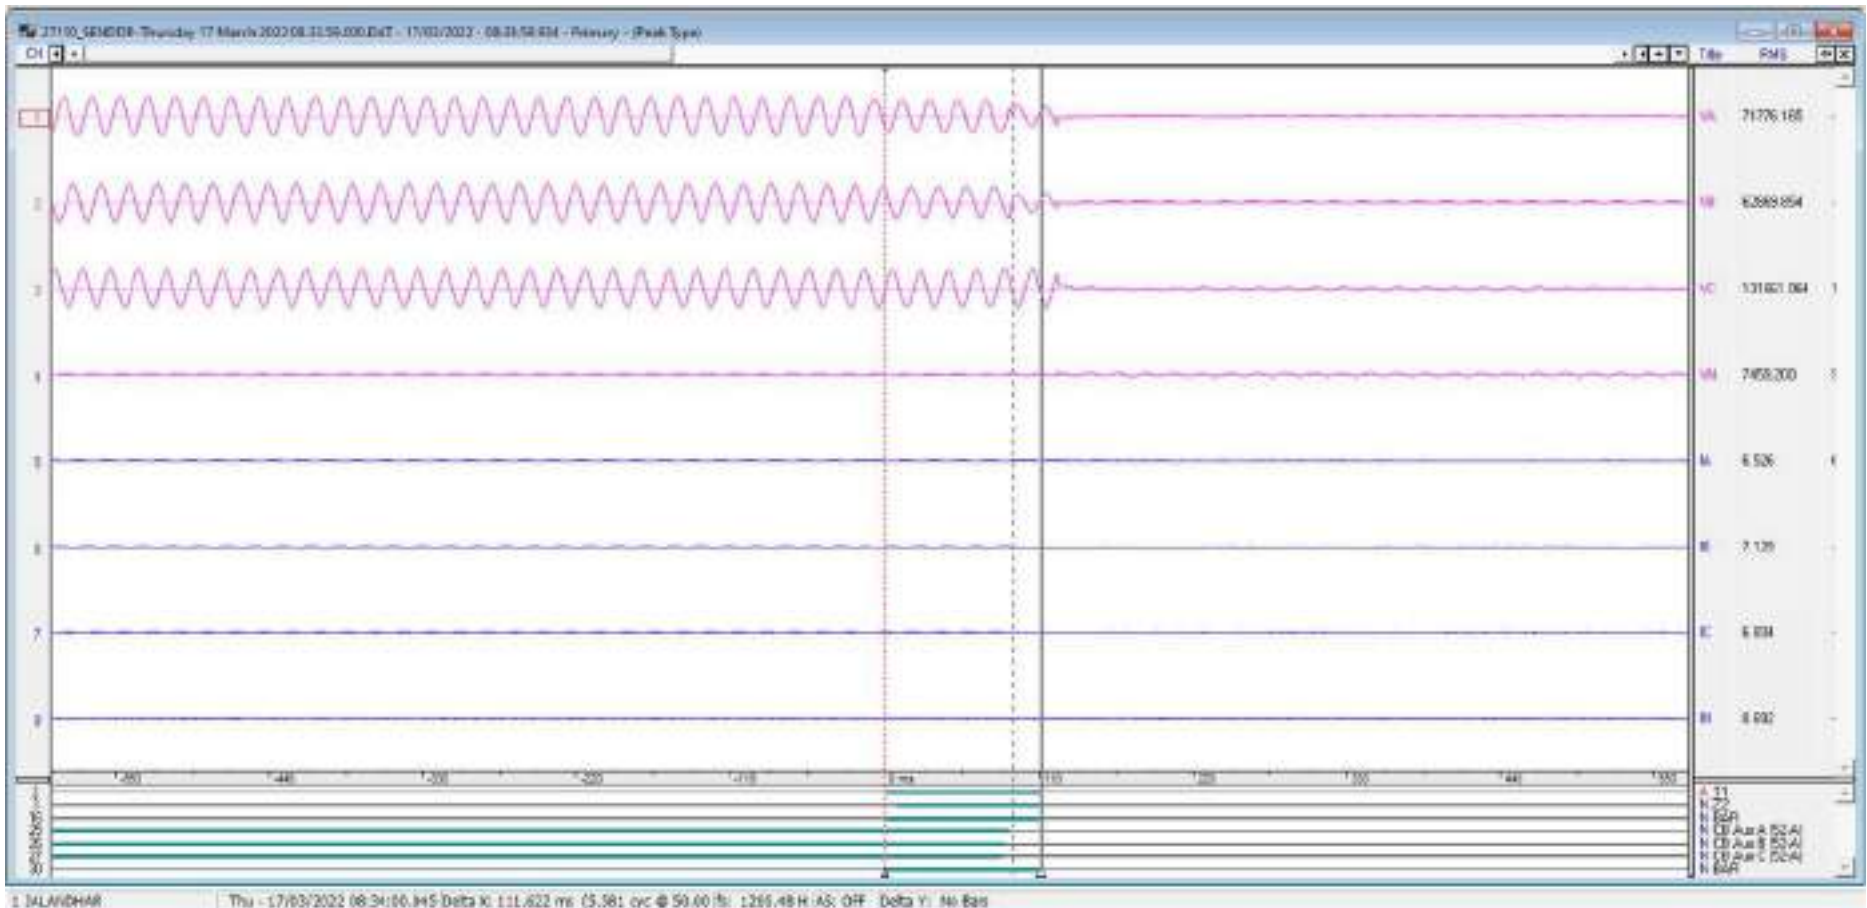
# DR of 220 kV Jalandhar (End) – Pong – 2 Line

1. Line tripped on Zone-2 from Jalandhar End.
2. Zone – 2 timer at Jalandhar end seems to be 100 ms ?
3. No carrier received from Pong?

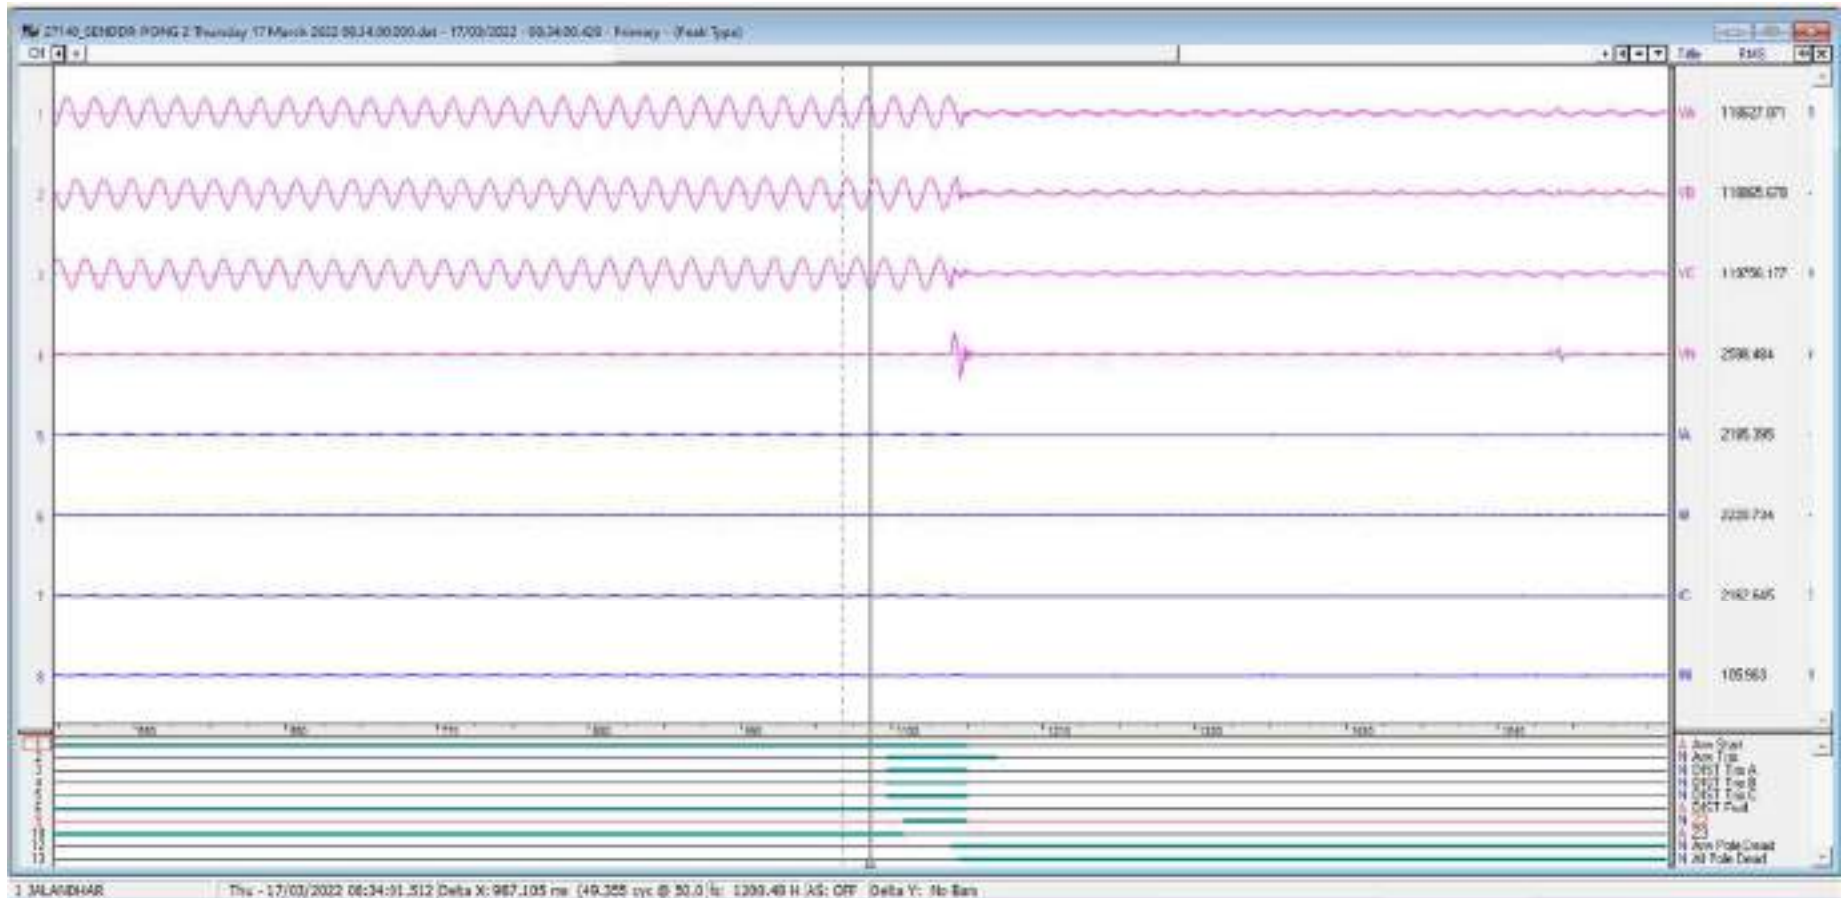
# DR of 220 kV Jalandhar (End) – Pong - 1 Line

1. Line tripped on Zone-3 from Jalandhar End.
2. No carrier received from Pong?

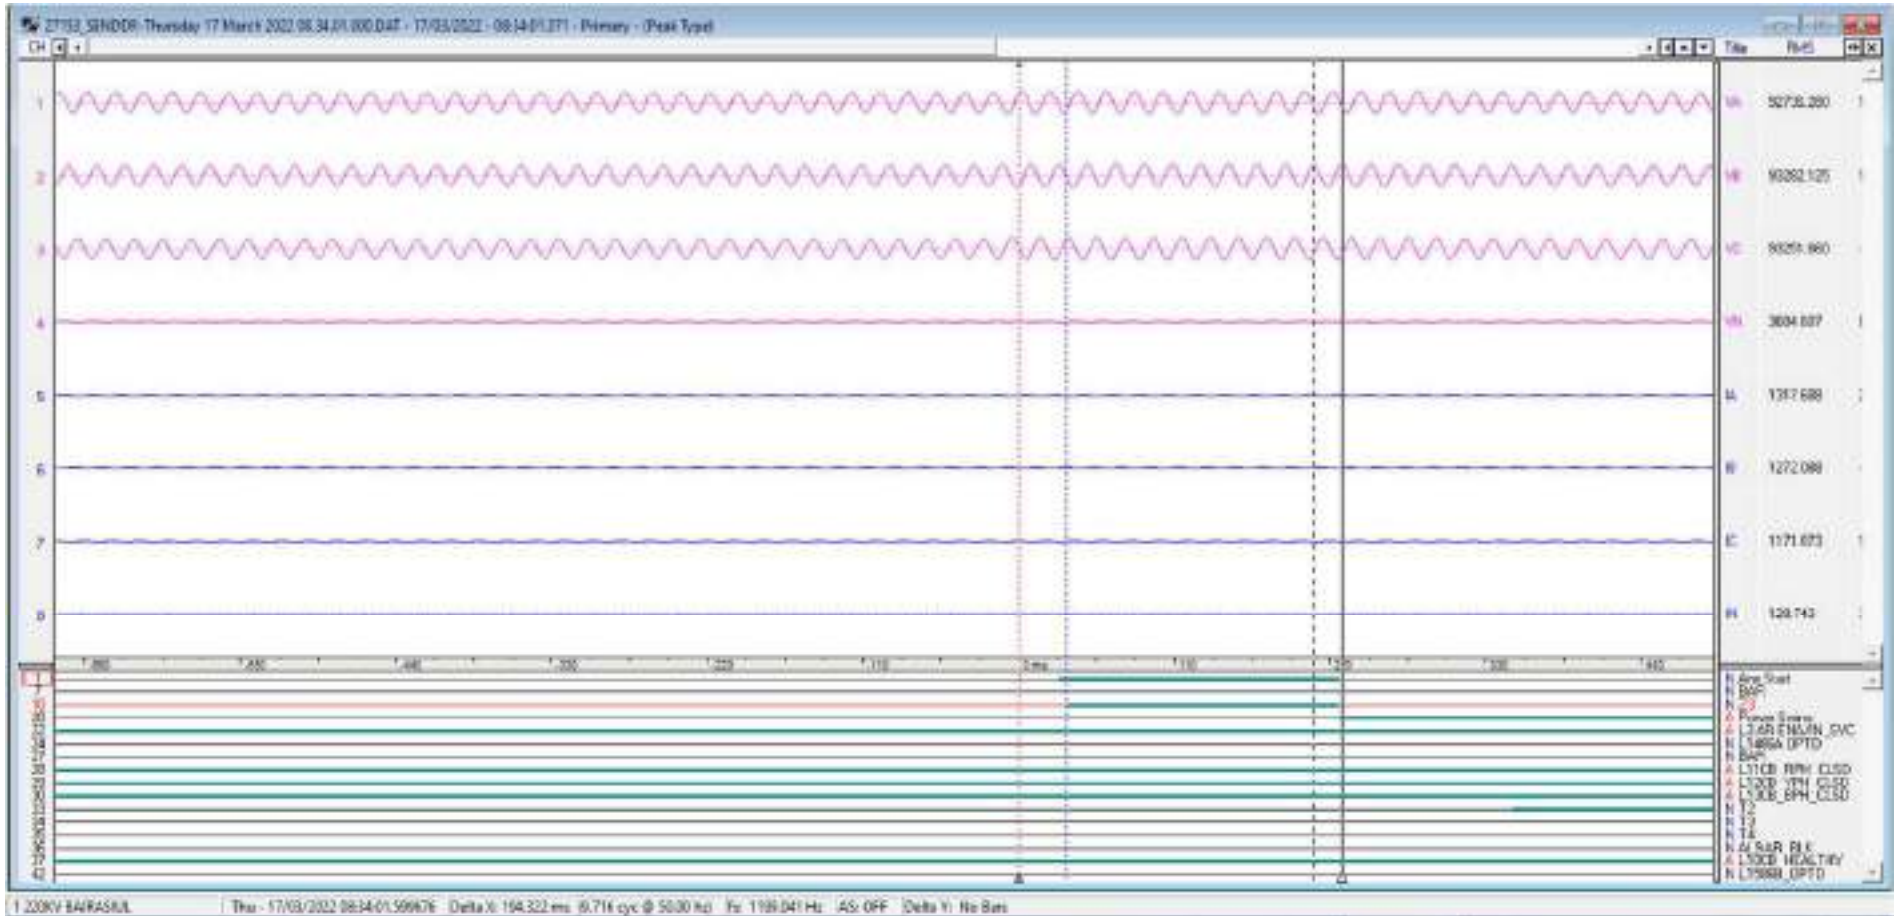
# DR of 220 kV Bairasiul – Pong - 1 Line

1. Line tripped on Zone-3 from Bairasiul end.
2. Zone-3 timer seems to be 200 ms.
3. No carrier received from Pong?

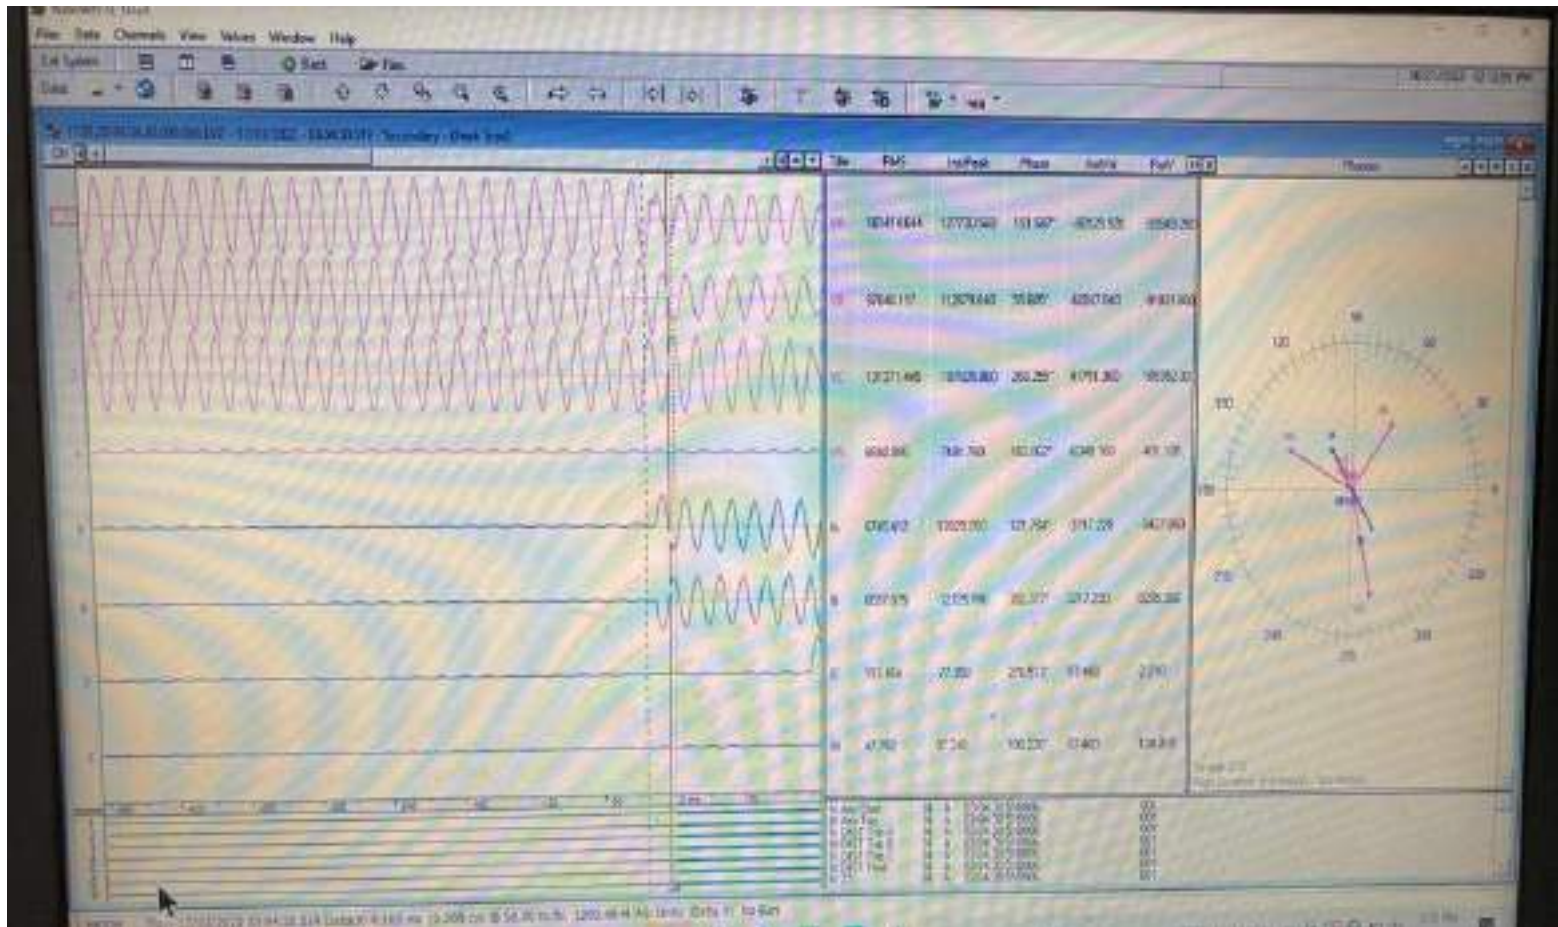
## DR of 220KV Pong Jalandhar Ckt –I

- While busting of Y-Phase Wave-trap of 220 KV Pong- Jalandhar Circuit-1, the Distance Protection relay of Pong-Jalandhar Ckt-I operated and master trip relay 86B &86C operated, but trip supply from Trip Transfer Switch TTS (Normal, Inter & Transfer switch) did not extended to breaker due to loose wire strand in thimble of TTS switch of this feeder/panel. So that the breaker did not tripped and the breaker at Jalandhar end tripped on Zone-I added. Since the fault persist on the Bus and the fault was cleared from other end on Zone-2/3 of other circuits. It is further added that the LBB/BBP relay installed at PPH Talwara is old type electromechanical relay and the operation of this relay may be sluggish. So it may be the cause of delay in operation. The Replacement of this old relay with new Numerical relay is under process.

- During checking, it found loose wire strand in thimble of TTS switch (Normal, Inter & Transfer switch) of 220KV Pong Jalandhar ckt-I and same was made corrected and checked out all control & protection wiring in Control & Relay panel including the operation of Circuit Breaker.
- LBB operation also checked after that and found in order.

- The replacement of existing electro mechanical LBB protection relay is under process with new numerical protection relay.
- Looseness of old Control & protection wiring to be checked regular basis on PTW.

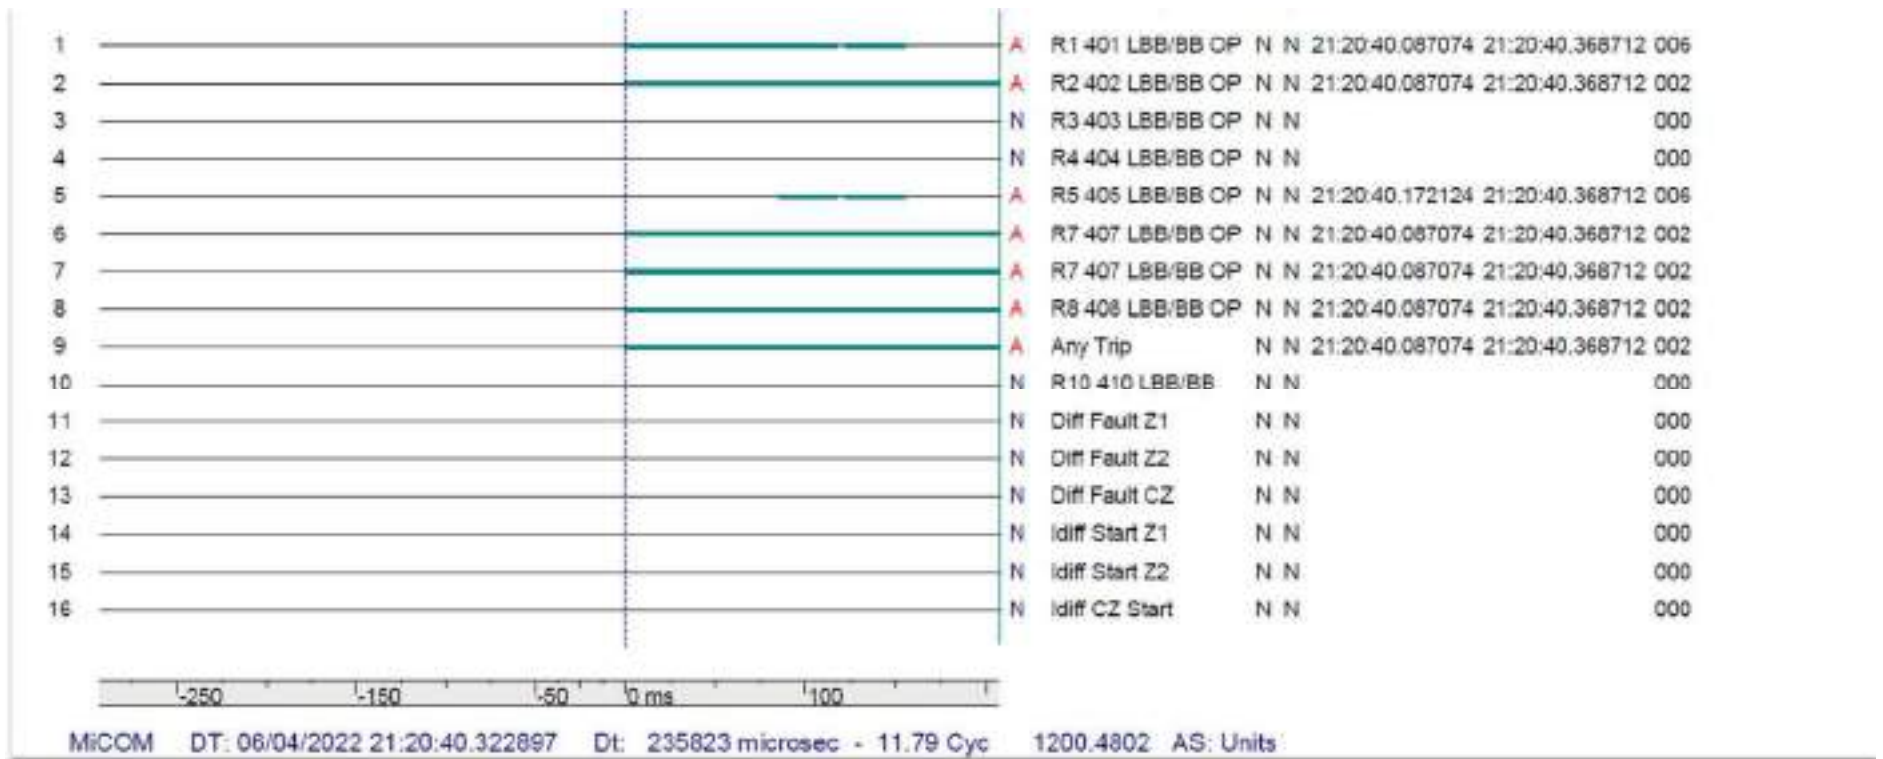
# Noida Sector – 148 S/S - DR of Busbar relay

1. LBB/BB trip signal high in all the bays.
2. Signal is high intermittently in some bays such as 405.

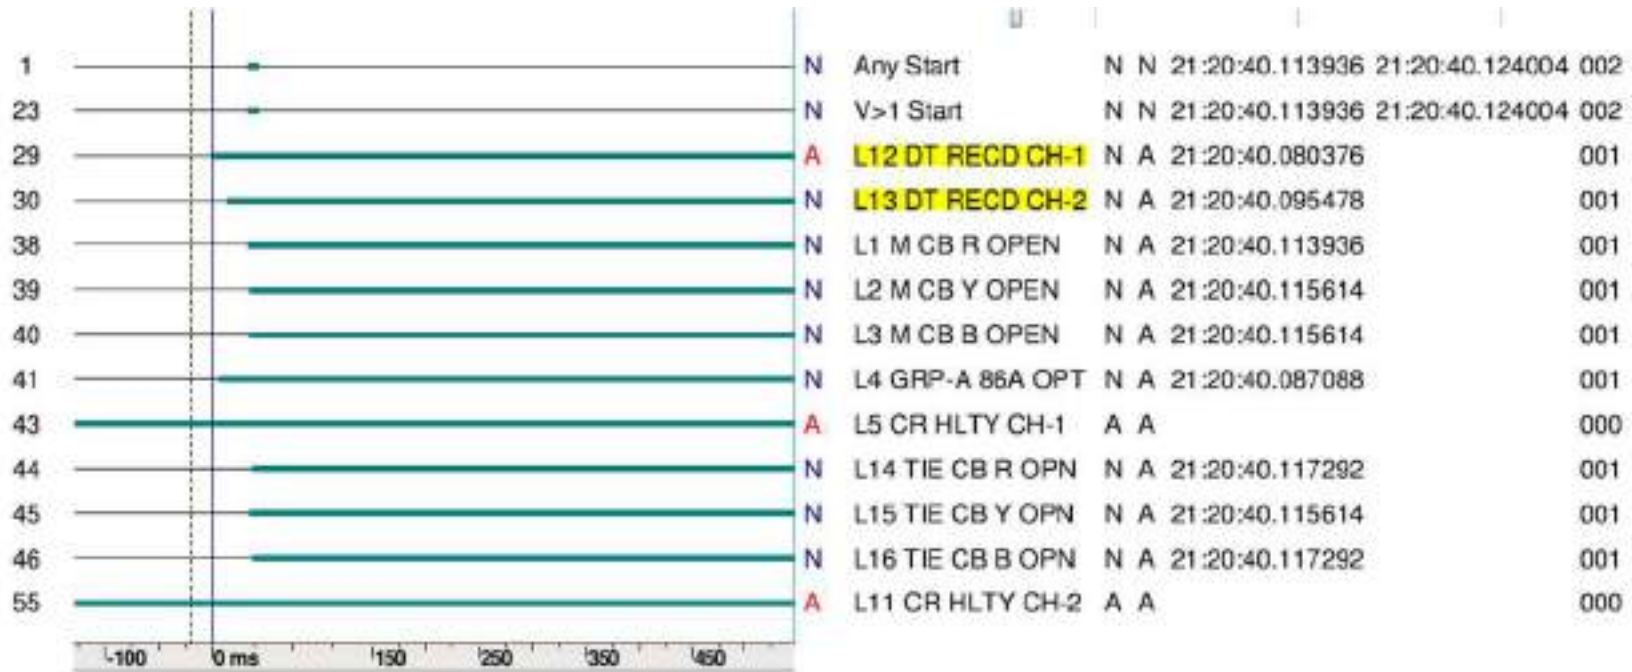
# 765kV Greater Noida (End) - Noida Sector – 148 Line DR

1. Current and voltages in line were normal at time of tripping and no fault observed.
2. Tripping occurred on DT received from Noida Sec-148 end.

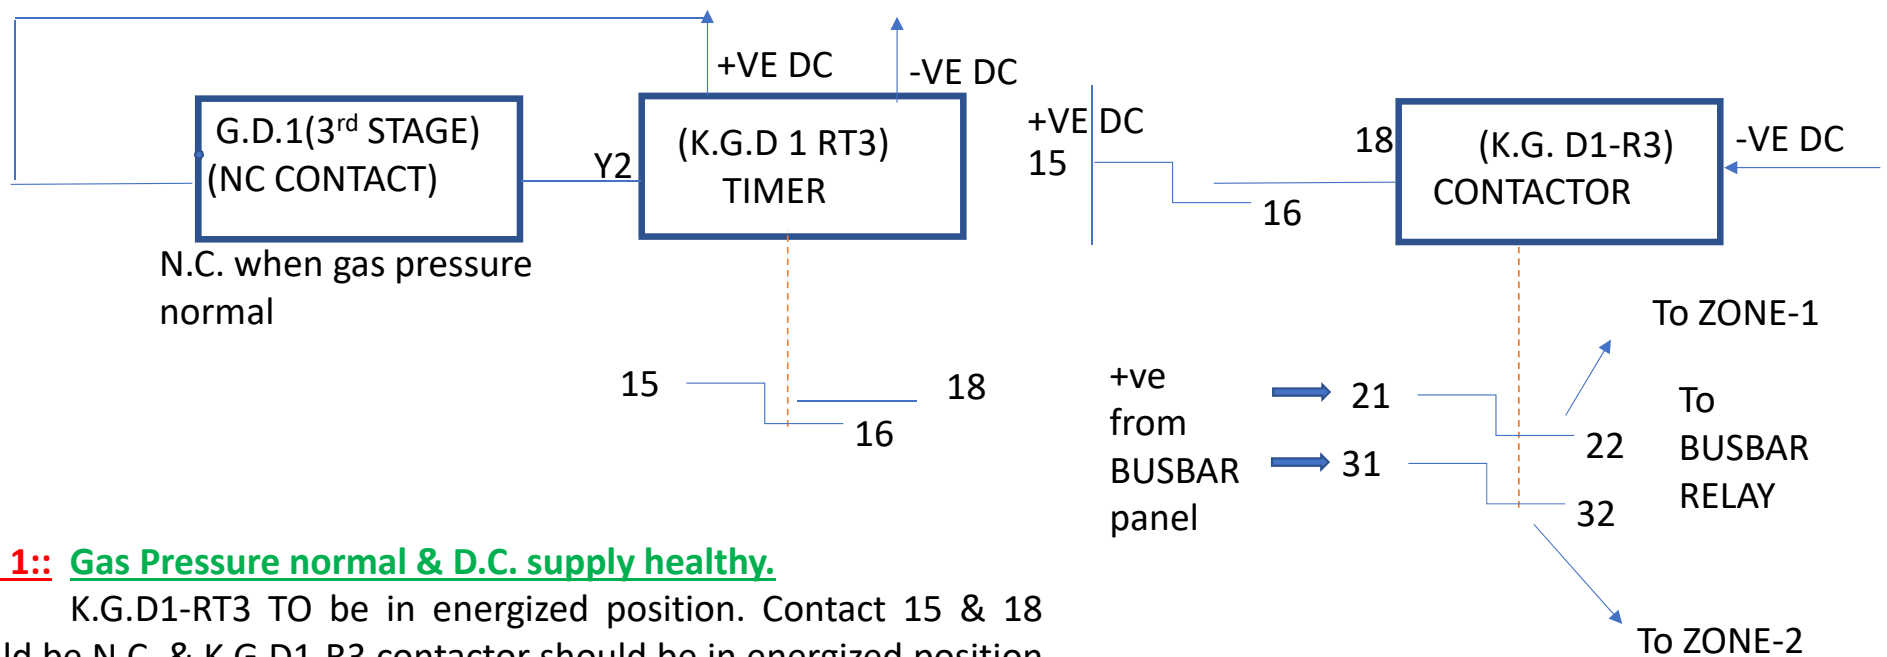
# Why did Busbar Operate on DC Fail

## **Case 1:: Gas Pressure normal & D.C. supply healthy.**

K.G.D1-RT3 TO be in energized position. Contact 15 & 18 should be N.C. & K.G.D1-R3 contactor should be in energized position & therefore, bus bar tripping contact 21,22 & 31,32 will be N.O. & system will run healthy without tripping.

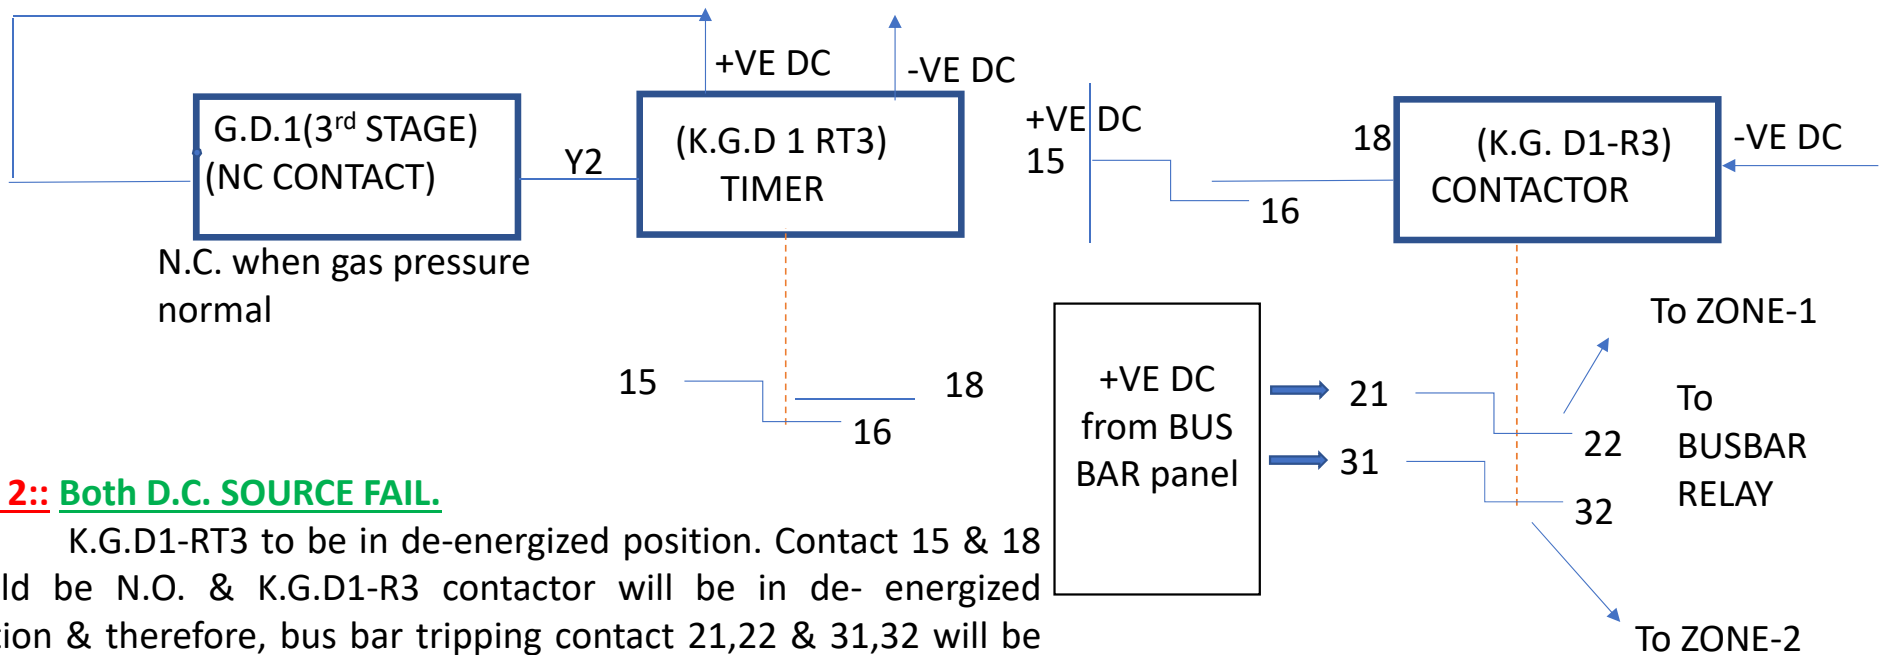
# Why did Busbar Operate on DC Fail

## Case 2:: Both D.C. SOURCE FAIL.

K.G.D1-RT3 to be in de-energized position. Contact 15 & 18 should be N.O. & K.G.D1-R3 contactor will be in de-energized position & therefore, bus bar tripping contact 21,22 & 31,32 will be N.C. & Busbar Relay D.I will become High(Logic-1) and thus led to busbar tripping.

- Is there single DC source at Noida Sec-148 S/S?
- No. There are two DC sources at Noida Sec-148 S/S.
- What is the bus bar protection scheme adopted.
- Bus Bar protection operation on Bus differential/LBB, Gas Detector Stage-3 and Both DC source failure.
- In GIS gas detectors whether NO or NC is used?
- Yes. NO or NC are used, in normal condition gas detector contacts remain in close condition .
- Was 400KV Noida Sec-148-Noida Sec 123 line already out?
- No. 400KV Noida Sec-148-Noida Sec 123 line was in charge condition before busbar tripping.
- What remedial measures have been taken?
- Defective cards in battery charger have been changed so that dc failure does not occur again.
