भारत सरकार  
Government of India  
विद्युत मंत्रालय  
Ministry of Power  
उत्तर क्षेत्रीय विद्युत समिति  
Northern Regional Power Committee

**विषय:** संरक्षण उप-समिति की 45<sup>वीं</sup> बैठक के कार्यवृत्त।  
**Subject:** Minutes of 45<sup>th</sup> Protection Sub-Committee Meeting.

## ***Minutes of 45<sup>th</sup> Meeting of Protection Sub-committee***

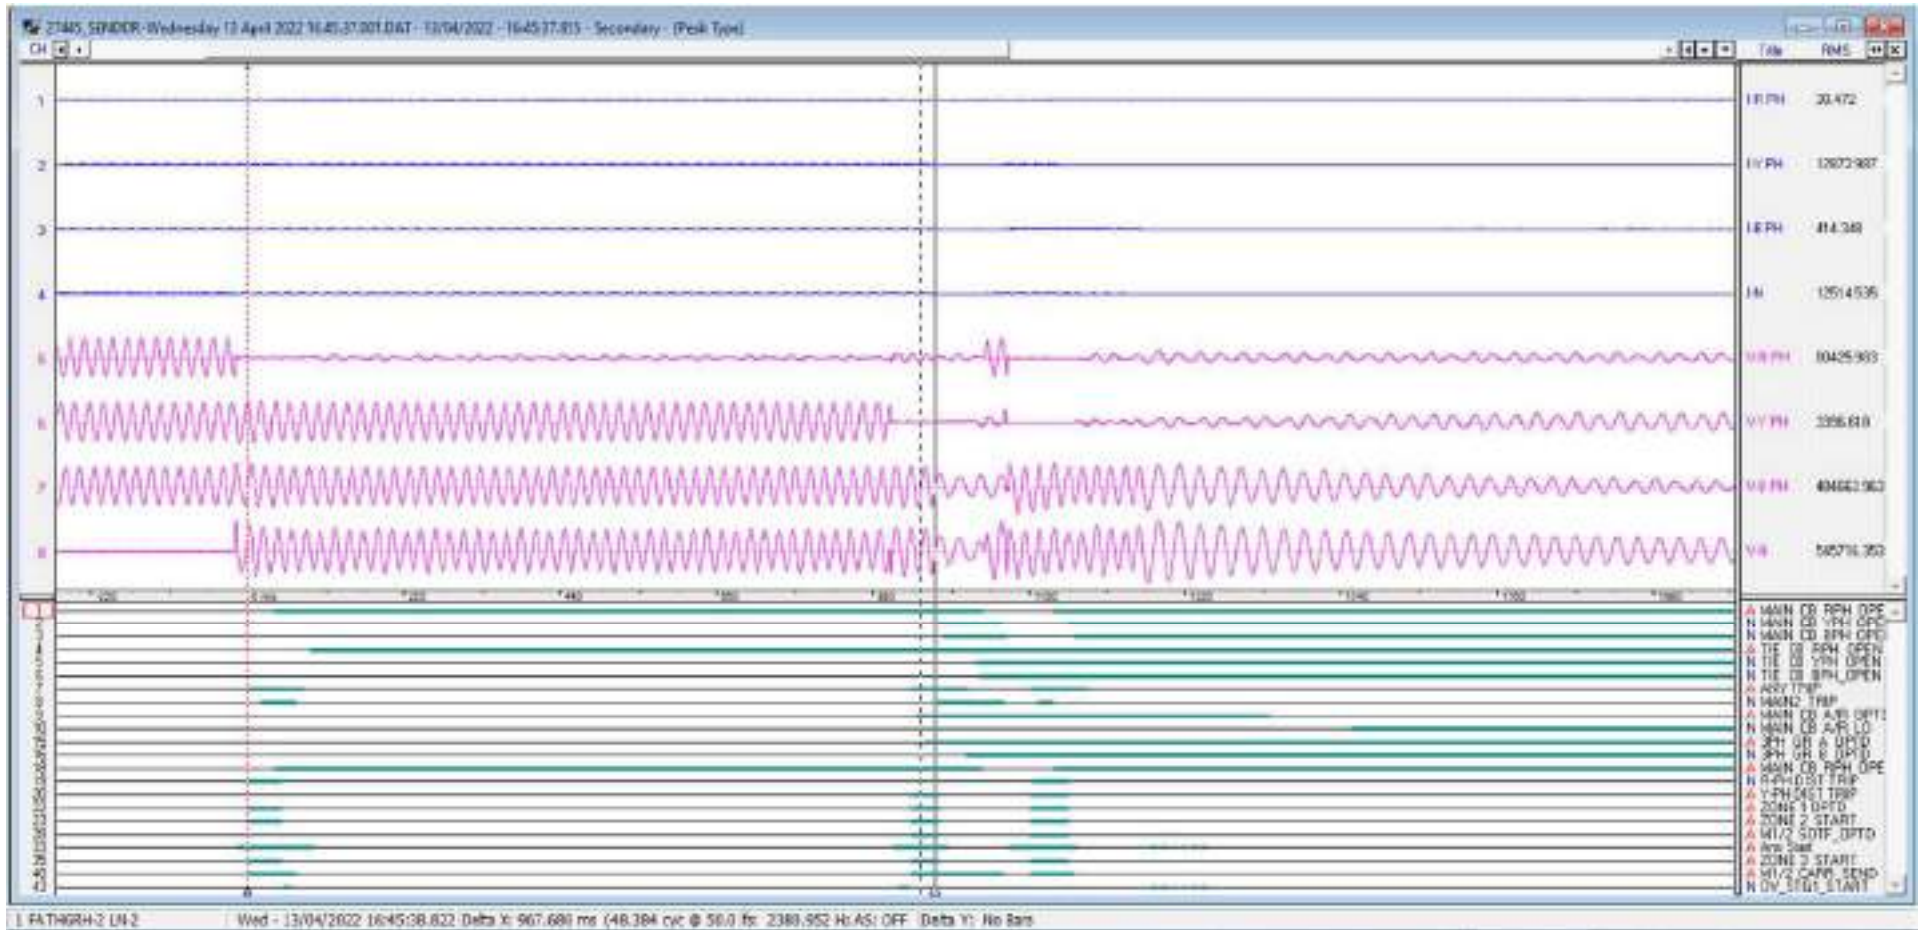
# DR of 765 KV Bhadla\_2 (PG)-Fatehgarh\_II(PG) (PFTL) Ckt-2

1. R-Phase to earth fault, FC-13 kA
2. AR attempted but Y-Phase to earth fault appeared, FC-12 kA.

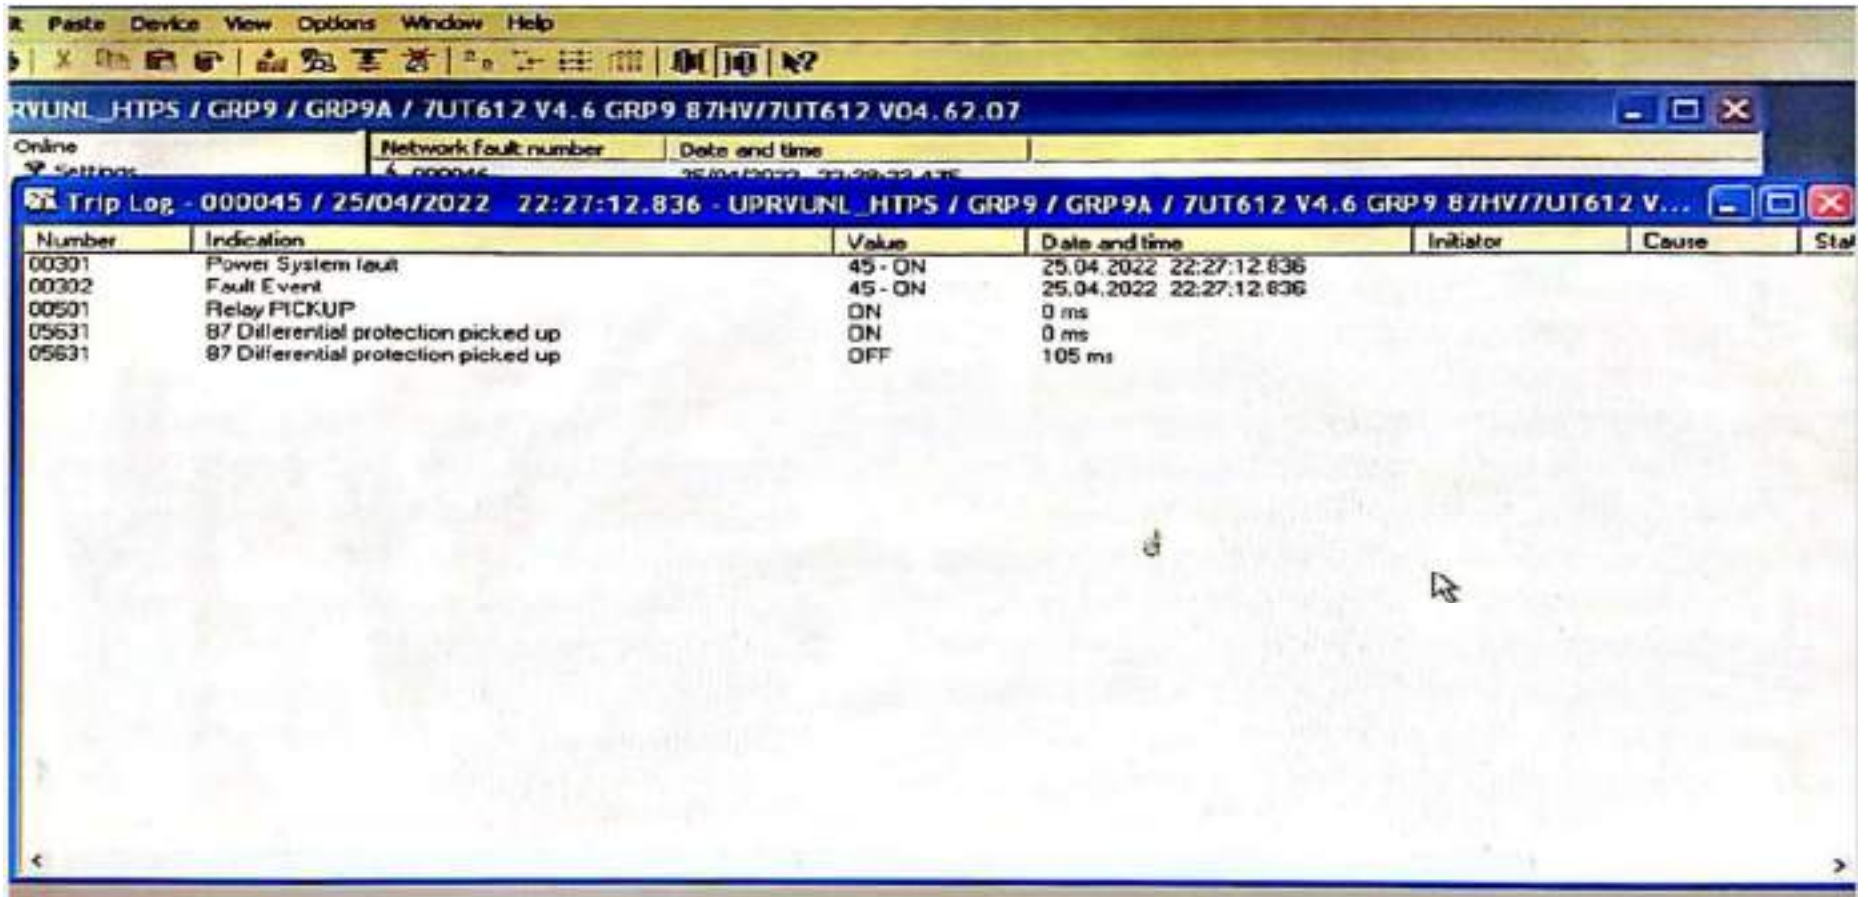
# DR of 250 MW Unit - 9

87 Differential Protection Start.

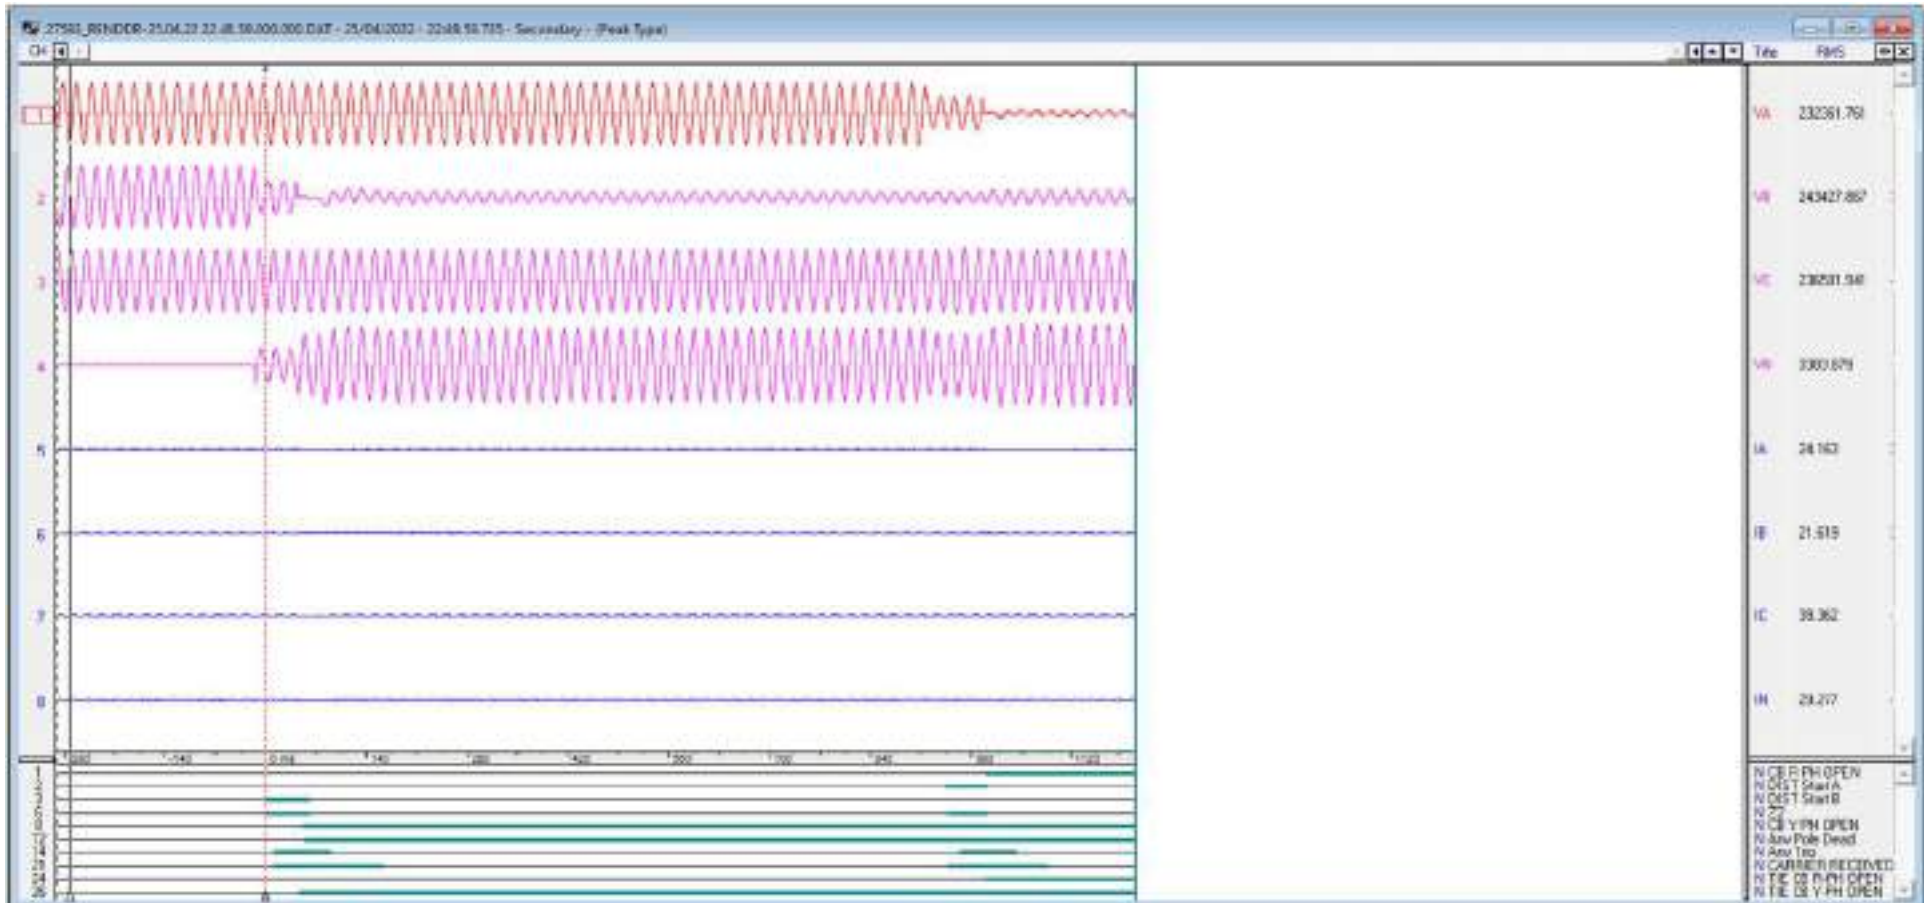
# DR of 400 kV Harduaganj – Aligarh(End) Line

1. Time sync faulty.
2. Y-Phase fault evident. Zone-2, Carrier receive.
3. AR attempted but unsuccessful.
